**Serious incident** to the ATR72-212A  
registered **F-ORVO**  
on Monday 29 September 2025  
at Nuku Hiva airport (French Polynesia)

**Restriction in nose-down deflection then uncoupling of  
elevator controls during final approach**

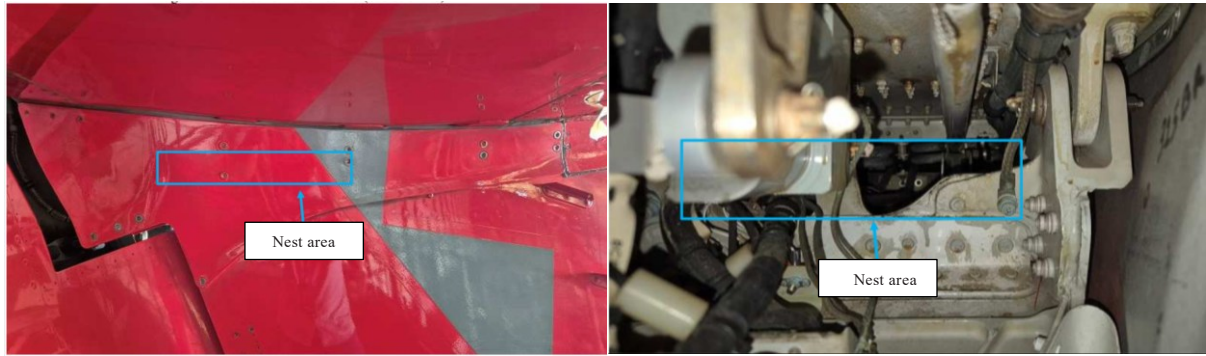
Between 30 September and 21 October, all of the elevator control channel was inspected by Air Tahiti in coordination with the BEA and ATR. Apart from some bird nests found at the top of the vertical stabilizer, no anomaly was reported.

*Figure 2: area where nests were found and then removed (source: Air Tahiti)*

Air Tahiti found several nests or nest material on a few aeroplanes, including F-ORVO, inside the vertical stabilizer and in particular at the feedthrough of the elevator control rods.

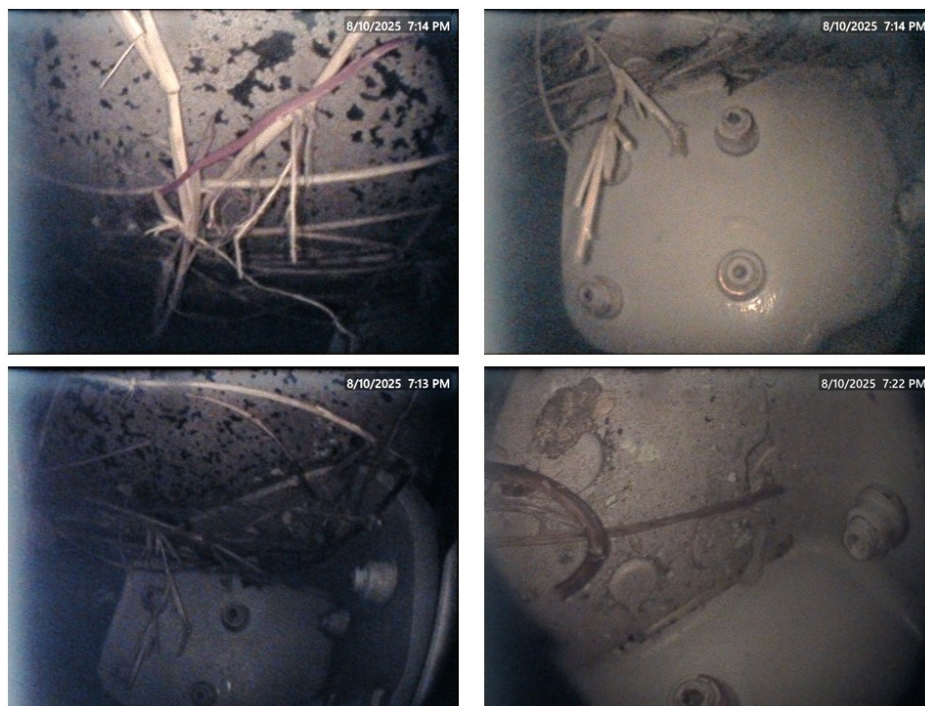
*Figure 3: nest material identified on F-ORVO during the complete inspection of the elevator control channel, carried out several days after the detection and removal of the first nests the day of the incident (source: Air Tahiti borescope inspection)*

The presence of nest material in certain areas of an aeroplane is a phenomenon sometimes observed by operators and aircraft manufacturers. Similar cases of nest building have been reported in the past by ATR operators on completion of inspections. Their presence had not been detected by the crews during the before take-off control deflection tests and had not had an operational impact.

As there was no other hypothesis to explain the restriction in the nose-down deflection during the occurrence, ground tests were carried out on an ATR test plane in the presence of the BEA to assess the possibility of the elevator control having been jammed by nest material inside the vertical stabilizer.

None of the tests performed reproduced jamming of the elevator controls by nest material at the junction between the aeroplane's horizontal stabilizer and vertical stabilizer, the area in which the nests had been identified during inspections carried out by Air Tahiti.
