**Serious incident** to the ATR72-212A  
registered **F-ORVS**  
on Monday 4 April 2022  
at Hiva-Oa-Atuona (French Polynesia - Marquesas Islands)

**Non-stabilised approach, windshear, opposite dual inputs,  
hard landing, balked landing**

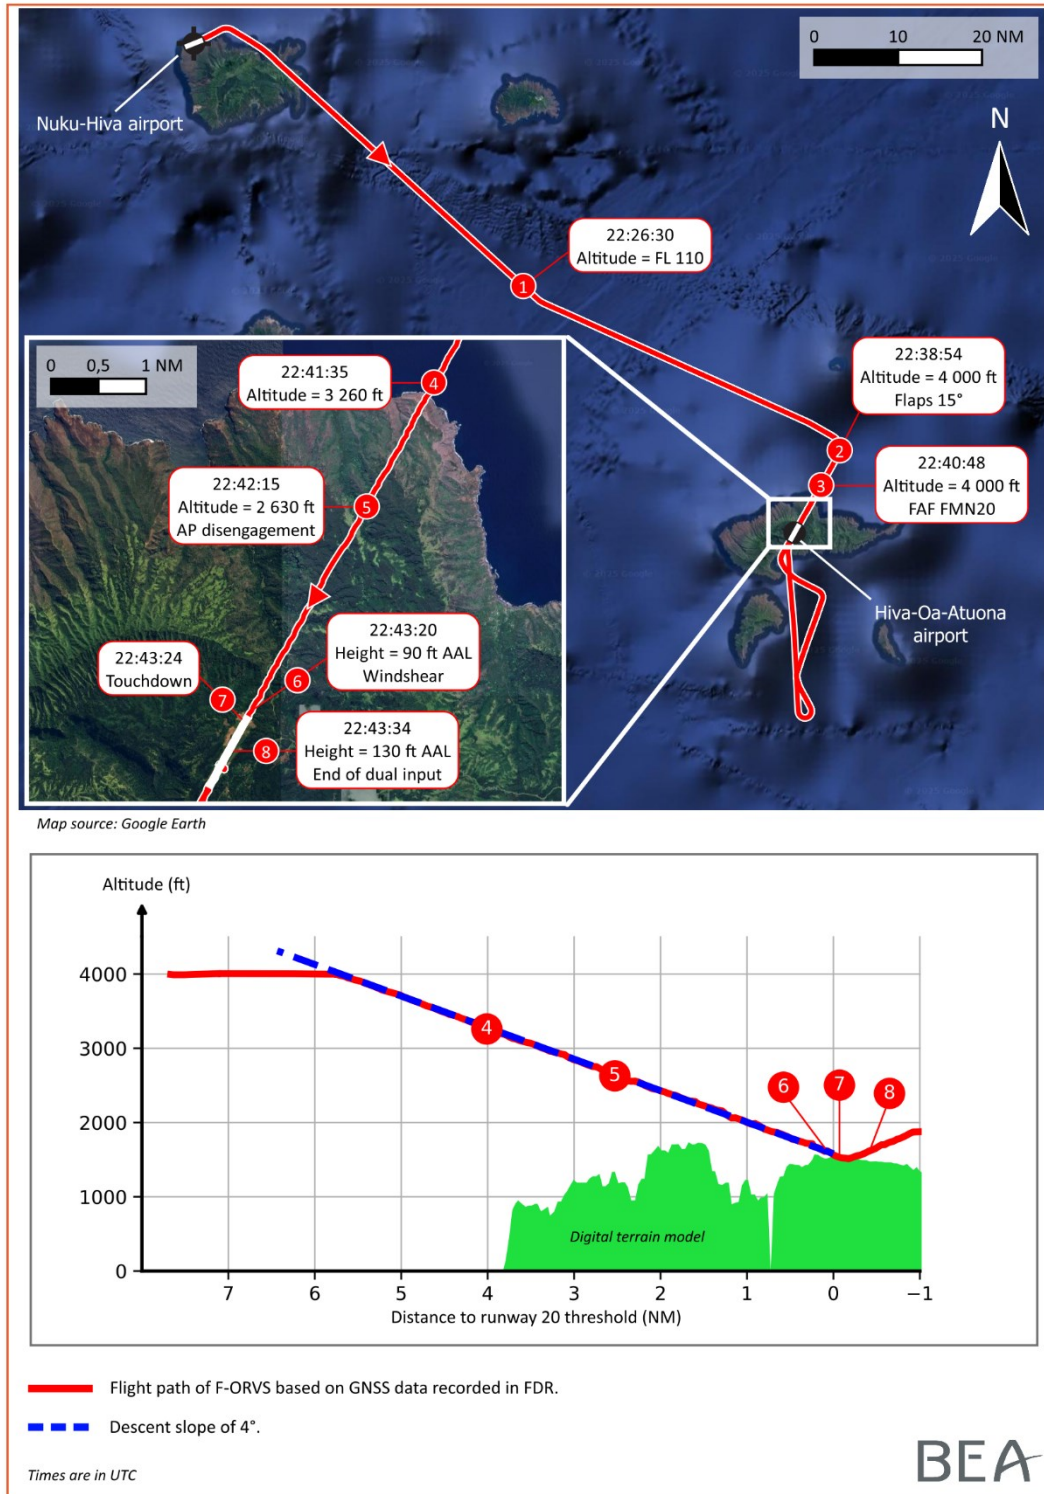
Figure 1: flight path of F-ORVS (source: BEA)

From 22:41:35 (point ④), the aeroplane entered a zone of turbulence and the load factor varied between 1.25 g and 0.76 g. The aeroplane descended through 3,260 ft, level with the north coastline of Hiva-Oa island at 4 NM from the threshold of runway 20. The captain and co-pilot discussed the turbulence encountered and decided for this reason, to hold the speed above  $V_{APP}$ .

At 22:43:20, the aeroplane encountered windshear when descending through 1,610 ft (90 ft AAL) (point ⑥). The calculated wind direction passed from 140° to 067°. The wind strength on the longitudinal axis of the aeroplane varied between a 4 kt headwind and a 10 kt tailwind in three seconds. The indicated airspeed decreased from 130 kt to 109 kt in five seconds.

Less than one second later, the wheels of the main landing gear touched down hard on the runway. The recorded vertical load factor increased up to 2.97 g (point 7). The aeroplane bounced. The captain called out that he was taking the controls and starting a go-around. At the same moment, the **PITCH DISC** procedure was displayed on the central screen and the **MASTER WARN** aural and visual alert was activated. The co-pilot and the captain continued to make opposite dual inputs on their respective control columns for 11 s.

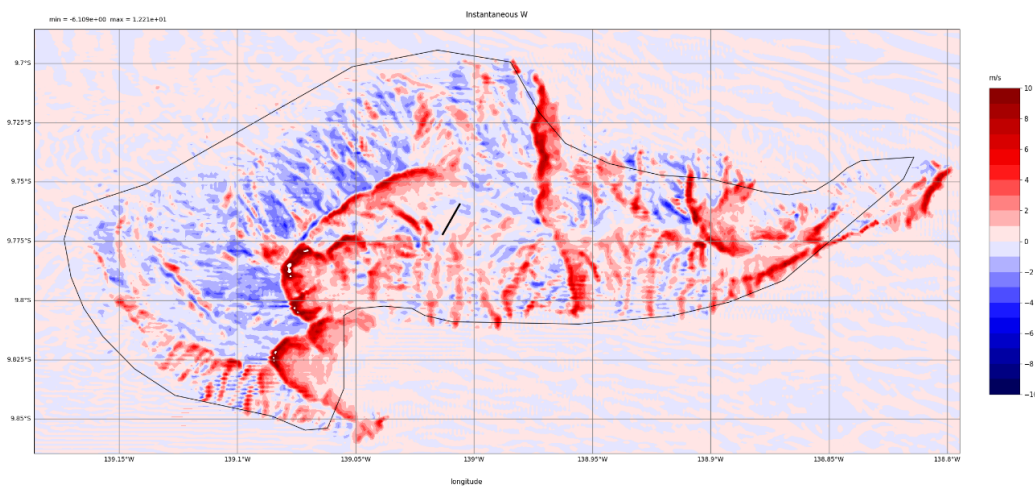
Figure 4: instantaneous vertical speed chart ( $m.s^{-1}$ ): 4 April 2022 at 23:00 TU.  
Height 100 ft (source: Météo-France)

The vertical cross-section on the approach path illustrates the presence of ascending and descending air of significant intensity in the vicinity of the aerodrome, extending from the ground to a height of around 1,500 ft at both ends.

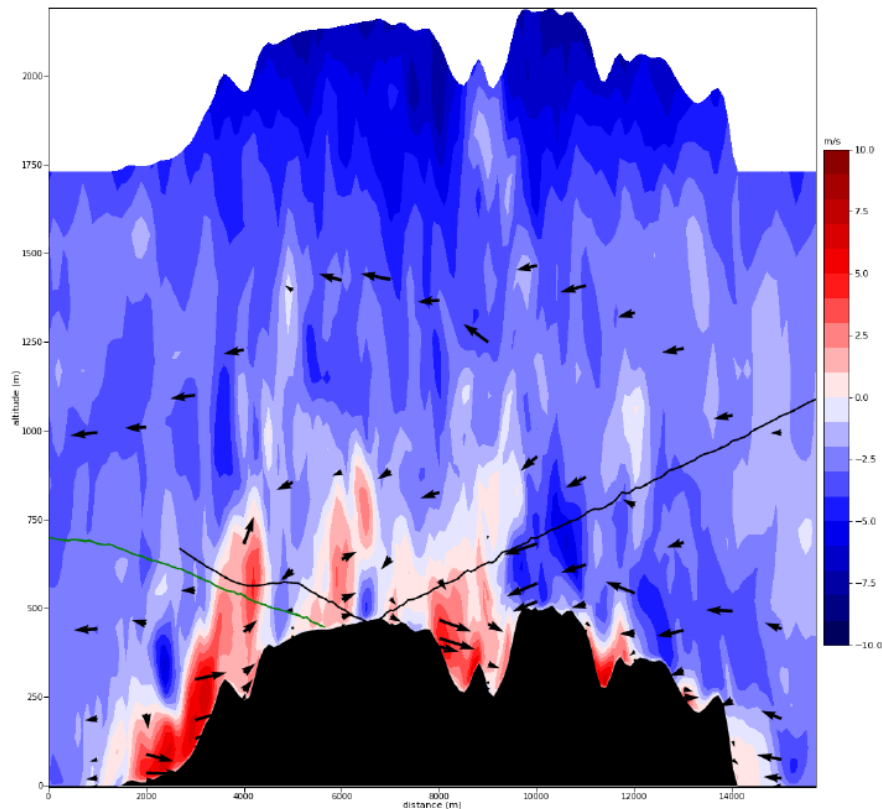
*Figure 5: vertical cross-section of vertical wind speeds along the runway axis, APP 20 (black line), APP 02 (green line) – 4 April 2022 at 23:00 UTC (source: Météo-France)*

The succession of zones of ascending and subsiding air illustrates the presence of vertical windshear in the lower layers.

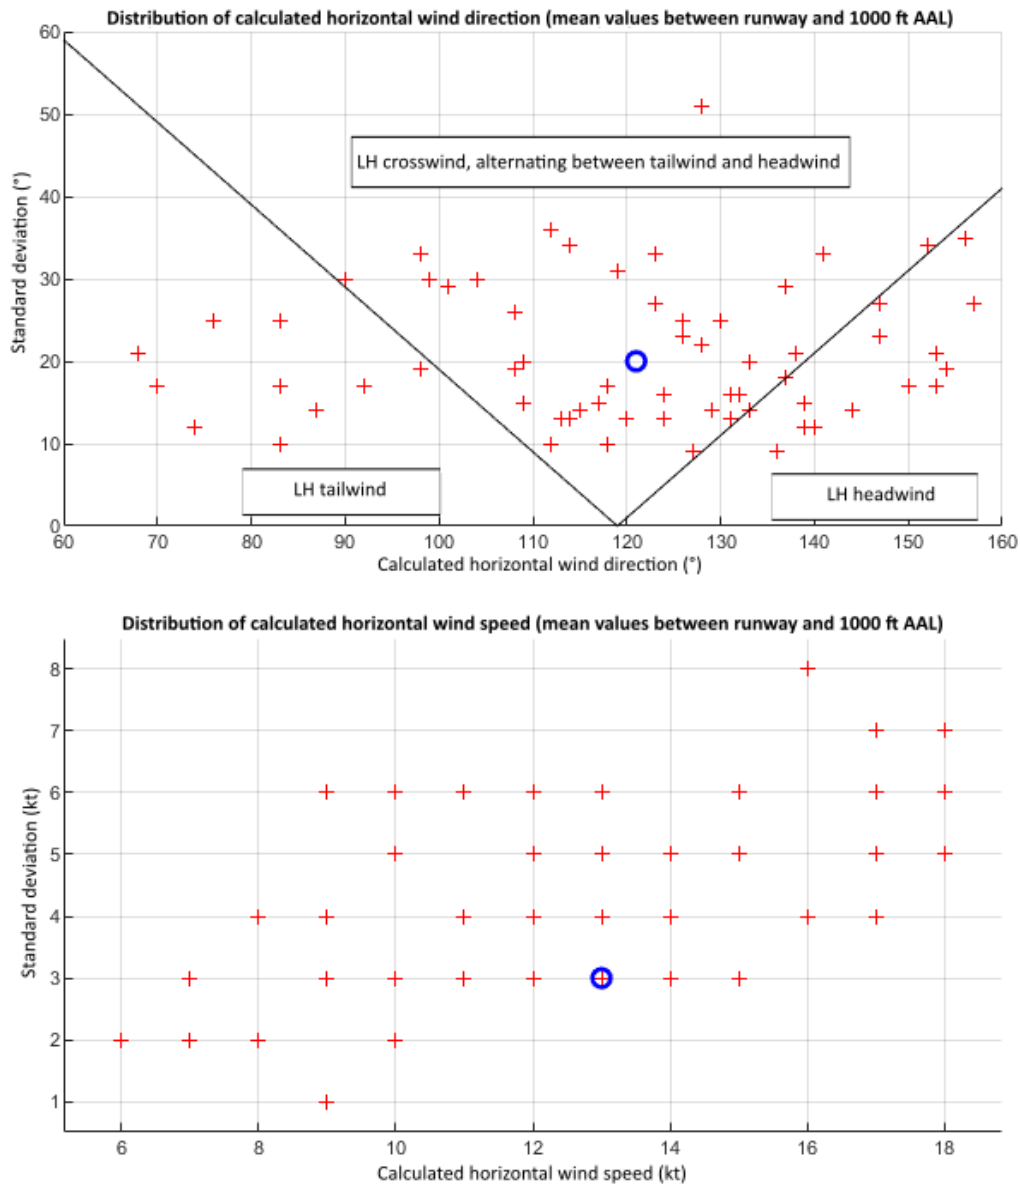
The results of the calculations for the occurrence flight (blue circle on previous figures) show that the aerological conditions encountered on the approach between 1,000 ft agl and touchdown were not among the most turbulent of the sixty-six approaches analysed. The average wind direction was 121° (standard deviation 20°), i.e. a left crosswind coming alternately from behind or ahead, with an average intensity of 13 kt (standard deviation 3 kt).

The significant difference with the other approaches is the presence of horizontal windshear between a height of 100 ft and 50 ft.

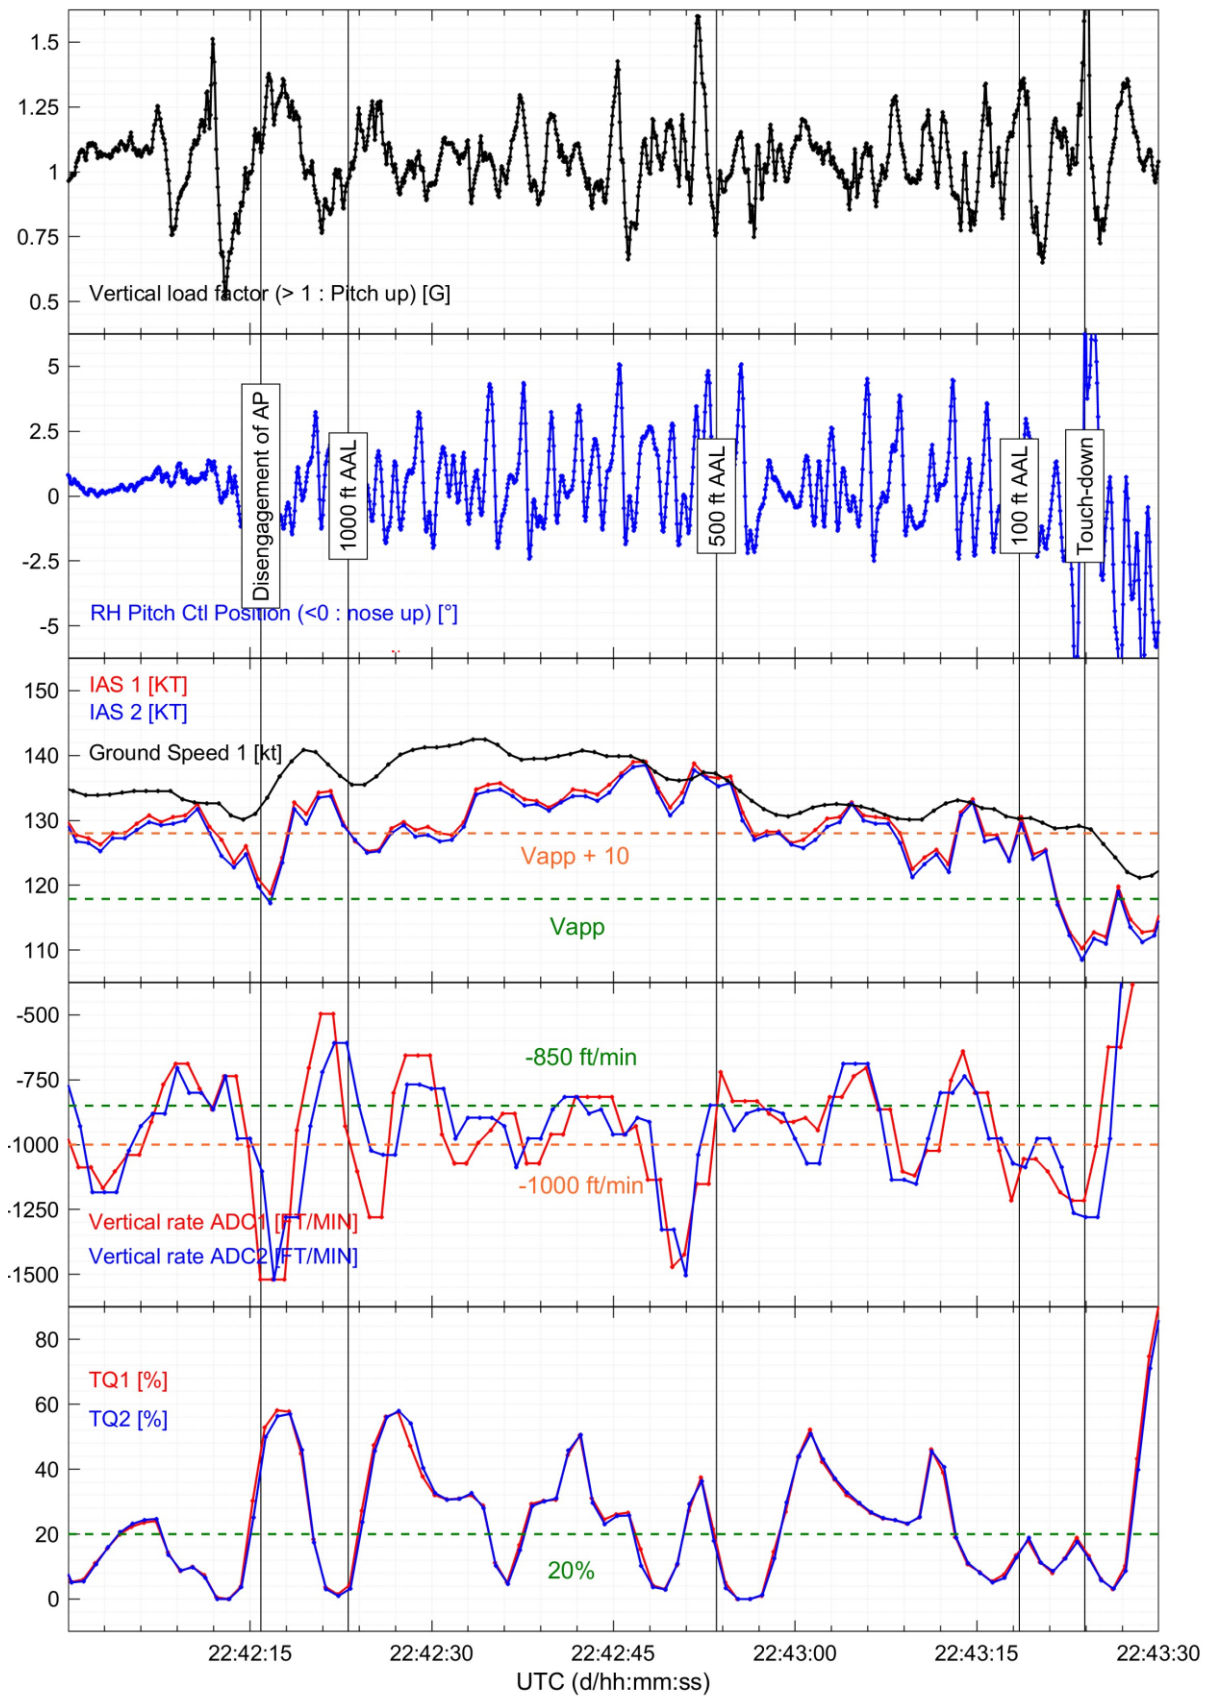
Figure 9: destabilisation of approach (source: BEA)

The analysis of the flight parameters found a destabilisation of the approach below 500 ft. It was notably characterised by:

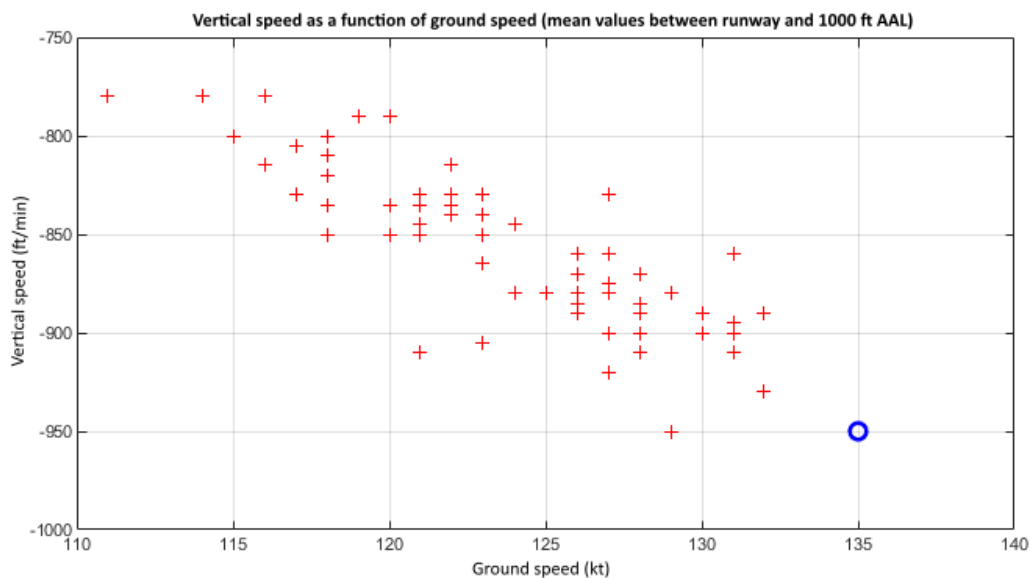
Figure 10: analysis of average energy on approach (source: BEA)

These three values were greater than all those calculated for the other approaches.

The energy during the approach (vertical speed-ground speed pair) of the occurrence flight (blue circle) was significantly higher than for all the other approaches analysed (red cross).

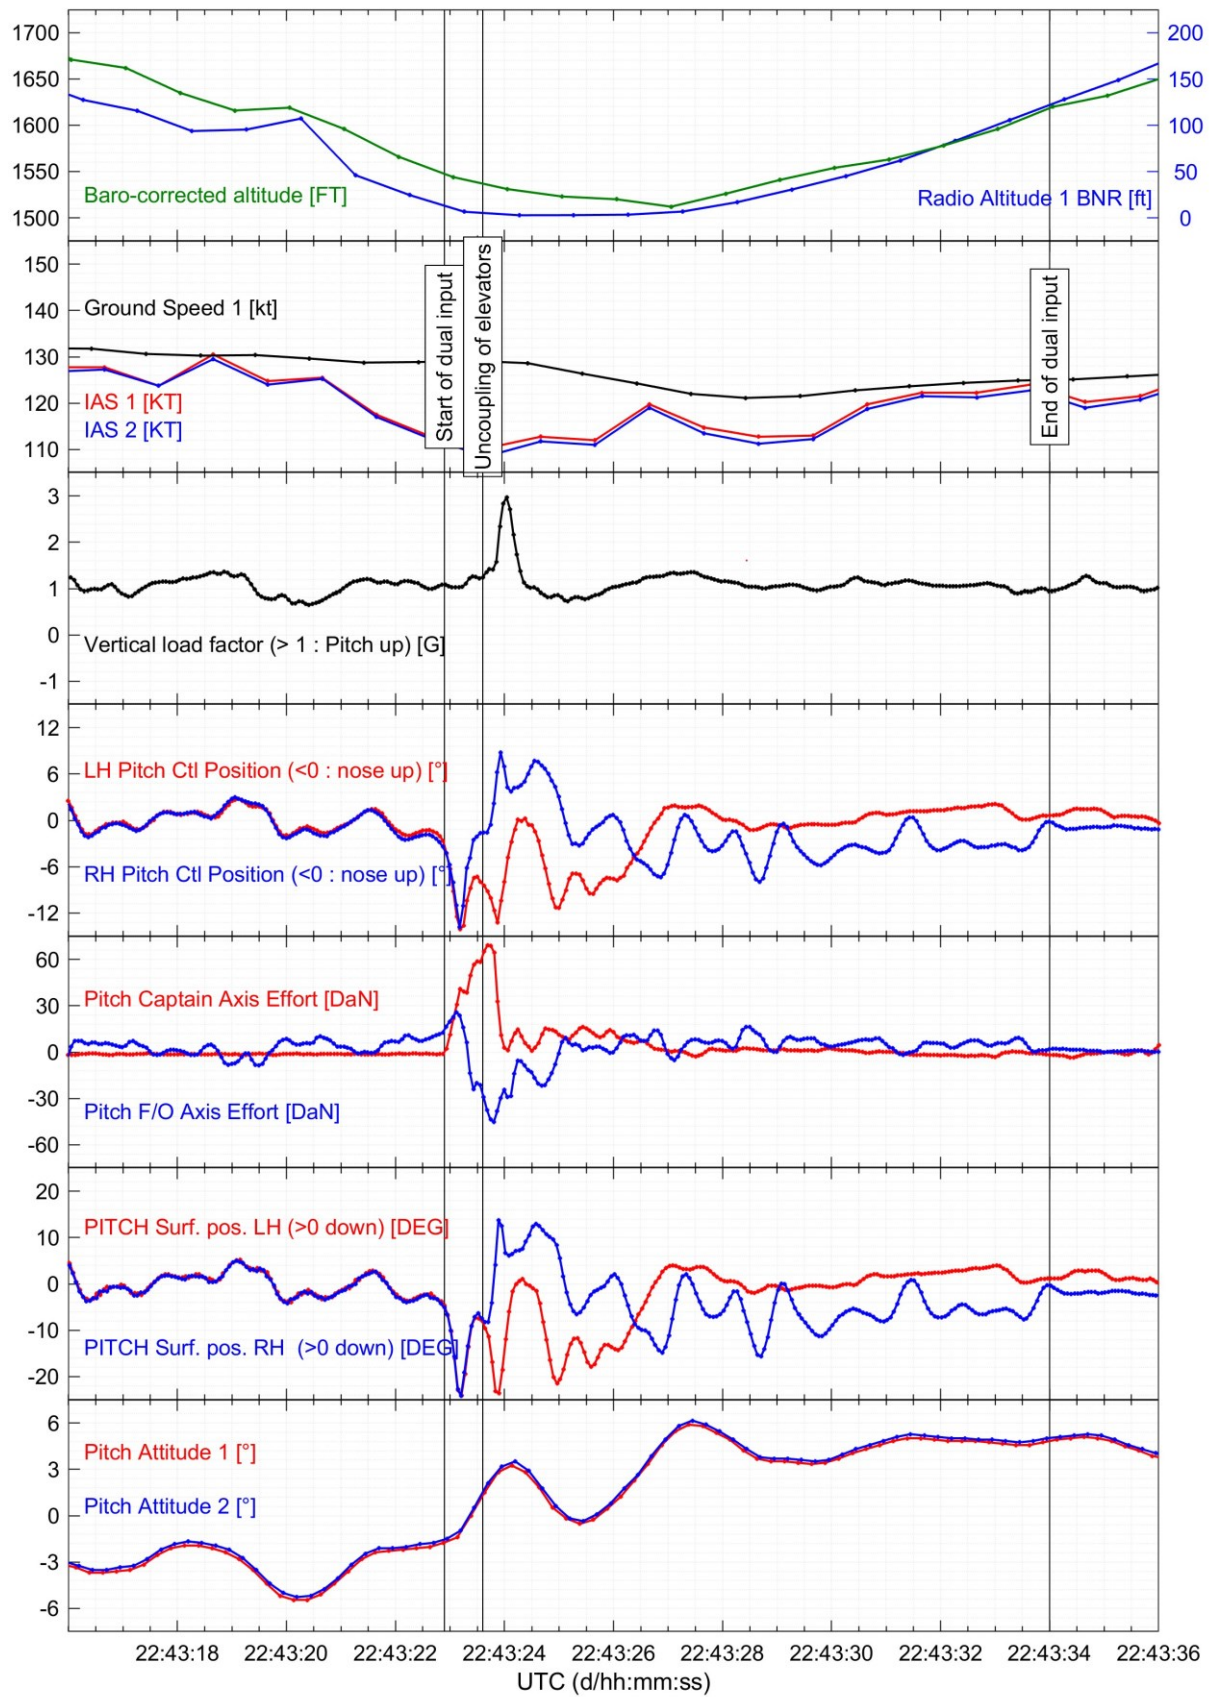
Figure 12: uncoupling of elevators (source: BEA)

The analysis of the parameters concerning both the elevator positions and the loads applied to the control columns precisely identified the point at which the LH and RH elevators were uncoupled. It occurred less than one second before wheel touchdown when the PM was applying a nose-up load of 65 daN and the PF a nose-down load of 30 daN.

The PM had called for power and then acted on the control column in a reflex manner in reaction to a sudden loss of height due to windshear. Being a reflex action, he did not call out his input. The co-pilot who, until that time, had been correcting flight path deviations caused by severe aerological disturbances was surprised by this load and countered it. The captain called out, “Go-around” at 22:43:24, then indicated the Pitch disconnect warning and added that he had the controls in the following second.
