Incident to the ATR72-212A
registered **F-OZKN**
on Friday 20 December 2024
at Ouvéa-Ouloup airport (New Caledonia)

Time	Around 19:35 ¹
Operator	Air Calédonie
Type of flight	Passenger commercial air transport
Persons on board	Captain (PM ²), co-pilot (PF), 2 cabin crew members and 68 passengers
Consequences and damage	Tail slightly damaged
This is a courtesy translation by the BEA of the Final Report on the Safety Investigation. As accurate as the translation may be, the original text in French is the work of reference.

Limited external visual references, early flare, tailstrike with runway, at night

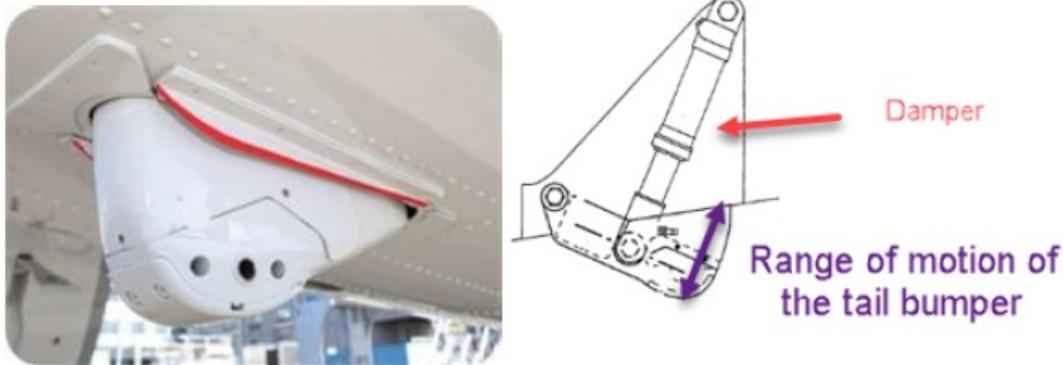
Figure 2: tail bumper (source: ATR)

The ATR 72 is equipped with a tail bumper, at the rear of the aeroplane, under the fuselage. It is designed to dampen any tailstrike with the runway (see **Figure 2**). During the walk-around inspection, the pilot checks that there are no marks on the red lines which indicate whether the tail bumper has been compressed or not.

After the incident, the crew observed the presence of marks on these red lines which led to an inspection by the operator's maintenance department. This inspection took place on 21 December 2024 and did not reveal any additional damage.
