**Accident to the NICOLIER HN700  
registered F-PADB  
on Monday 2 May 2022  
at Blois-Le Breuil aerodrome**

**Incorrect installation of roll control cables, loss of control  
on take-off, tipping over, collision with the ground**

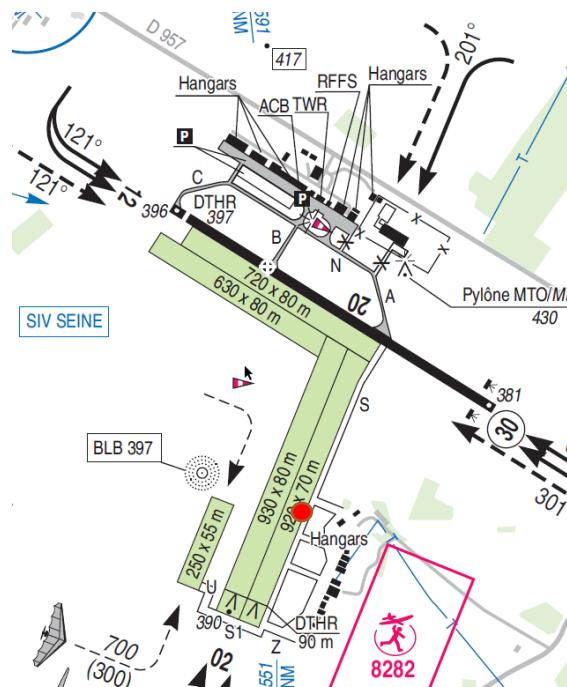
The aeroplane accelerated, took off, entered a left roll, tipped over and collided with the ground. It stopped 300 m after the threshold of runway 02, on the right side of the runway, about 5 m from the edge of the runway.

Figure 1: location of the wreckage (runway 02/20) shown in red

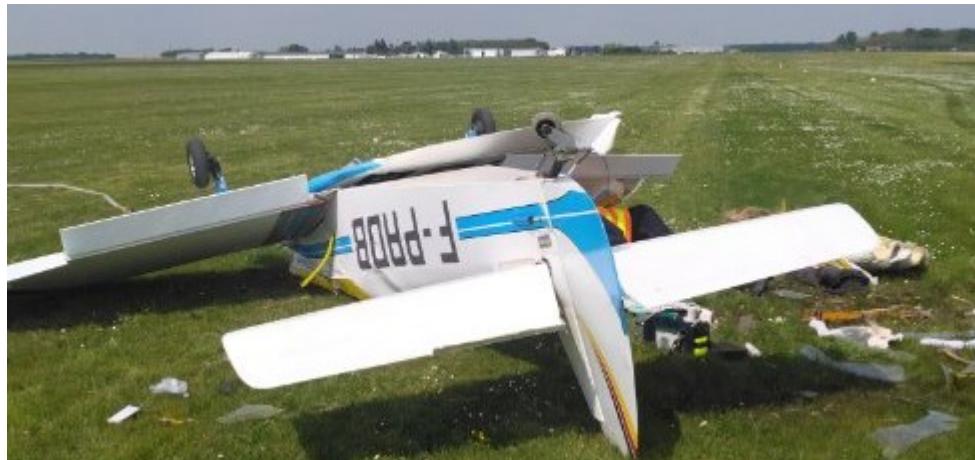
Figure 2: wreckage of F-PADB after the accident (source: aerodrome manager)

- signs of fuel were visible on the ground;
- the area where the engine collided with the ground could be identified. Propeller parts were also found there;
- small trenches perpendicular to the path of the aeroplane were found a few metres before the wreckage. These marks are characteristic of a rotating propeller making contact with the ground.

These observations showed that the engine was most likely torn off from the airframe during the collision with the ground, that the airframe continued its course until it came to a stop a few metres further on, and that the propeller was rotating when it made contact with the ground.

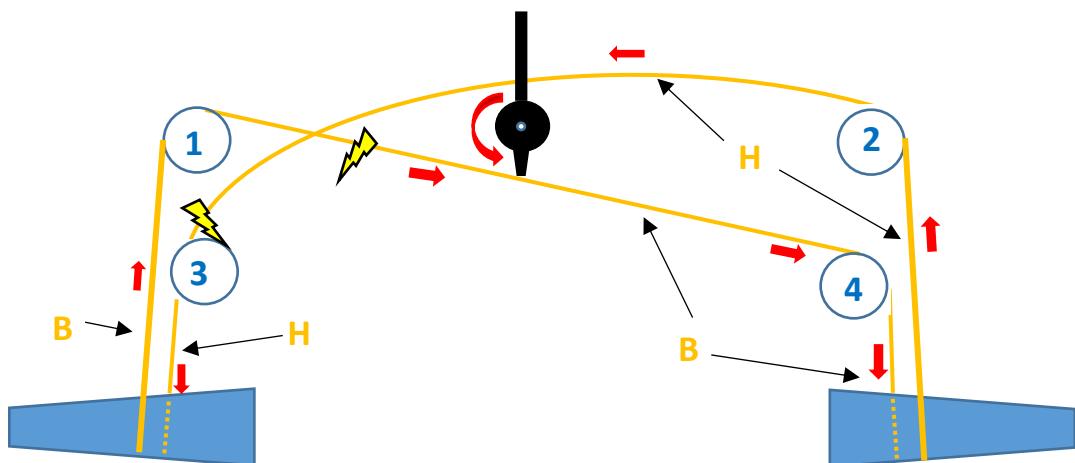
Figure 4: aileron control as installed on F-PADB, on the day of the accident.

) show the discontinuities observed. The examinations carried out at the BEA's laboratory determined that these cables were severed, probably when the wreckage was recovered. Examination of the rupture faces indicated that the cables were most likely installed as in **Figure 4**.

In contrast to the cables' nominal assembly, two errors were observed: the stick actuated cable B instead of cable H, and cable B and cable H were inverted on the left side. As a consequence:

- when a left roll input was made on the stick, the left aileron raised, and the right aileron raised too;
- when a right roll input was made on the stick, the left aileron lowered, and the right aileron lowered too.

This means that the left aileron travel direction was consistent with the movements of the stick, while the right aileron travel direction was inverted. The aeroplane was therefore uncontrollable in roll.

As a member of a federation, such as [the RSA](#), amateur builders can benefit from support in their actions. In particular for certain critical tasks, such as operations on control linkages, it would seem appropriate to have the completed operations reviewed by a third party.

Pre-take-off checklists generally include verifying that the flight controls are unrestricted, but less commonly ask for checking the travel direction, which could help detect potential inversions following a maintenance operation.
