**Accident** to the EUROPA  
registered **F-PHRC**  
on Saturday 27 May 2023  
at Montans

<b>Time</b>	Around 11:20 <sup>1</sup>
<b>Operator</b>	Private
<b>Type of flight</b>	Local
<b>Persons on board</b>	Pilot and passenger
<b>Consequences and damage</b>	Pilot fatally injured, passenger seriously injured, aeroplane destroyed

## **Missed approach, loss of control, collision with ground**

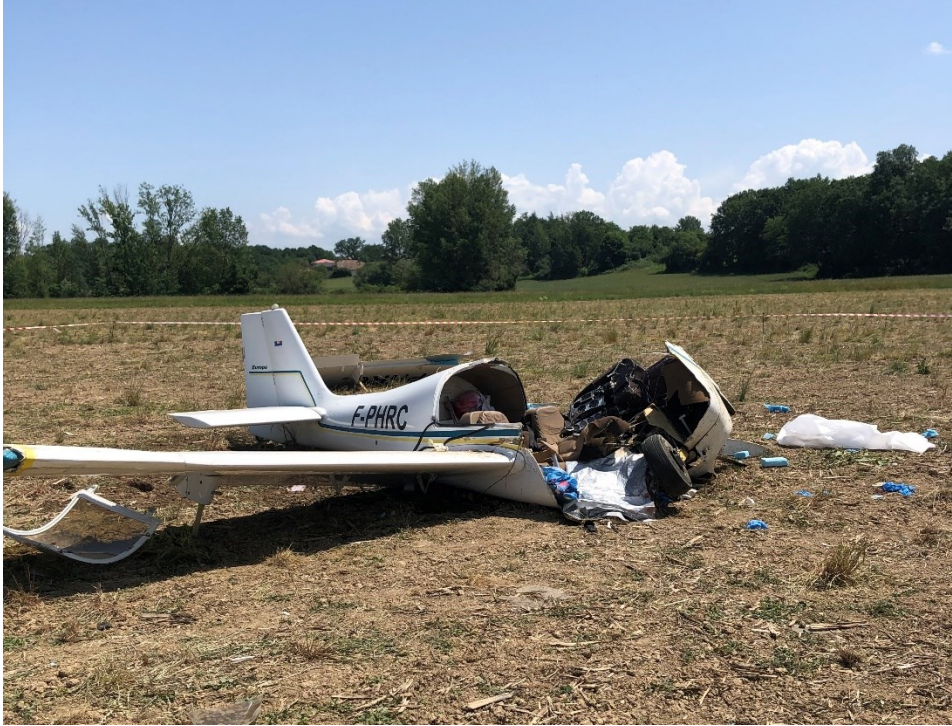
Figure 1: site and wreckage (Source: BEA)

The power plant had separated from the firewall and was at an angle of 90° (to the left) with the airframe. The fuel tank still held fuel.

The three propeller blades had ruptured at the blade root. The electric propeller pitch-change motor was damaged and had separated from the hub.

The cockpit was destroyed. The left wing was separate from the rest of the wreckage. Marks on the ground indicated that it was the first part of the aeroplane to have contacted the ground.

It was not possible to determine with certitude, the position of the landing gear. The flaps seemed to be extended.

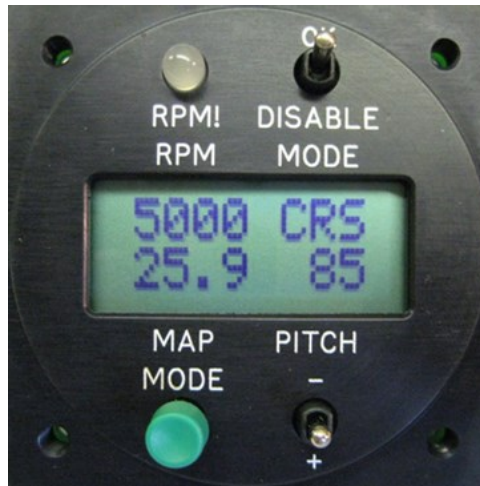
Figure 2: CSC-1 governor screen (source: Smart Avionics)

On the pitch-change governor equipping F-PHRC, the pitch was set using the mode selector (see Figure 2, green MODE button) which the pilot had to press to display the indication CLM (climb) on the digital screen.

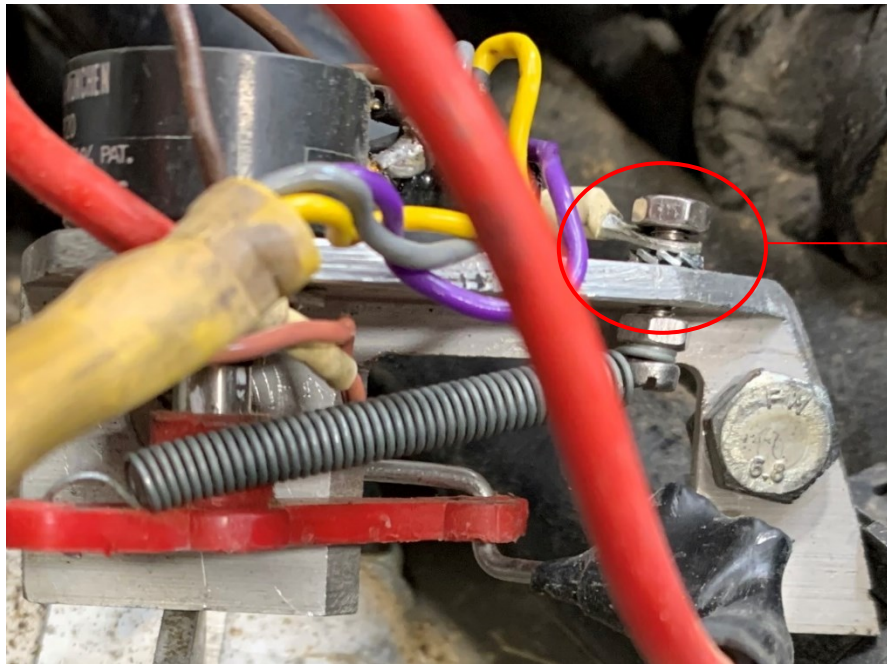
The observations made of this propeller pitch-change system confirmed that at the time of the impact:

- the propeller blades were in the coarse-pitch position;
- the pitch-change and parameter checking system was functional;
- the pilot had all the information on the governor screen situated in the cockpit (RPM (engine rating), MODE (operating mode), % PITCH (propeller pitch) and MAP (manifold pressure));
- the electric ground was not tight on the metal mount of the electric motor, resulting in random operation of the propeller pitch-change electric motor. The ground fault prevented the operation of the pitch-change motor and thus any variation in the propeller pitch, irrespective of the operating mode selected on the governor (OFF, CRS, CLM or MAN).

Figure 3: ground conductor lug not tight (source: BEA)

The pilot carried out a missed approach after having tried to land and exceeding his aiming point. During the missed approach, the aeroplane neither accelerated nor gained height. The examinations found that the control of the propeller pitch-change electric motor was faulty (see paragraph 2.2.2). This malfunction, not detected by the pilot, very probably prevented the propeller from changing to the full fine-pitch setting, thus degrading the aeroplane's climb performance.

An operational procedure to check for the correct operation of the propeller governor, at the latest before the final descent, would allow pilots to adapt their landing strategy if there is a fault by selecting for example, an aerodrome with a longer runway and/or without obstacles in its climb-out area.

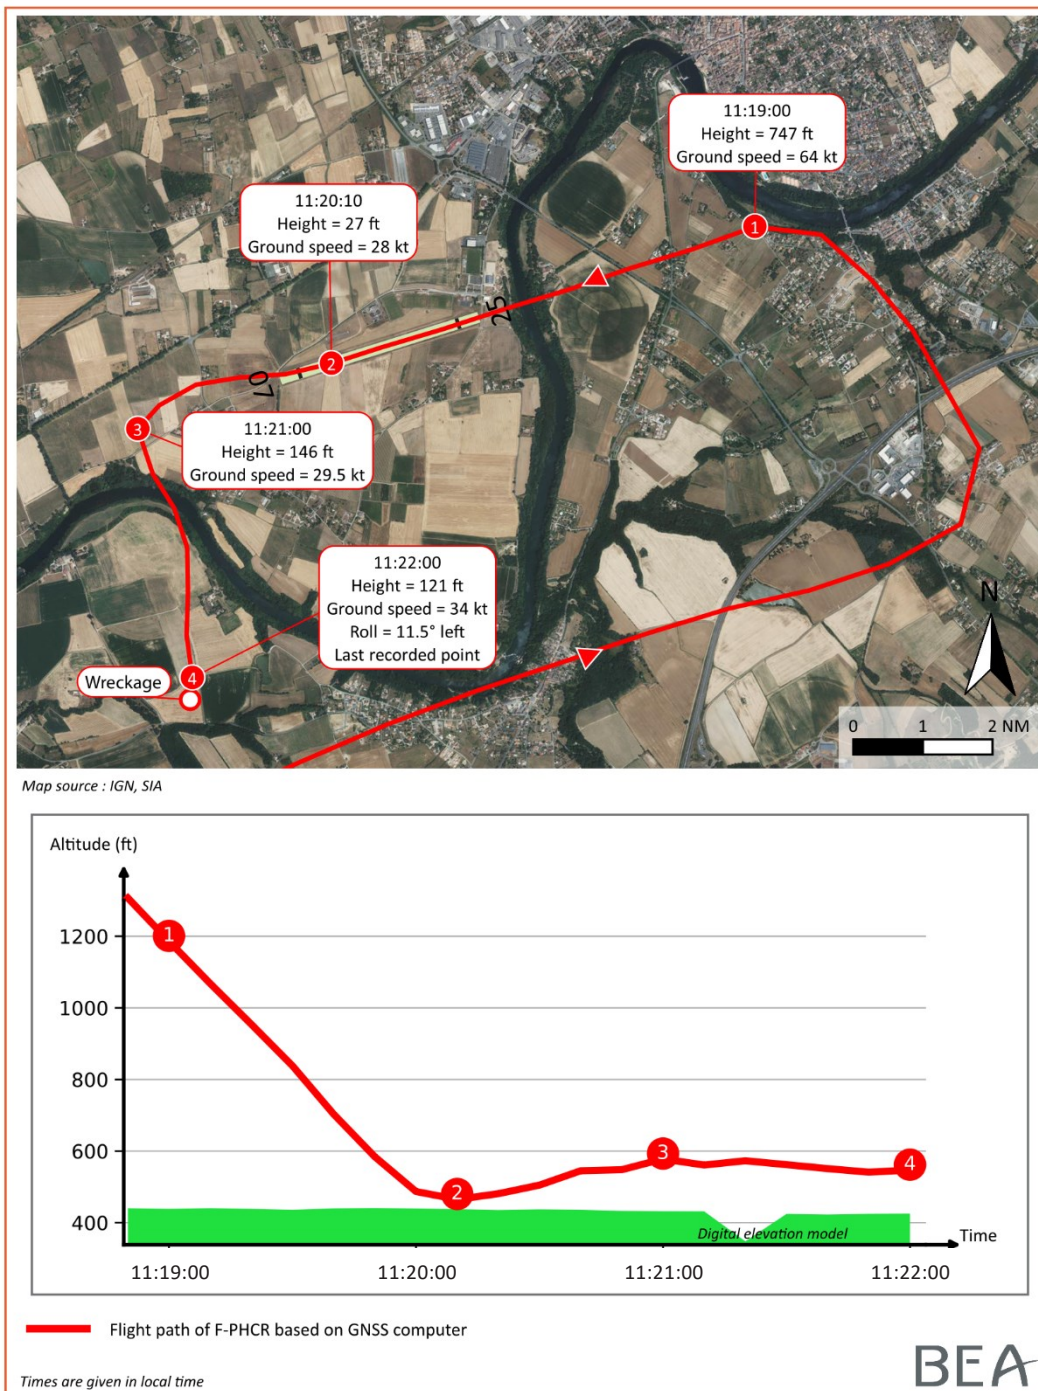
Figure 4: flight path based on GNSS computer data

- the final approach was carried out with a recorded speed of between 60 and 65 kt and a recorded vertical speed of between -600 and -900 ft/min;
- at 11:20:10 (see Figure 4, point 2), the minimum recorded height overhead the runway (last third) was 27 ft (i.e. an altitude of 465 ft) and the speed close to 49 kt; the pilot then increased power;

- at 11:20:20, the speed reached 51 kt and the vertical speed increased to 130 ft/min;
- at 11:20:30, the speed stabilized at around 48 kt, the vertical speed increased to 190 ft/min; the recorded pitch attitude was close to 15°;
- at 11:21 (see point 3), at a height of around 150 ft, the pilot turned left onto the crosswind leg with a slight bank, in level flight;
- at 11:22 (see point 4, last recorded position), the speed<sup>5</sup> was 46 kt, the pitch attitude close to 17°, the vertical speed practically zero, the pilot was in the process of turning left (bank angle of 11°) onto the downwind leg.
