Accident to the DYN AERO MCR 01
registered **F-PJEA**
on Saturday 16 September 2023
at Prévencières

**Loss of external visual references,
collision with ground**

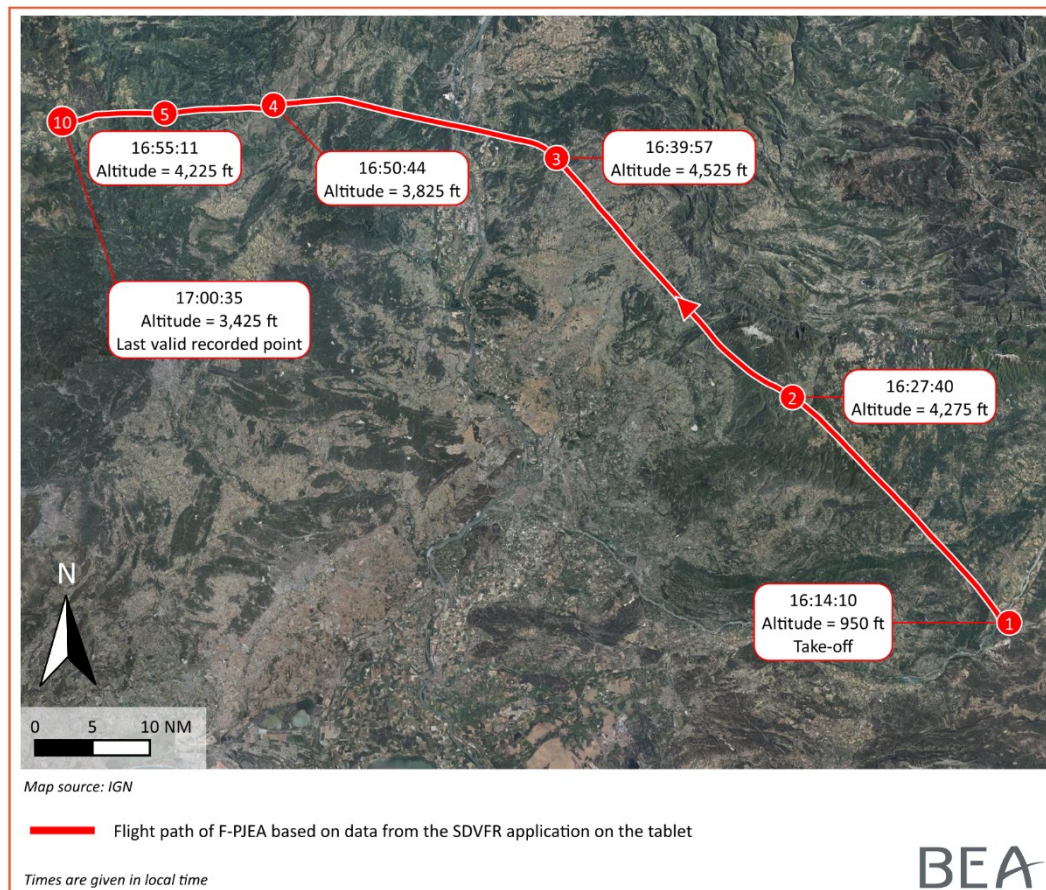
Figure 1: flight path of F-PJEA based on the data recorded by the SDVFR application on the pilot's tablet

He took off from Vinon-sur-Verdon at 16:14 (see **Figure 1**, point **①**).

At 16:27 (point **②**), he contacted the controller of the flight information service, Provence Info and specified that he had planned to fly to Cassagnes-Bégonhes passing by the Montélimar and Mende VORs². He added that he was taking an indirect route due to the weather conditions and was zigzagging a bit according to the weather. The controller acknowledged the message and suggested that he got back into contact with him if necessary.

At 16:39 (point **③**), shortly before Montélimar, he reported that he was heading towards Aubenas.

At 16:51 (point 4), he left the Provence Info sector and contacted the flight information service Marseille Info. A short time later, he reported that he was 15 min from Mende in not very good conditions. The controller specified that around 20 min earlier, another aeroplane had passed further north. The pilot replied that he would see but did not modify his flight path. The controller recommended to the pilot that he stay in VMC conditions to which the pilot replied that he was trying to.

At 16:55 (point 5), the controller called back the pilot to specify that, based on the information at his disposal, the weather conditions were better after Mende. The pilot replied that he had the information that Rodez was supposed to be CAVOK, and that the problem was going to be passing Mende.

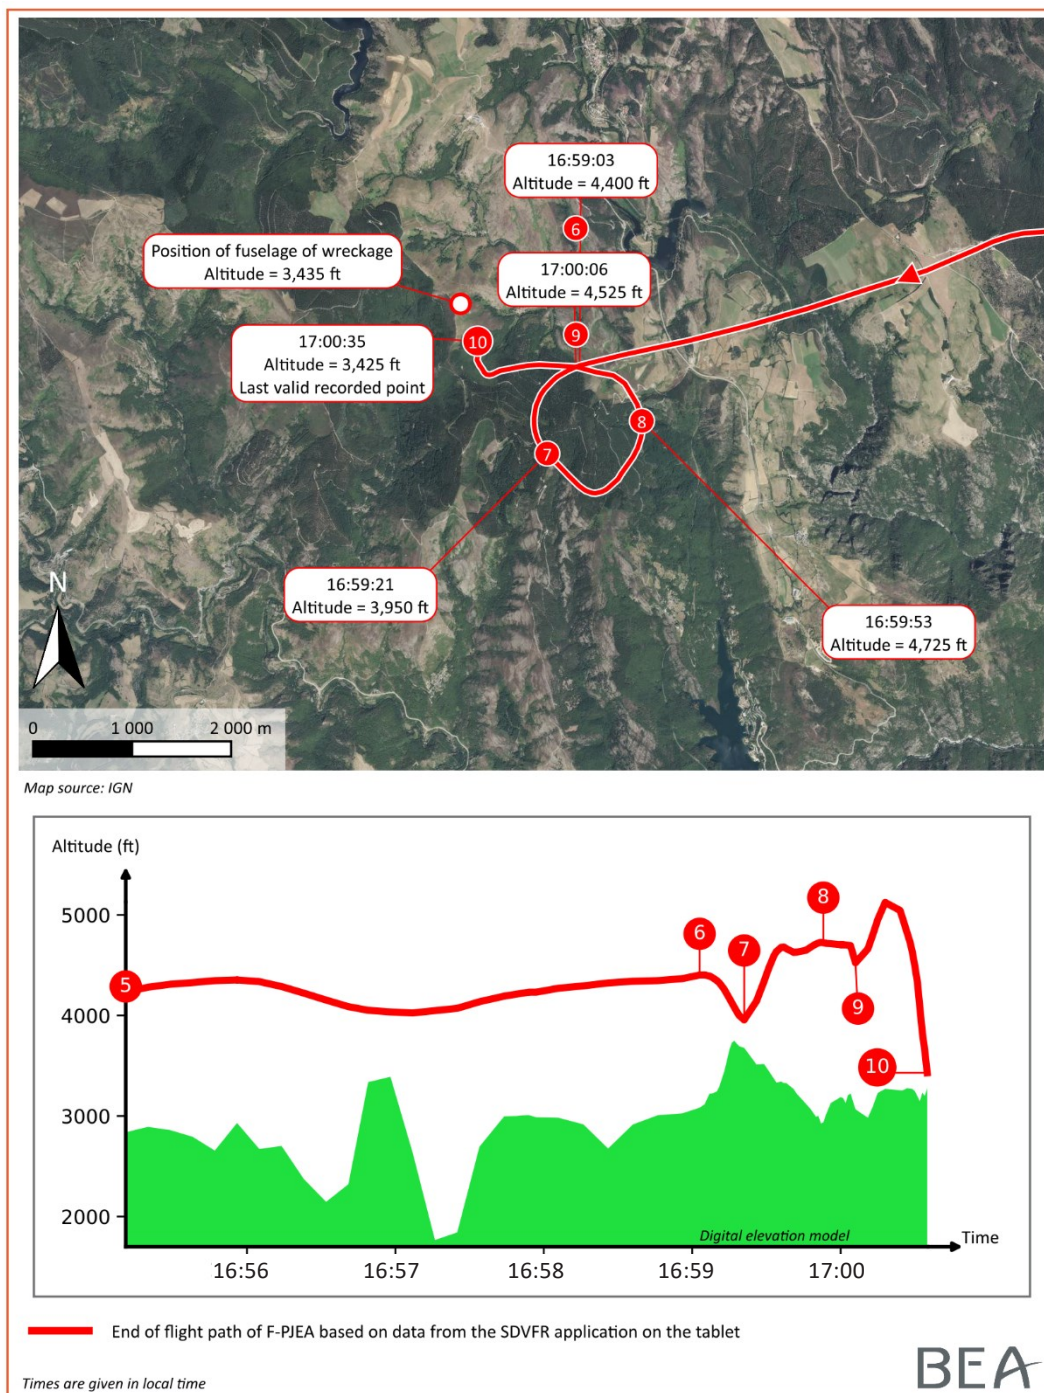
Figure 2: end of flight path of F-PJEA

At 16:59 (see Figure 2, point 6), at around 4,400 ft, the pilot started a LH 360° turn with a high rate of turn, twice that of a standard turn, which implies a steep bank angle. During this turn, the aeroplane substantially descended to around 4,000 ft and flew over the terrain at a height of less than 85 m (point 7). The pilot then quickly climbed to 4,725 ft (point 8).

At 17:00 (see point 9), at the end of this 360° turn, the pilot took a westerly heading, in climb. He reported that he was now in IMC and asked for a heading to return to Aubenas. Thereafter, he no longer responded to the controller's messages.

A few seconds later, the flight path of the aeroplane described a tight RH turn, in steep descent until the last valid point recorded at 17:00:35 (see point 10), at 3,430 ft. This sudden change in flight path very probably corresponded to a loss of control.

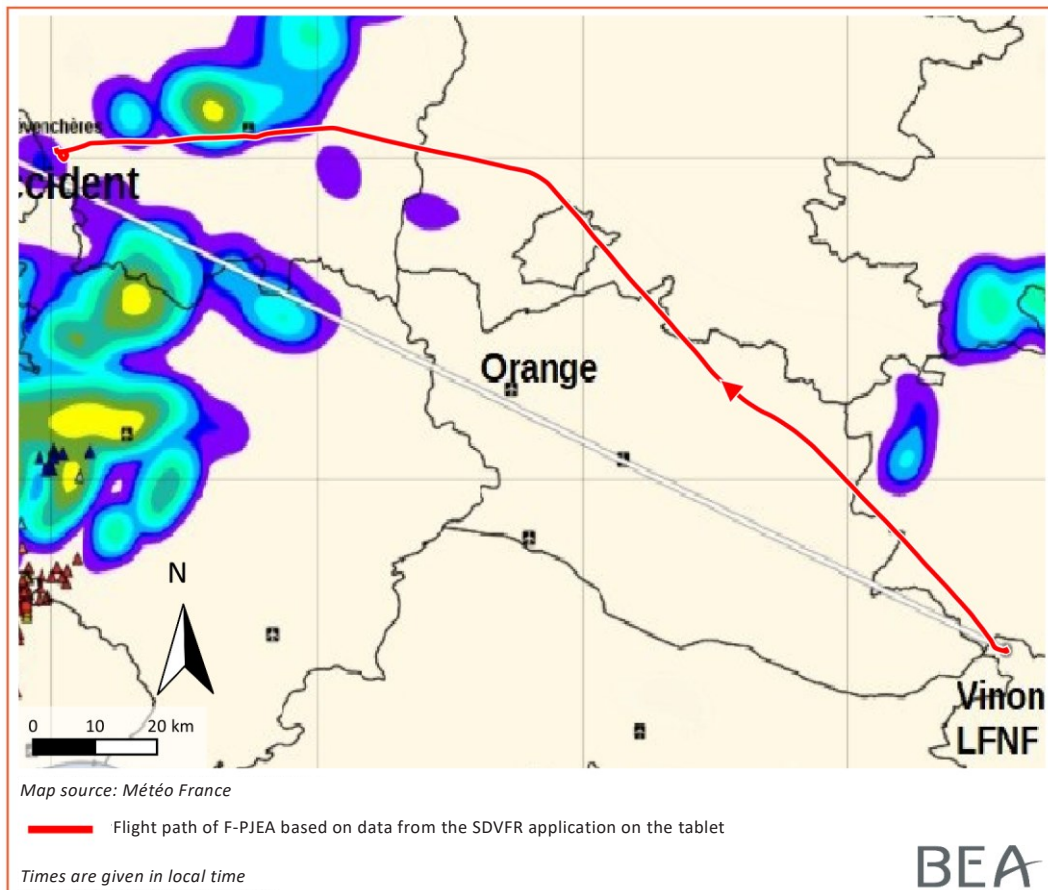
Figure 4: rainstorm situation at around 17:00 (Source: Météo-France)

The readings transmitted by Météo-France indicated that the pilot was flying north of a very active storm zone. The flight path taken avoided most of the precipitation.

At around 17:00, in the vicinity of Prévencières, the cloud mass descended to the ground, surrounding the terrain. The cloud tops were situated between 6,000 and 6,500 ft and there was another cloud layer between around 9,800 ft and more than 15,000 ft.

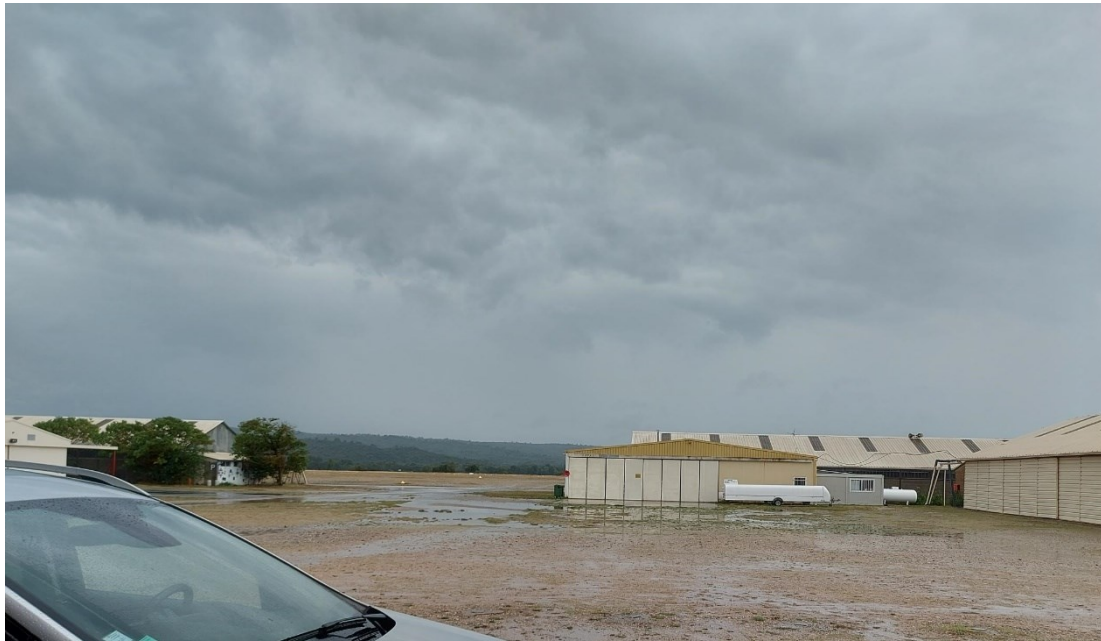
Figure 5: photo sent by pilot at 13:47

Shortly after, he had a telephone conversation with his wife before sending her a photo of the sky taken from Vinon-sur-Verdon aerodrome. His wife added that she had expected him to postpone his return until the Sunday or the Monday.
