Accident to the JODEL - D113 V
registered **F-PLUM**
on 23 June 2022
on the Argentière glacier

Time	Around 16:20 ¹
Operator	Private
Type of flight	Instruction flight
Persons on board	Instructor and student pilot
Consequences and damage	Instructor and student pilot fatally injured, aeroplane destroyed

Collision with glacier surface, in mountains, fire

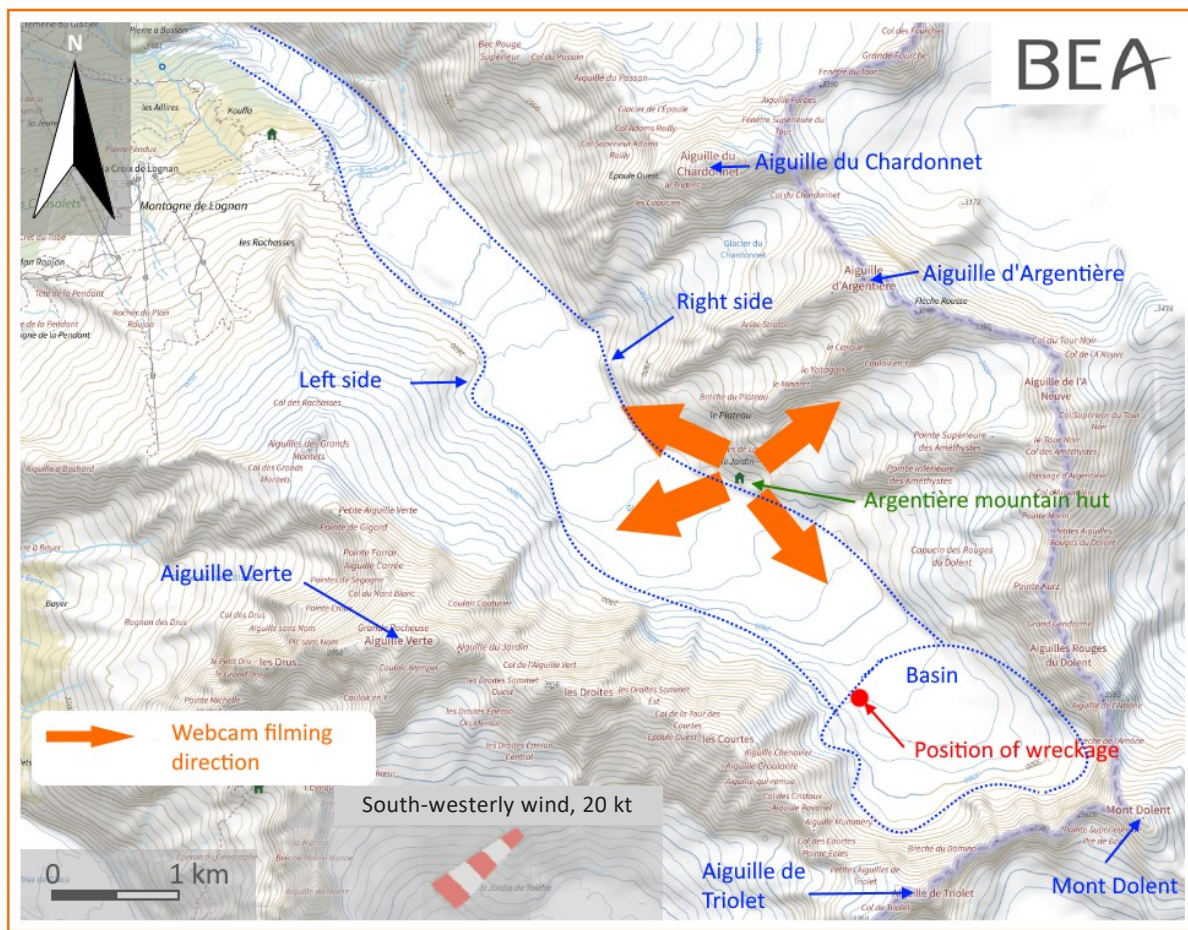
During the evening, a member of the flying club observed on the video surveillance camera that the hangar doors were still open and that the aeroplane was not parked in the hangar. He gave the alert. The wreckage of the aeroplane was found the following morning on the Argentière glacier, situated 65 km north-east of Albertville (see *Figure 1*).

Figure 1: key features of Argentière glacier and surrounding terrain (source: Géoportail, IGN map annotated by the BEA)

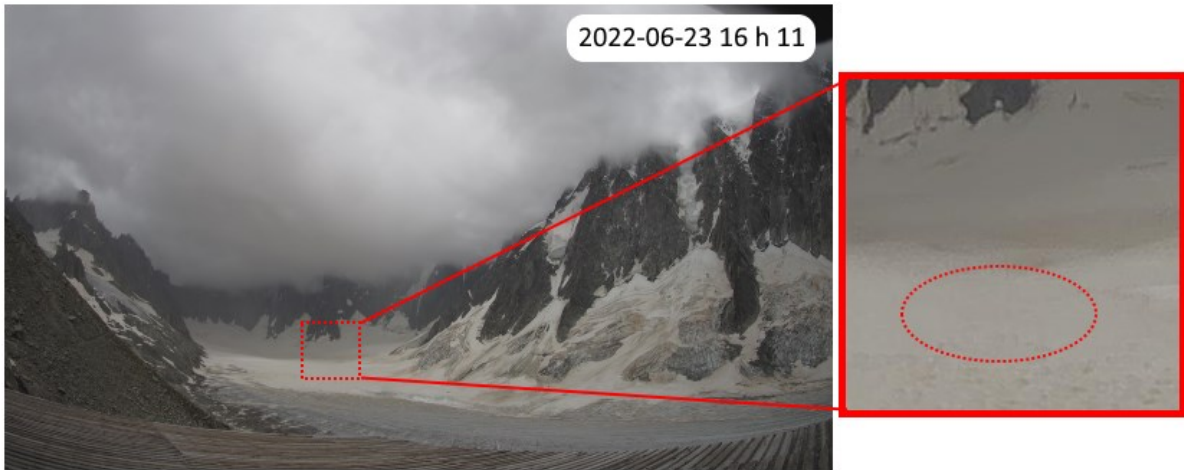
Figure 2: image looking south-east at 16:11 - no wreckage

The two successive images taken looking south-east at 16:11 and 16:21 show that the accident occurred during this period.

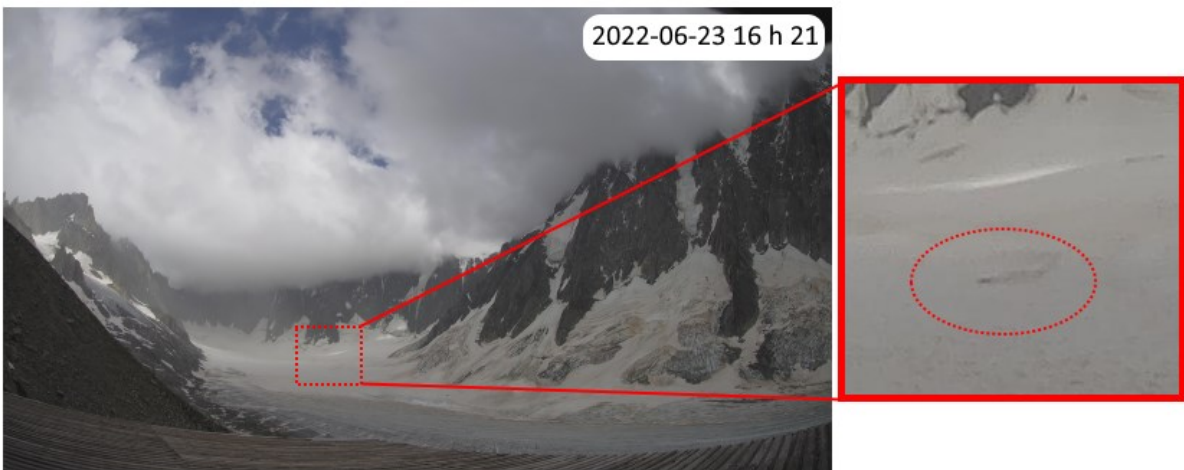
Figure 3: image looking south-east at 16:21 - wreckage present

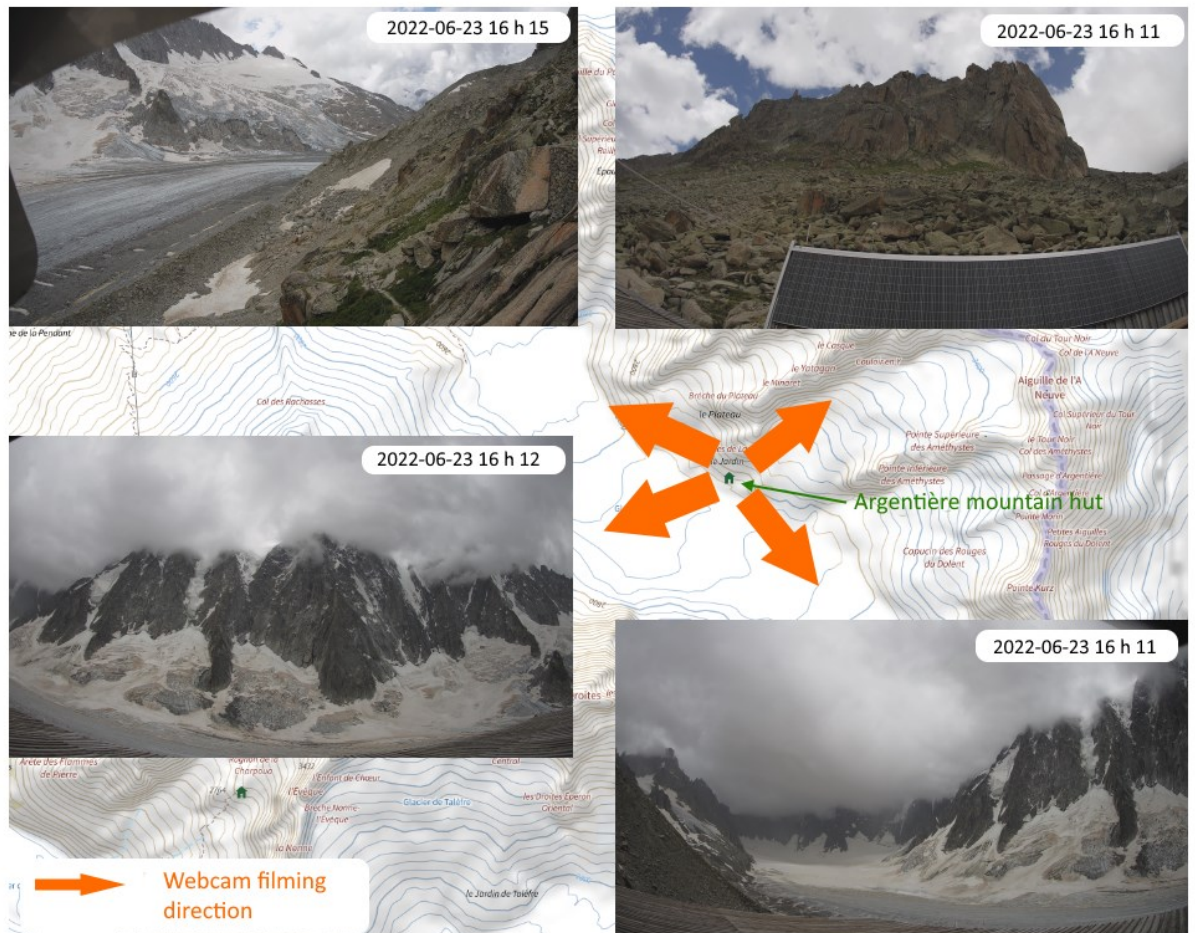
The general conditions on the glacier estimated using the images from the other webcams in the ten-minute interval during which the accident occurred were as follows (see *Figure 4*):

- the sky was overcast over the basin of the glacier up to the mountain hut, the summits were hidden by clouds. The height of the cloud base in relation to the surface of the glacier in the area of the accident was estimated at between 500 and 700 ft;
- from the valley to the mountain hut: on the left side, the clouds were broken and their base was level with the summits; on the right side, the clouds were scattered and their base was above the ridge line.

Figure 4: images recorded by the four surveillance camera in the ten-minute interval in which the accident occurred
