**Accident** to the BEECH - 18 - 3TM  
registered **G-BKGL**  
on 14 September 2021  
at Vescovato (Corsica)

<b>Time</b>	Around 10:25 <sup>1</sup>
<b>Operator</b>	Private
<b>Type of flight</b>	Post maintenance functional check flight
<b>Persons on board</b>	Pilot <sup>2</sup> and two passengers
<b>Consequences and damage</b>	Pilot and front passenger seriously injured, rear passenger injured, aeroplane destroyed

**Engine shutdown and reduction in rpm of second engine at end of downwind leg, forced landing near airport, fire**

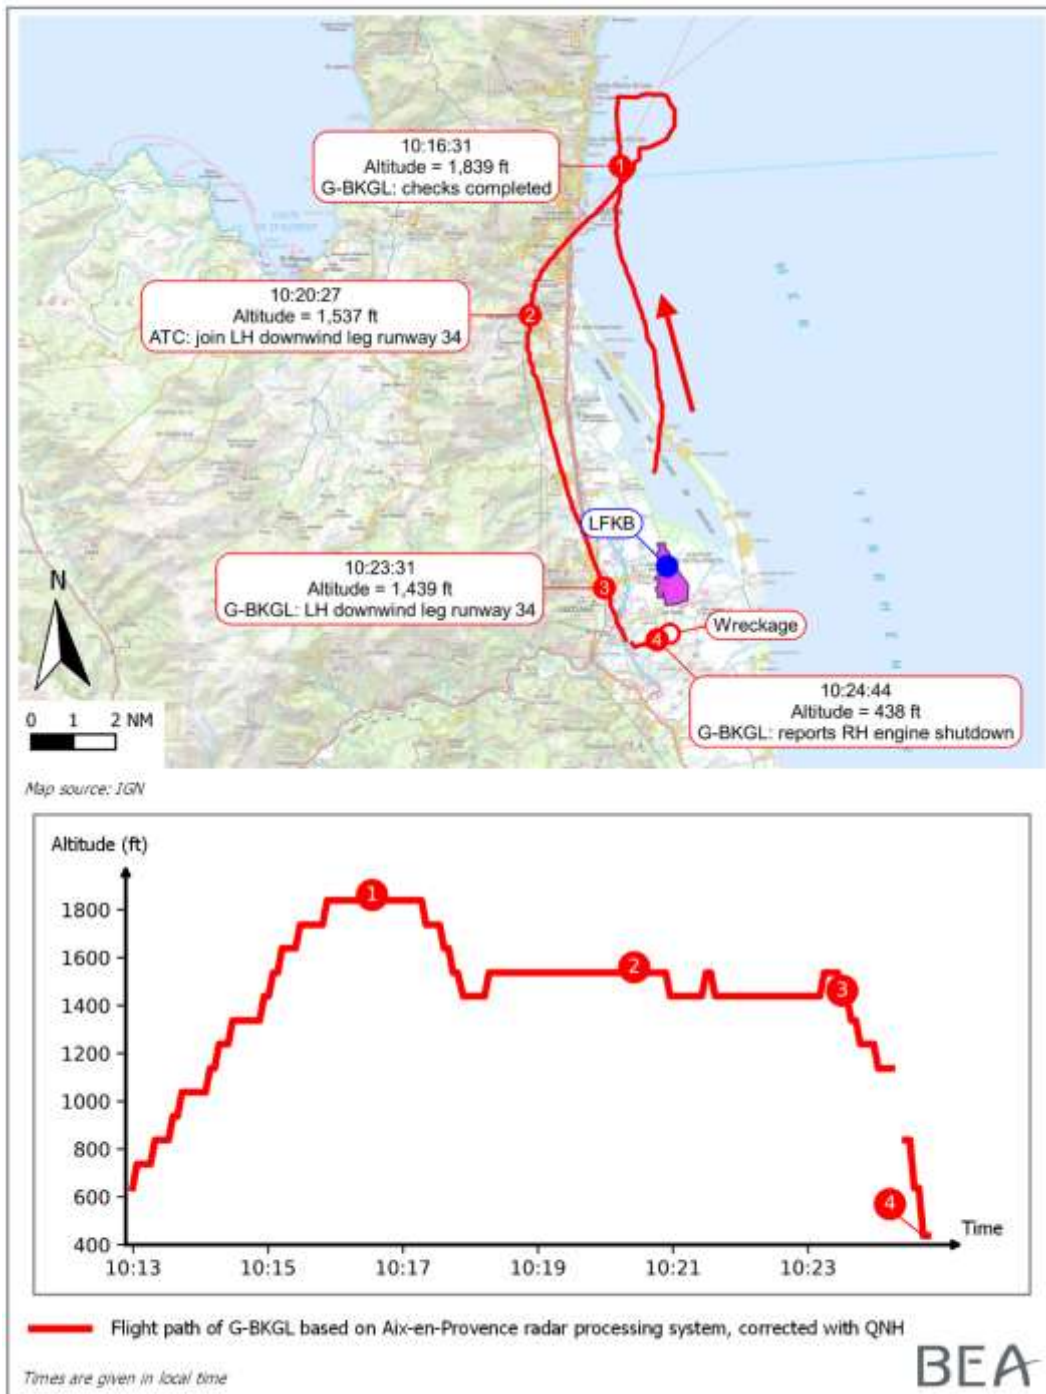
On 14 September, the pilot took off at 10:10 from Bastia-Poretta airport (Corsica), in the company of the new owner in the front right seat and the technician in the rear seat in order to carry out a functional check flight following the work carried out the day before. At 10:16, the pilot reported to the controller that he had completed the checks and asked for authorisation to return to the airport (see Figure 1, point ①). Due to an IFR flight departing from runway 34, the controller asked him to follow the mountains to return to the airport<sup>3</sup> and then join the LH downwind leg for runway 34 (see Figure 1, point ②). At 10:23, the pilot reported that he was on the downwind leg (see Figure 1, point ③). At the end of the downwind leg, the right engine shut down followed around 20 s later, by a reduction in the power of the left engine. The pilot turned onto the base leg and reported the shutdown of the right engine over the radio (see Figure 1, point ④). The aeroplane quickly lost altitude with a vertical speed of between -900 and -1,500 ft/min. Too far from the runway, the pilot was obliged to land outside the airport perimeter. Just before touchdown, the aeroplane struck trees. After the aircraft had come to a halt, a fire broke out; the pilot and technician evacuated the aeroplane. The passenger had difficulties releasing his seatbelt and evacuated a few moments later. They then waited for the emergency services which took charge of them around 10 min later.

Figure 1: accident flight path

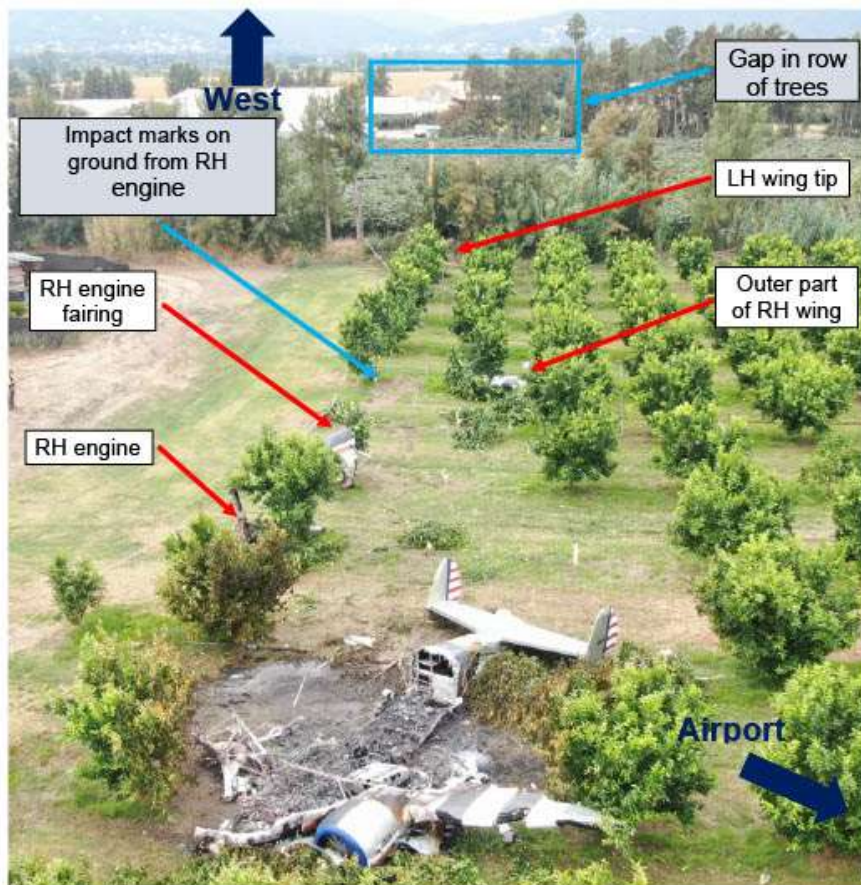
The wreckage was located in a mandarin grove at around 1,200 m south of the runway 34 threshold. The examination of the site showed that with its wings level, the aeroplane struck a line of trees around 10 m tall while following a straight downward path on an east heading. The aeroplane then banked to the right, its right wing and engine were torn off on striking mandarin trees and then the ground. The fire which subsequently broke out destroyed the aeroplane (see Figure 2).

**Figure 2: general view of accident site (source: Air transport police (GTA))**

The examination of the wreckage which was limited due to the extent of damage to it, did not find any technical failure prior to the collision with the trees and the ground. On raising the wreckage, it was observed that both engines rotated without friction points. The two propellers were rotating at the time of impact without there being obvious evidence of power.

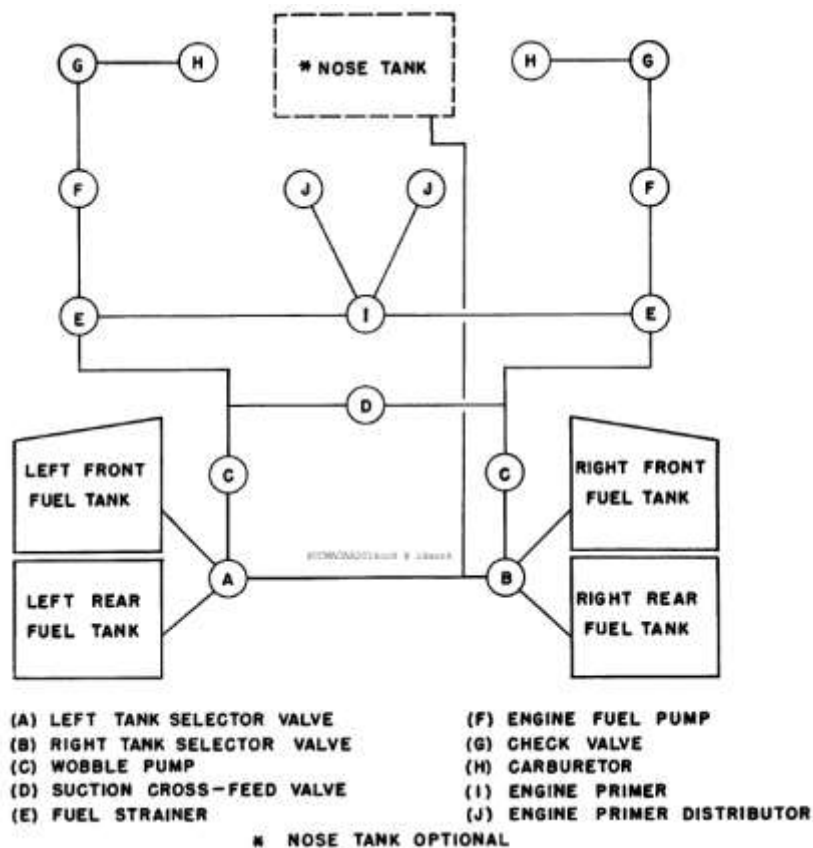
**Figure 3: diagram of fuel system**  
 (source: G-BKGL manufacturer flight manual)

Each engine is fitted with a mechanical pump. The aeroplane does not have an electric pump but each engine is equipped with an emergency manual wobble pump (see (C) Figure 3) operated by a common lever. A cross-feed situated downline of the selectors (see (D) Figure 3) can be used to supply both engines from a same tank (front or rear). The cross-feed control is situated under the front right seat.

Two selectors and the cross-feed (see (A) and (B) Figure 3, Figures 4 and 5) control the fuel supply to the engines. The role of the selectors is to manage the fuel supply to each engine and allow the pilot to choose one of the four following positions:

The flight manual specifies that the pilot must check that the front fuel tanks are selected before starting up the engines. It should be noted that the selector positions for the nose and front tanks are opposite each other, 180° apart. Furthermore, the ergonomics of the selector handles might lead the pilot to place the handle in the opposite position to the correct one. In these conditions, it is possible to accidentally select the nose tank instead of the front tanks.

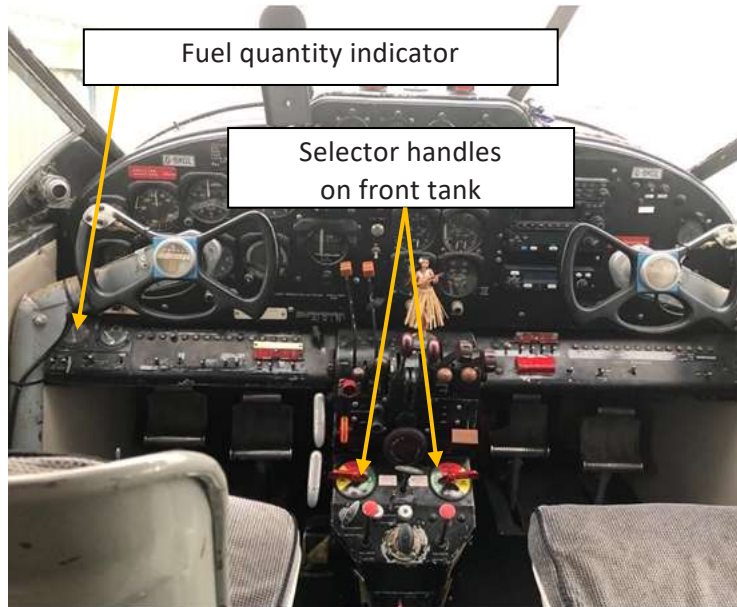
**Figure 4: position of selectors and fuel quantity indicator**  
(source: Alastair Goodrum, annotated by the BEA)

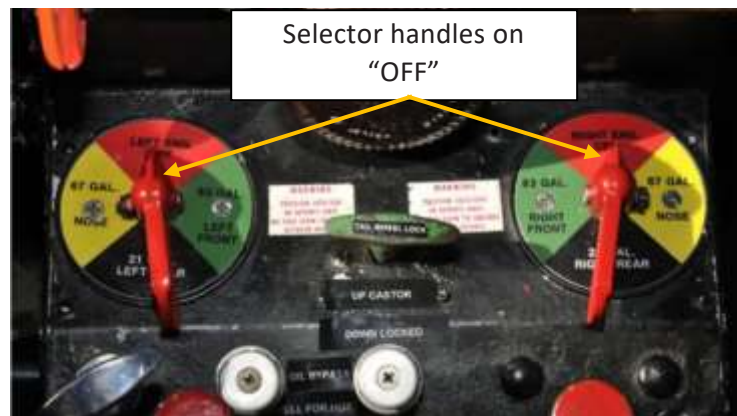
**Figure 5: examples of positioning of fuel selectors in OFF position**  
(source: Pilot, annotated by the BEA)

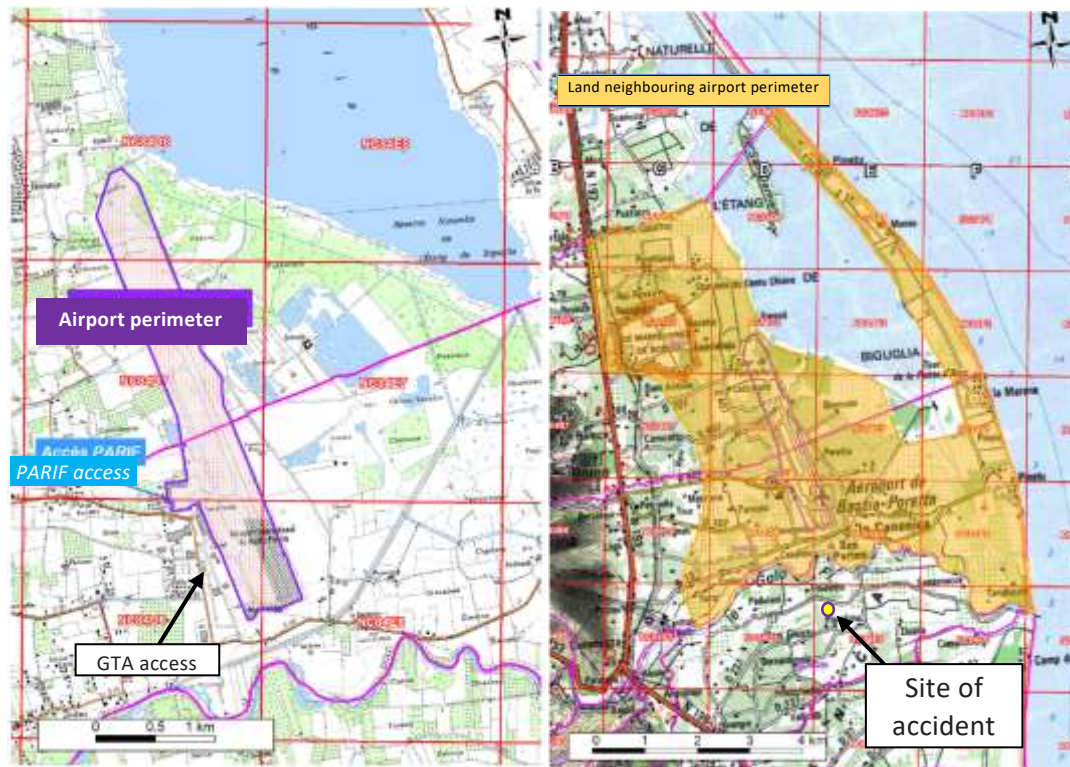
To notify the ARFF responders, the air traffic controller activated the “crash horn” which indicated a state of alert<sup>10</sup> instead of the siren to indicate an accident<sup>11</sup>. He told them by telephone that the accident had occurred south-east of the airport facilities without specifying if it was in the airport perimeter or in the neighbouring area<sup>12</sup>. In reality, the accident occurred outside the neighbouring area (see Figure 6).

**Figure 6: excerpt from Bastia Specialized Aerodrome Emergency Plan (annotated by the BEA)**

The ARFF vehicles set off one minute later without having any information about the type of aircraft, the number of occupants and the quantity of fuel. They thought that the accident had occurred in the airport perimeter and asked for clearance to pass by the runway to reach the airside grounds south of the airport. The controller then specified that the accident was situated in the neighbouring area. They therefore tried to leave using the “GTA access” gate as it was the quickest way from their position. The gate was closed and no-one being visible to open it, they had to leave through the “PARIF access” gate which extended their response time.

Following the accident and the difficulties encountered by its personnel in communicating with the departmental fire and emergency services during the response, the acquisition of two ANTARES TPH700 radio sets by the ARFF was decided on. This will facilitate operational communication in real time between the ARFF responding to an occurrence within the airport perimeter, and the departmental fire and emergency services that have to enter the airport grounds, as well as in the neighbouring area when the ARFF intervenes.
