## Accident to the Pipistrel Virus SW 121 registered G-OVSI

on 09 May 2021  
at Albert - Bray (Somme)

### Low-height flight over runway to offset wheel touchdown on landing, loss of control, in crosswind

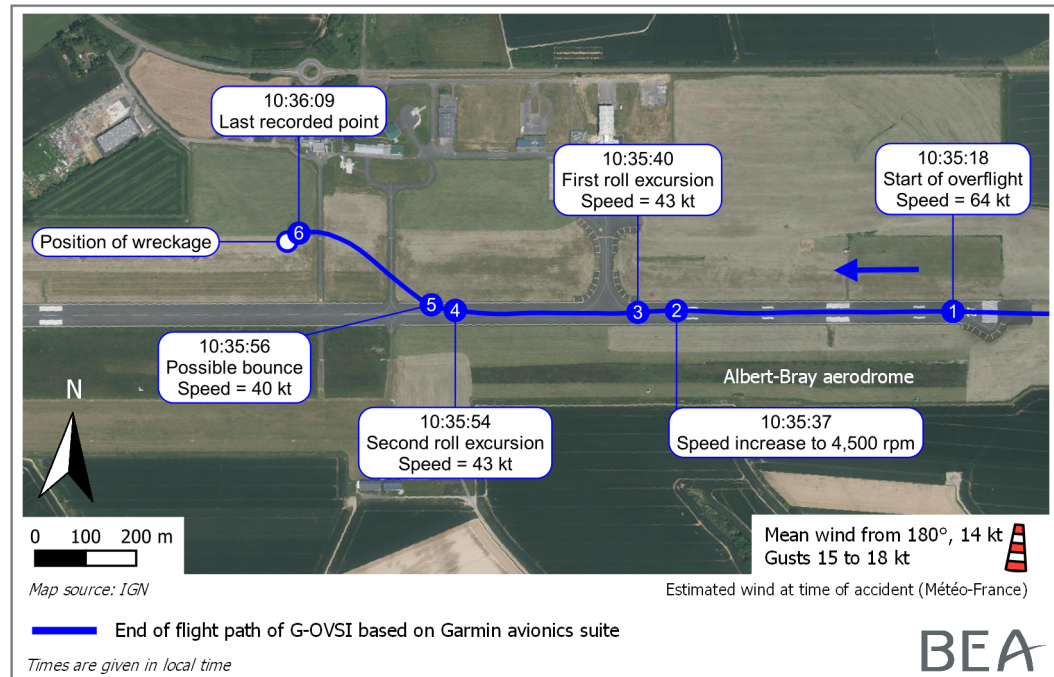
Figure 3: flight path of G-OVSI

- ❑ He then flew along the runway<sup>(5)</sup> for around 35 s. During this phase, despite adjusting the power to around 3,500 rpm, the aeroplane's speed decreased down to 43 kt. The pilot then increased the power to 4,500 rpm (see Figure 3, point ③). A 15° right roll excursion was recorded (see Figure 3, point ②) while the speed increased to 46 kt. A second roll excursion was recorded with a right bank which reached 20° and a decrease in pitch attitude of nearly 7° (see Figure 3, point ④). This was followed by acceleration peaks which might correspond to a bounce (see Figure 3, point ⑤) when the aeroplane approached the edge of the runway. During this sequence, the power, after a slight decrease, increased to 4,900 rpm.

- ❑ The subsequent variations in pitch, roll, altitude and speed seem to indicate that the pilot no longer had control of the flight path. The last recorded position (⑥) showed the aeroplane at a height of around 6 m, with a left roll of 29°, a nose-up attitude of 12° and a speed of 42 kt.

The aeroplane's roll attitude was destabilised twice probably due to variations in the crosswind. During the second destabilization which occurred when the pilot had initiated a reduction in power to land, the aeroplane bounced on the runway. The pilot then increased power. The investigation was not able to determine if this was a deliberate action and in this case, what his intentions were.

The pitch and roll evolutions which followed seem to indicate that the pilot had lost control of the flight path. It is not possible to affirm whether the pitch actions were controlled or not. The aeroplane very probably stalled at the end of this phase.
