Accident to the DG– LS8-e neo¹
registered **HB-2550**
on Thursday 6 April 2023
at Thorame-Basse

Time	Around 15:38 ²
Operator	Private
Type of flight	Local
Persons on board	Pilot
Consequences and damage	Pilot seriously injured, glider destroyed

Collision with tree during an off-field landing

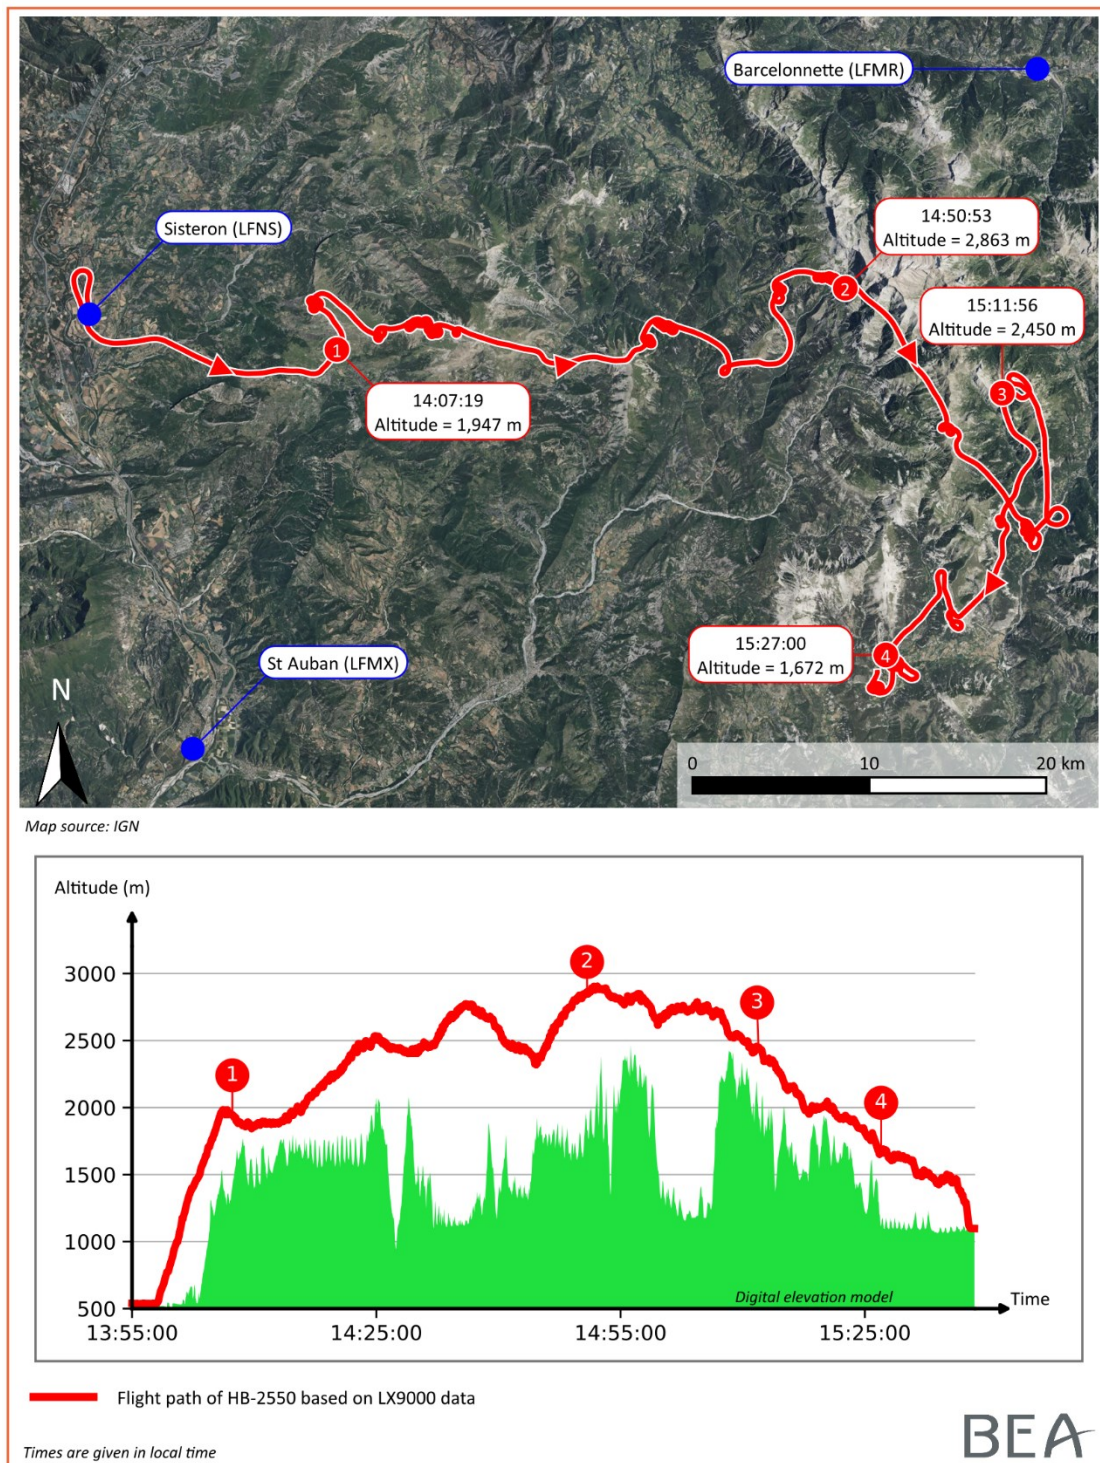
Figure 1: flight path of glider (complete flight)

At 13:55, the pilot carried out a towed take-off from Sisteron-Vaumeilh aerodrome (Alpes-de-Haute-Provence). He headed eastwards and managed to reach a maximum altitude of 2,863 m (see **Figure 1**, point **2**).

At 15:27 (see **Figure 1** and **Figure 2**, point **4**), the pilot entered Thorame-Basse valley. He carried out a few spirals to try to gain altitude but without success.

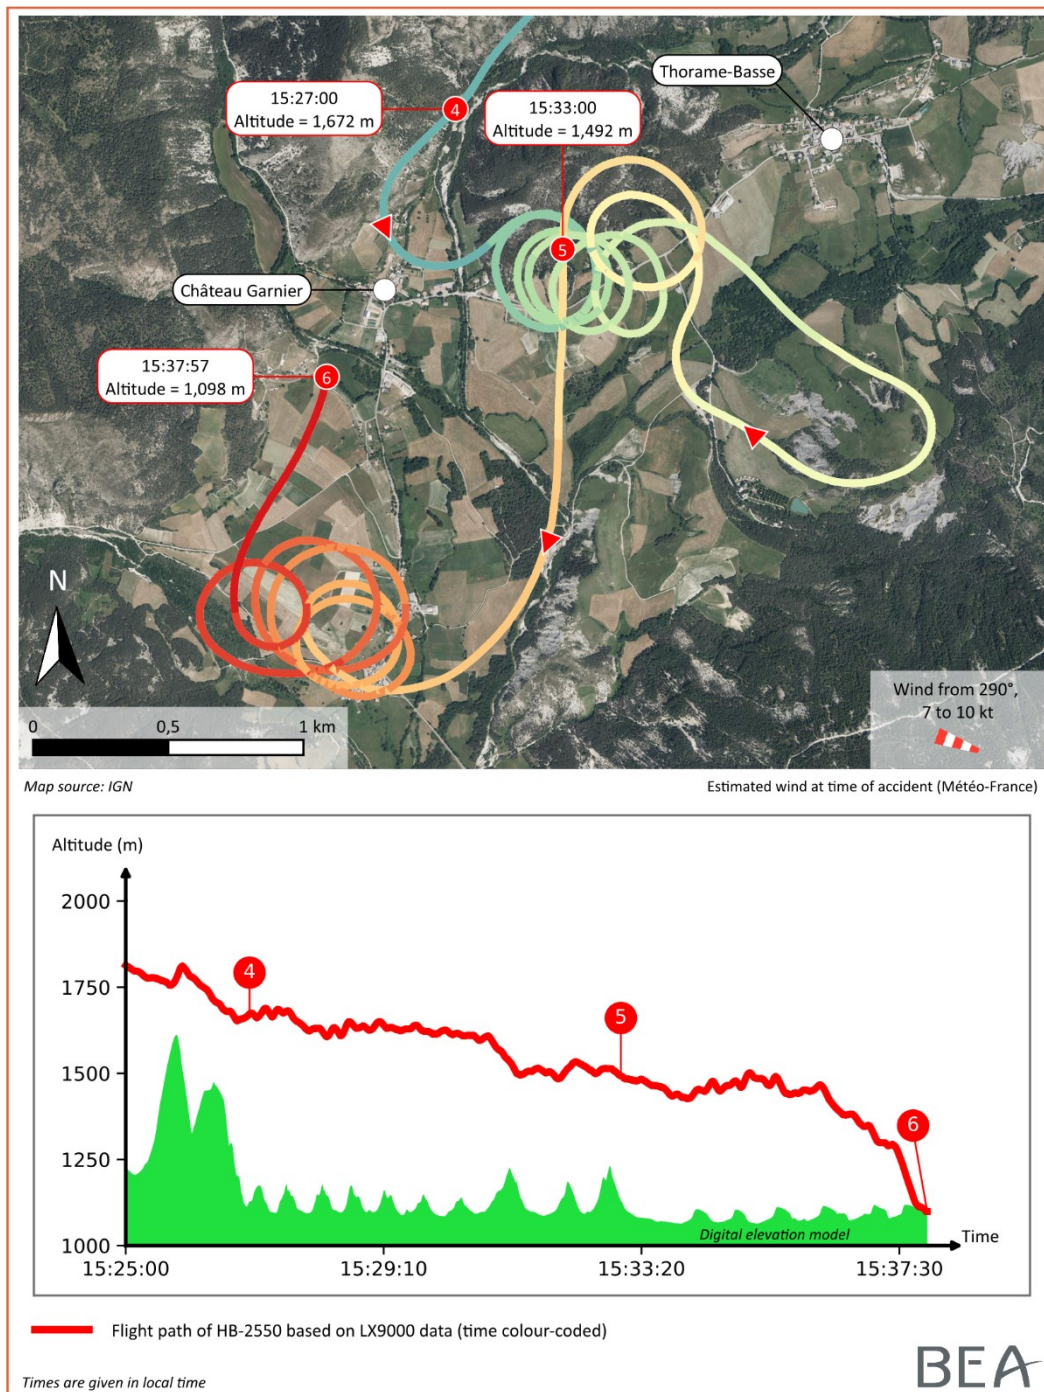
Figure 2: final flight path of glider

At 15:33 (see **Figure 2**, point **5**), after losing 200 m in altitude, he decided to perform an off-field landing. He chose a field that he believed had a slight upward slope, flew some spirals again to try

to gain altitude one more time and then started the final to land. The slope on short final was around 20% for an average vertical speed of -7.5 m/s. The recorded ground speed was roughly 150 km/h³.

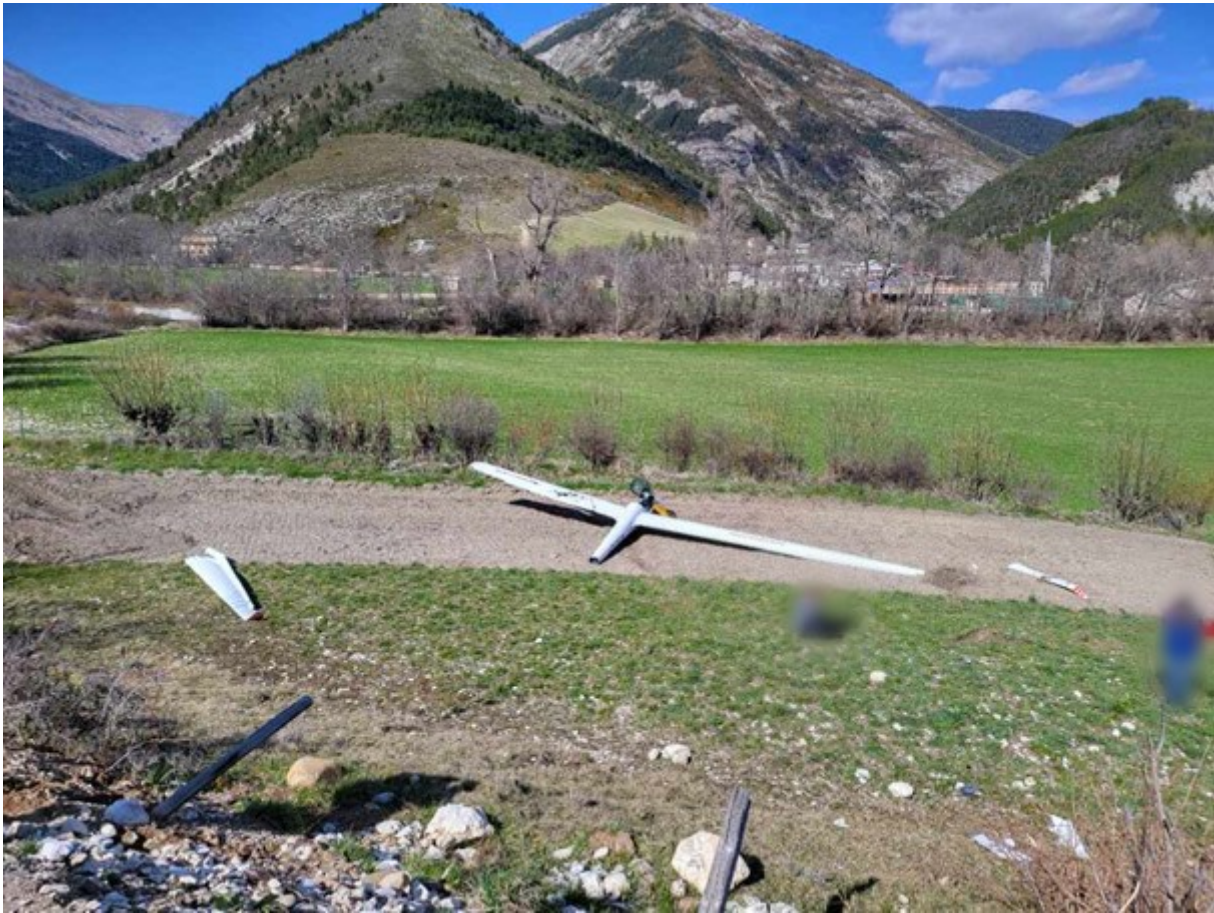
Figure 3: position of glider wreckage (source: BEA)

During the flare, the glider's central landing gear and then the left wing came into contact with the ground. The glider bounced, ran to the end of the field then violently struck a tree on its path before coming to a halt in another field lower down.

During the flare, the left wing struck the ground when the speed of the glider was still significant. The pilot lost control of the glider which continued its run to the end of the field and then collided with a tree. It is possible that the glider experienced a tailwind gust on short final which would have extended the landing distance.

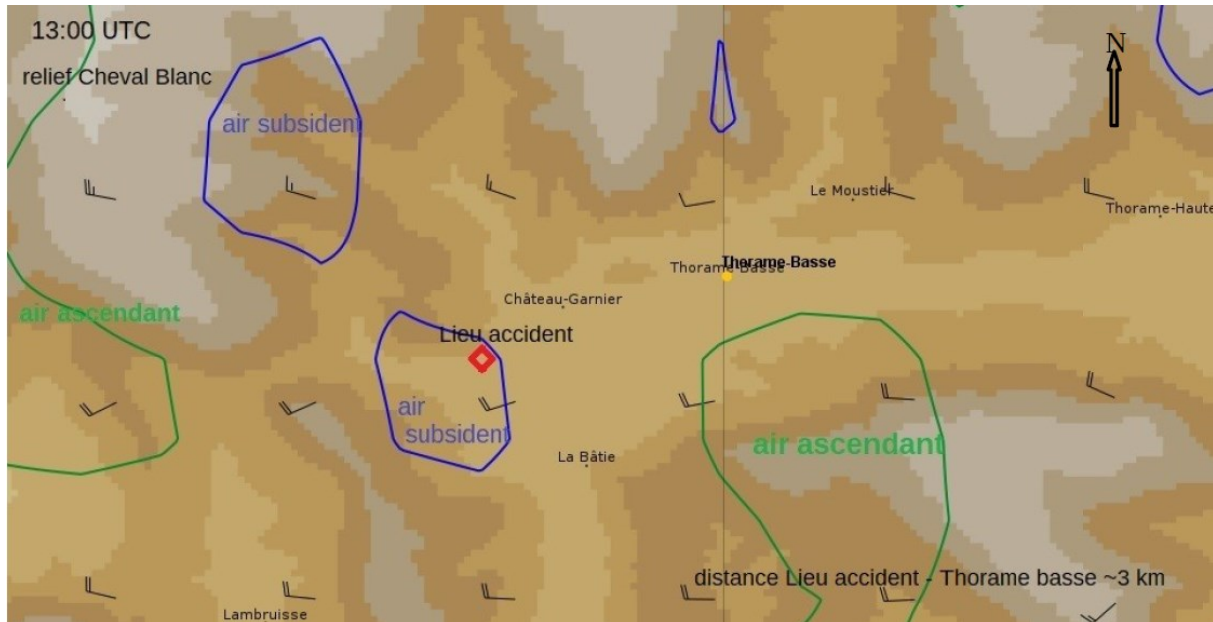
Figure 4: map of terrain, gusts and areas of subsiding air at 15:00.

The terrain situated at less than 5 km north west of the accident site rose to an altitude of 2,300 m. The 20 to 30 kt wind blowing from the north west at the top of the terrain created subsiding air on its lee side. The accident site was in the area of these downdrafts estimated as light, but nevertheless significant for gliding.

The gusts are shown using black barbs, the areas of subsiding air (downdrafts) are circled in blue and the areas of uplift circled in green.

When the pilot entered Thorame-Basse valley, he remained on the lee side of the terrain and encountered an area of subsiding air. He tried to gain altitude by performing spirals but did not manage to find uplifts. He might have been able to find uplifts upwind of the terrain south of Thorame-Basse (see **Figure 4**). He finally decided to land in a field that he considered suitable for an off-field landing.

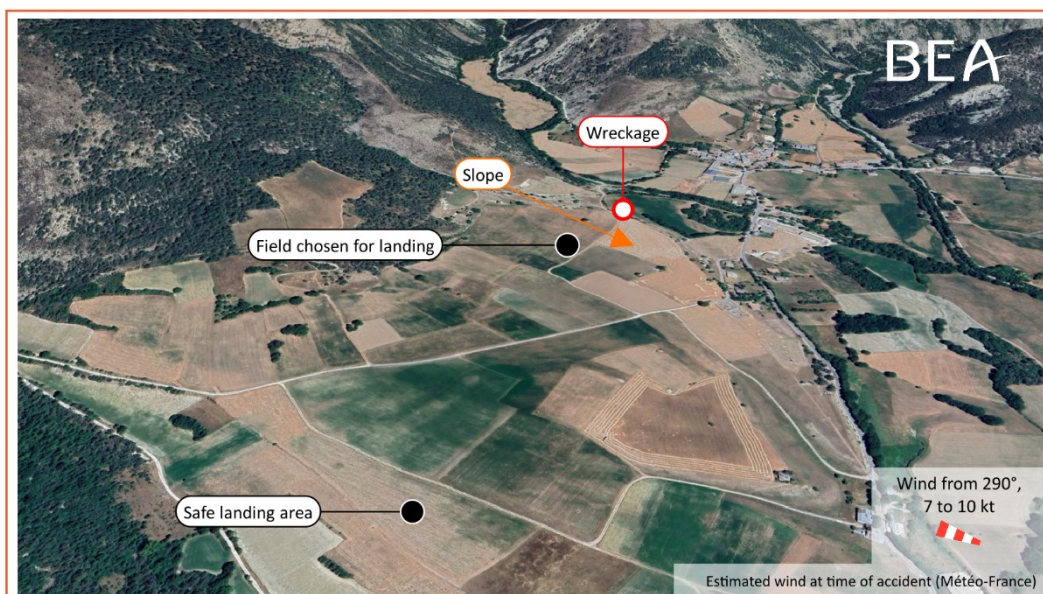
Figure 5: view of field (source: Géoportail, annotations BEA)

The mountainous environment probably made it difficult to estimate the horizon and thus assess the slope of the field.

This event highlights the difficulty of estimating the slope of a field when preparing for an off-field landing (see **Figure 5**) and in the absence of a reconnaissance and a suitable circuit.

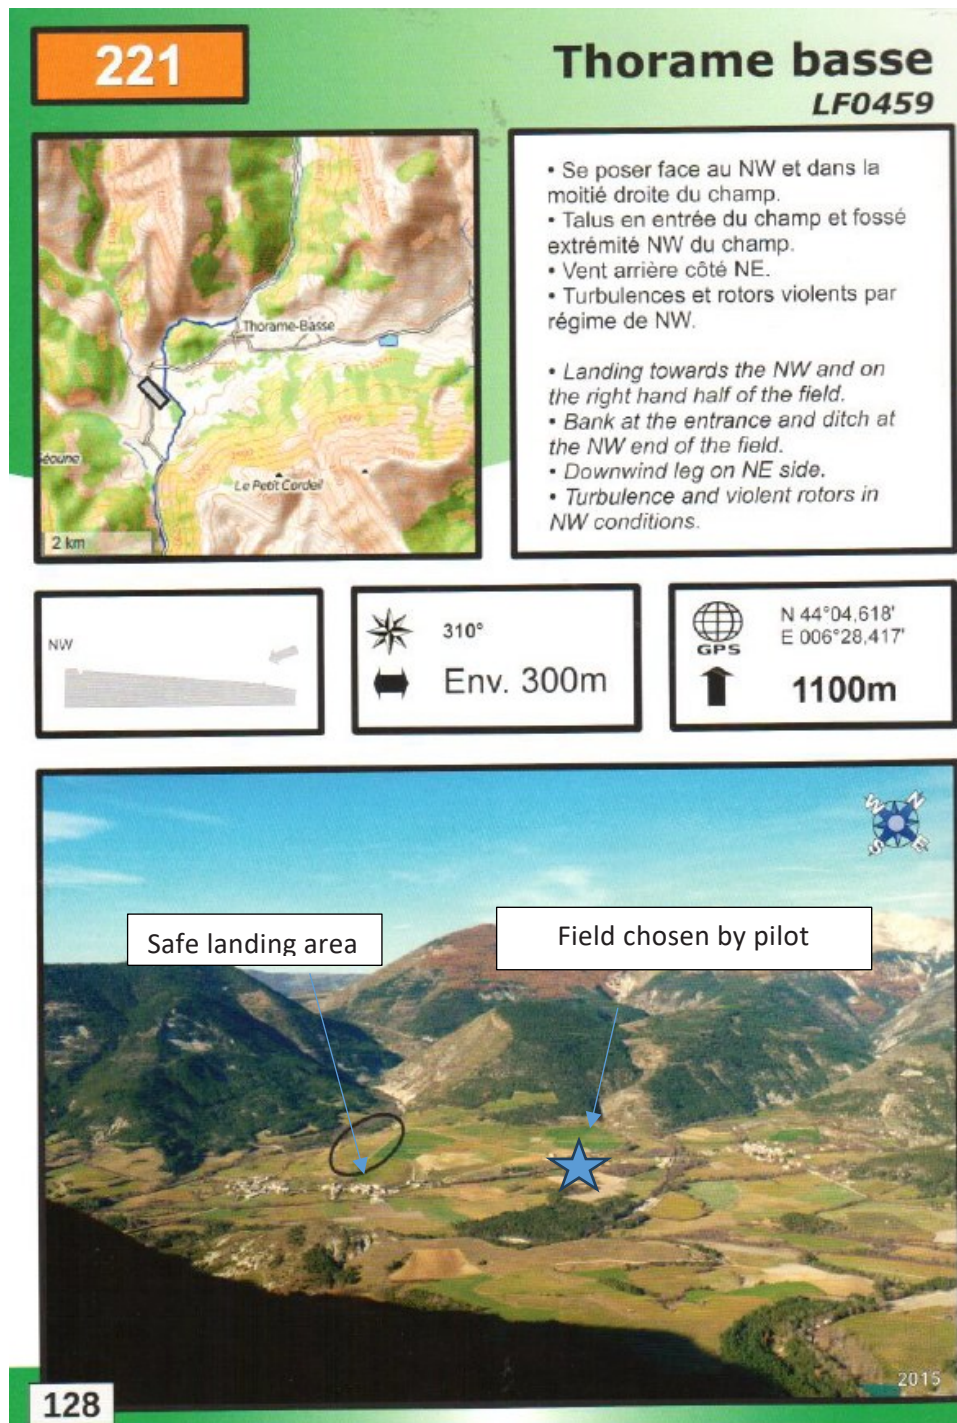
Figure 6: "Thorame-Basse" safe landing area (source: Guide des aires de sécurité, 4th edition)

The pilot was not aware of the existence of a safe landing area situated a few hundred metres from where he decided to land. He did not use the Guide to safe landing areas in the Alps published by the French glider federation (FFVP).

The Guide to safe landing areas in the Alps published by the FFVP allows the pilot to locate the most appropriate places for an off-field landing. There is an area referenced LF0459 "Thorame-Basse" which the pilot could have used to land (see **Figure 6**).

The document [Safety in mountain flying](#), available in several languages (French, English, German, Italian and Polish) specifies, "Study all the outfield landings known in the area and mark them on one's map; keep the updates on the GPS and the data bases. Do not take off without an updated safety out landing zone booklet."
