Accident to the PILATUS PC-6/B2-H4
registered **HB-FDU**
on Tuesday 21 January 2025
at Maripasoula aerodrome (French Guiana)

Loss of control on short final, collision with ground

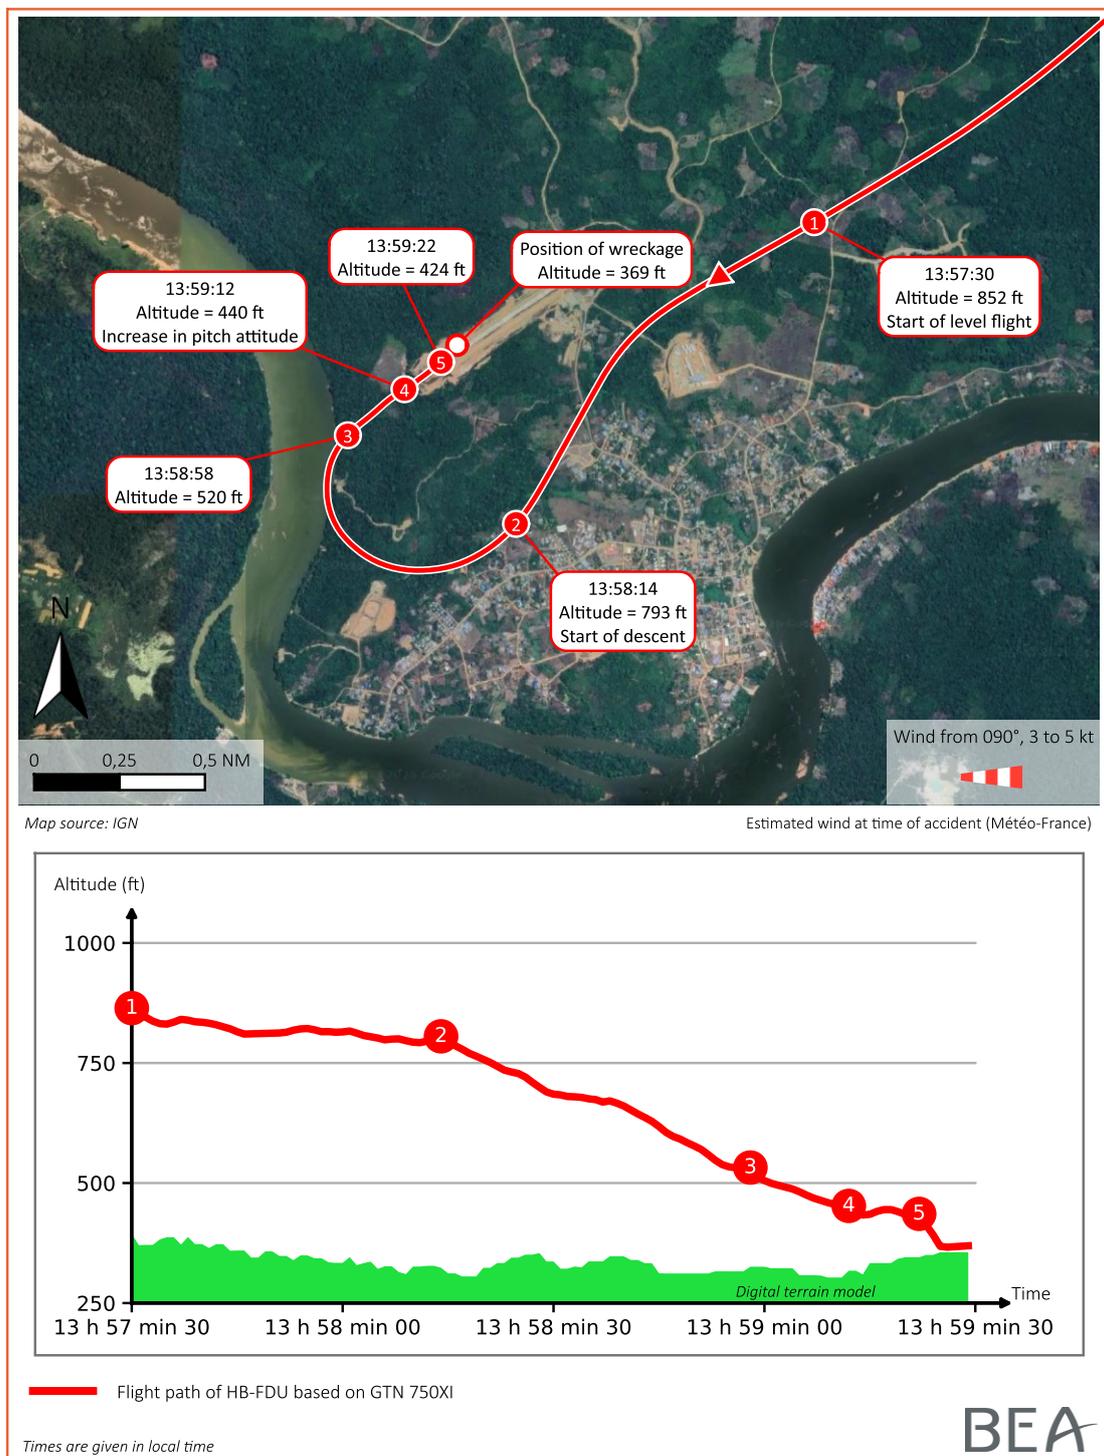
After a flight time of around 50 min, at a mean cruise altitude of 3,100 ft⁴, the pilot started the descent to Maripasoula. The pilot levelled off at an altitude of around 850 ft and joined the RH downwind leg for runway 07⁵ at Maripasoula (see **Figure 1**, point **1**). The pilot indicated that he positioned the power lever in order to have 20 PSI, activated the booster pump and started extending the flaps (four turns of the handle). The pilot made a LH turn to increase his distance with respect to the runway before starting his final descent. He started his final descent at an altitude of around 800 ft (point **2**) and carried out a large continuous 180° turn to line up with the axis of runway 07. At the beginning of the final approach, at an altitude of around 520 ft, the indicated airspeed (IAS) was around 61 kt.

Figure 1: end of flight path of HB-FDU

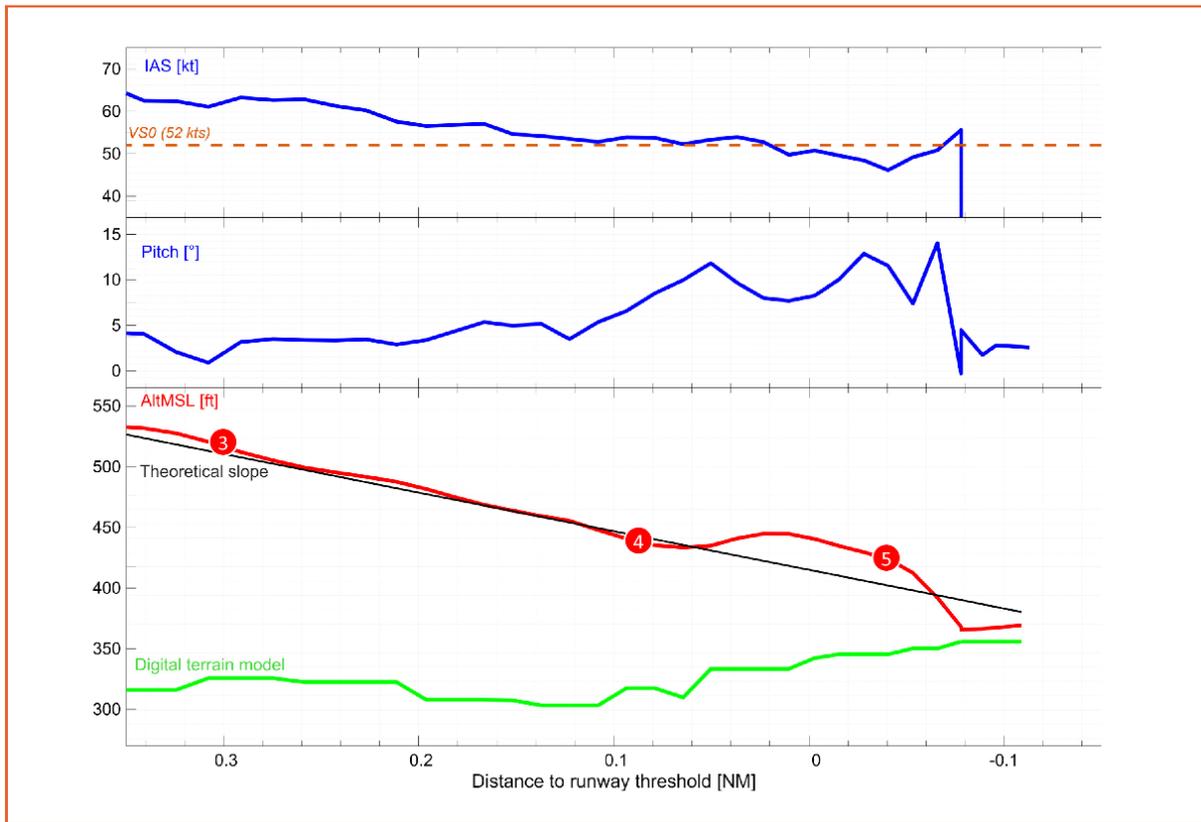
The pilot indicated that once on the axis, on short final, he extended the flaps to nearly full deployment and checked that they were correctly positioned. The speed progressively decreased and a few seconds later, the pitch attitude increased (point 4) to reach around 12°. The IAS was 53 kt at this point. The IAS continued to decrease until reaching a minimum of 46 kt. The pitch attitude oscillated, reaching a maximum of 14° before suddenly decreasing (point 5). The pilot lost control of the aeroplane. The aeroplane collided with the ground and came to a stop on the LH side of runway 07.

Figure 2: final descent of HB-FDU

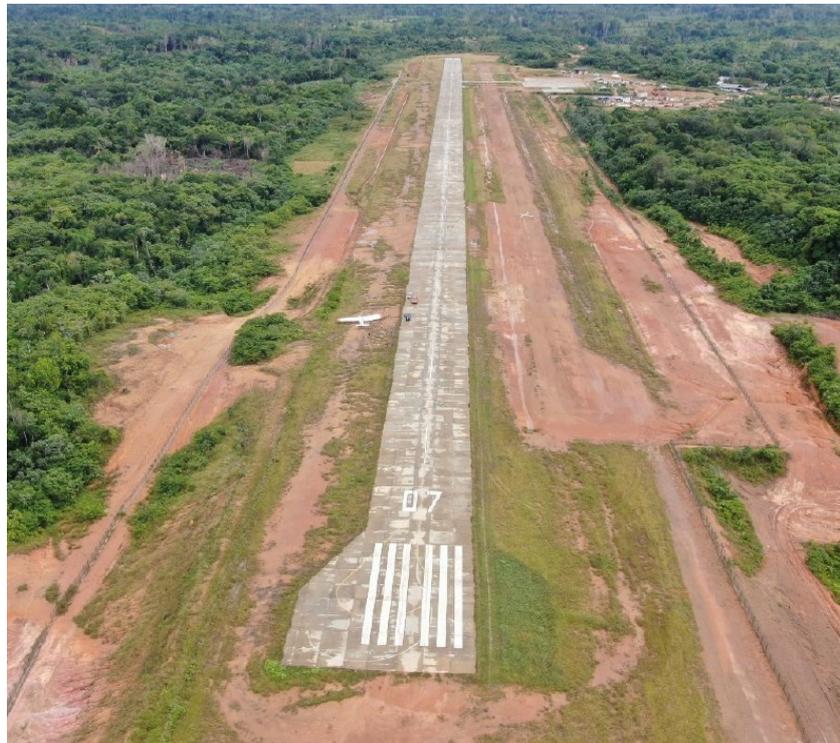
Figure 3: photo taken by drone of accident site (source: GTA)

The wreckage was situated 20 m to the LH side of the runway 07 centreline and approximately 160 m from the threshold. BEA field investigators and the air transport police went to the site. The latter weighed all of the aeroplane's cargo and obtained a measured weight of 1,069 kg. As the cargo had moved after the impact, it was not possible to accurately determine the distribution of the loads. The LH fuel tank gauge indicated less than 90 l, the RH fuel tank was found empty due to a leak after the RH wing was partially torn off.

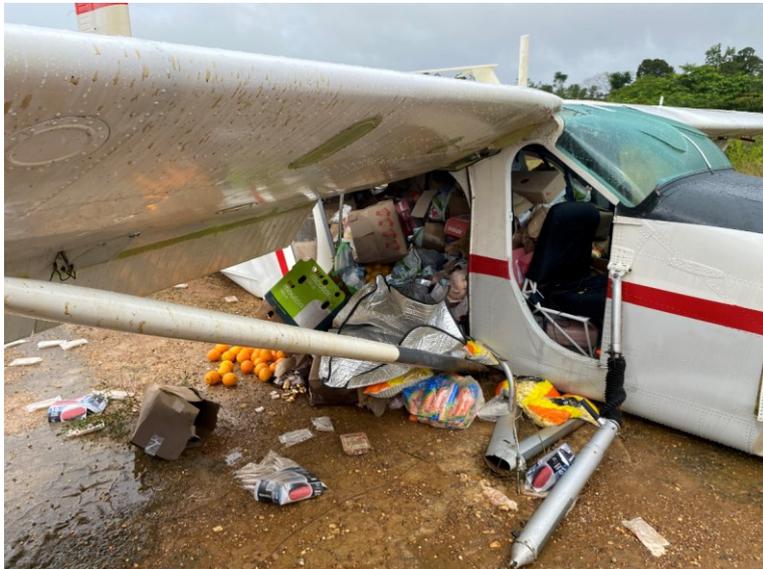
Figure 4: damage on airframe (source: GTA)

The trim indicator in the cockpit was found in position 2 (slightly nose-up). The position of the flaps corresponded to around ten turns of the handle for a maximum of eleven and a half. The flight controls were continuous and functional on the three flight control linkages. The examination of the propeller showed that there was engine torque (moderate to high power, no feathering) when the propeller struck the ground.

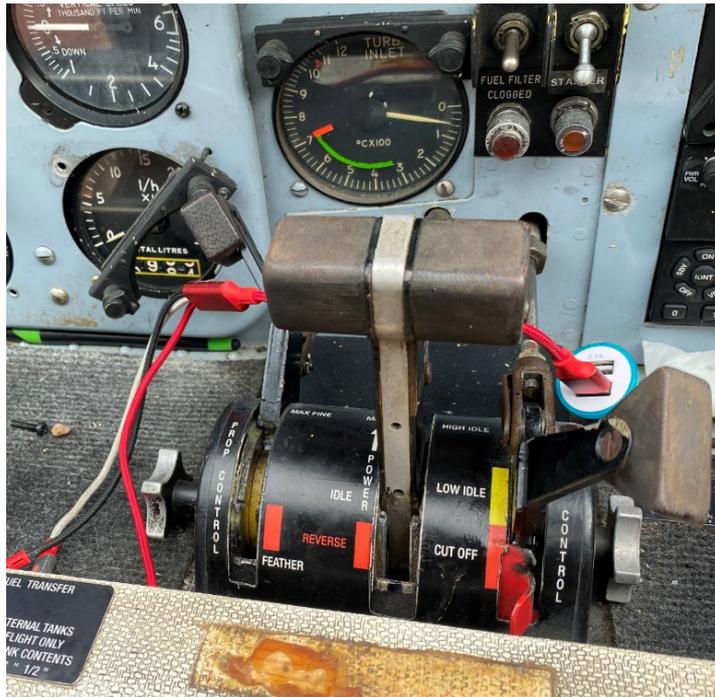
The idle control was found in the LOW IDLE position after the accident (see **Figure 5**). The investigation was not able to determine the position of this control during the final approach nor whether this control was moved after the accident (see paragraph 2.6.2).

Figure 5: photo of engine and propeller controls of HB-FDU taken after the accident (source: GTA)

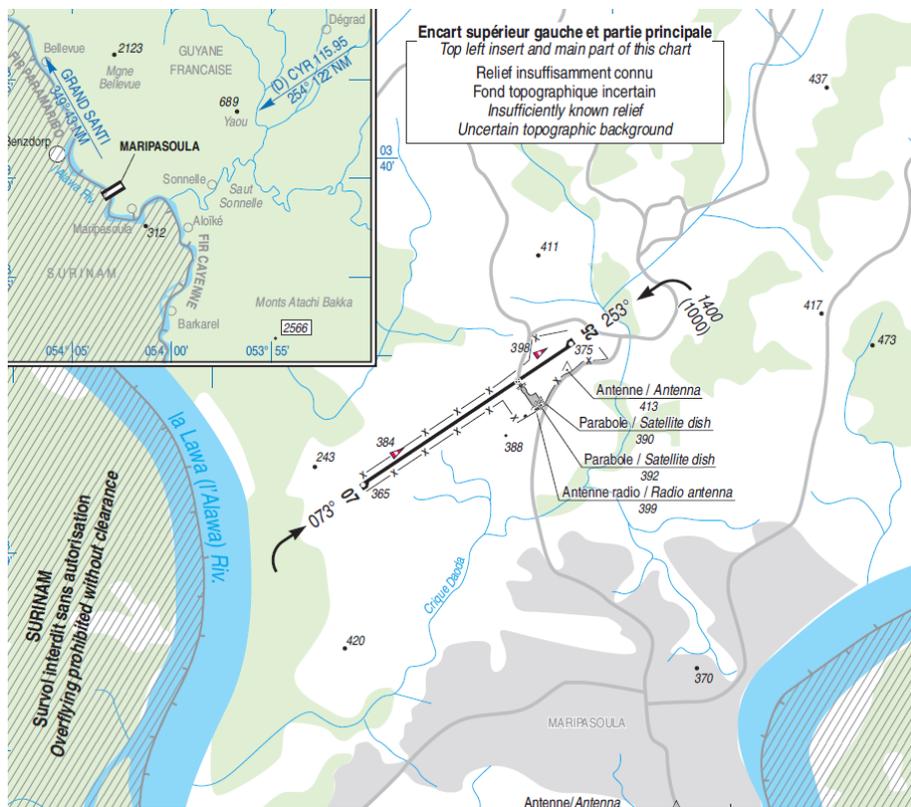
Maripasoula aerodrome is situated close to the border with Suriname. As the border is situated less than 800 m from the threshold of runway 07, the approach to this runway requires the pilot to carry out a short final so as not to fly over Suriname territory (see Figure 6).

Figure 6: excerpt from Maripasoula VAC (source: SIA)
