Accident to the Beechcraft 18 - C18S
registered **HB-GAC**
and to the Robin DR400-120
registered **F-GPHL**
on 21 May 2022
at Béziers-Vias

Collision between aeroplane taxiing and aeroplane at holding point

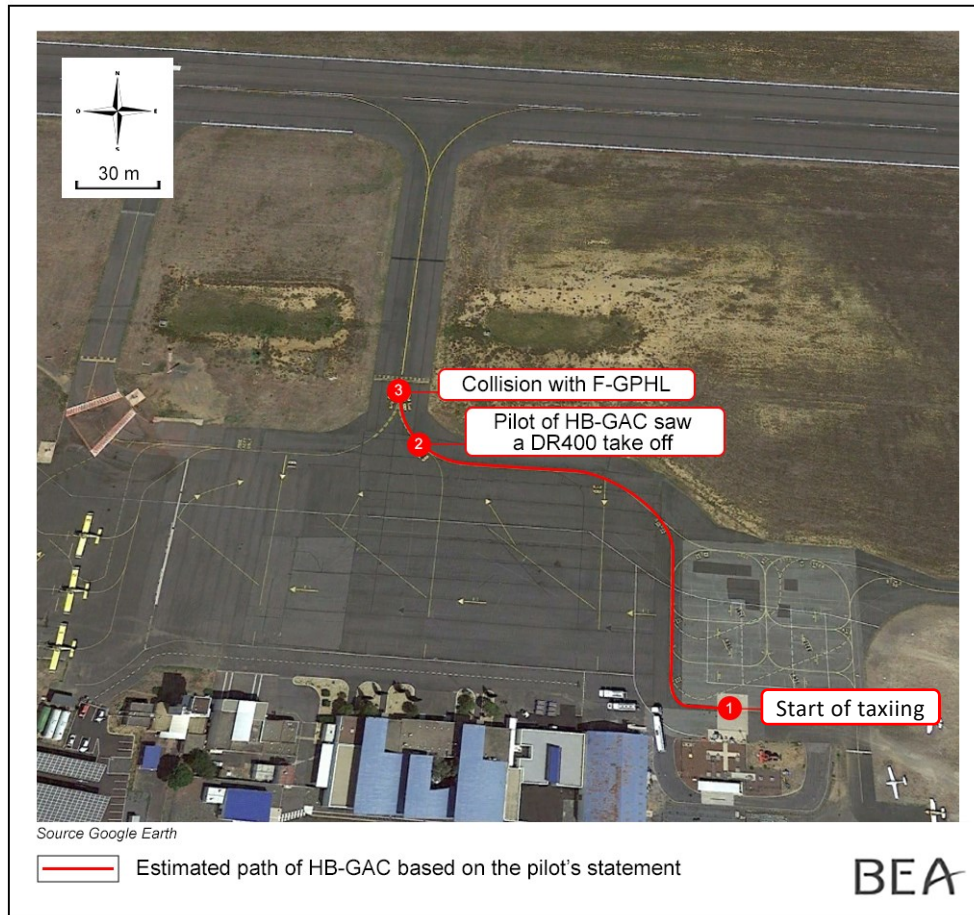
The pilot of HB-GAC left the parking area, taxied and turned onto taxiway A. Meanwhile, the pilot of F-GPHL announced that he was ready at holding point A. The controller asked him to hold at holding point A. The pilot of HB-GAC then saw a DR400 take off. As he reached the holding point, he collided with the DR400, registered F-GPHL. The propeller of the right engine severed the rear of the DR400, which was thrown to the right on impact.

Figure 1: path of HB-GAC when taxiing

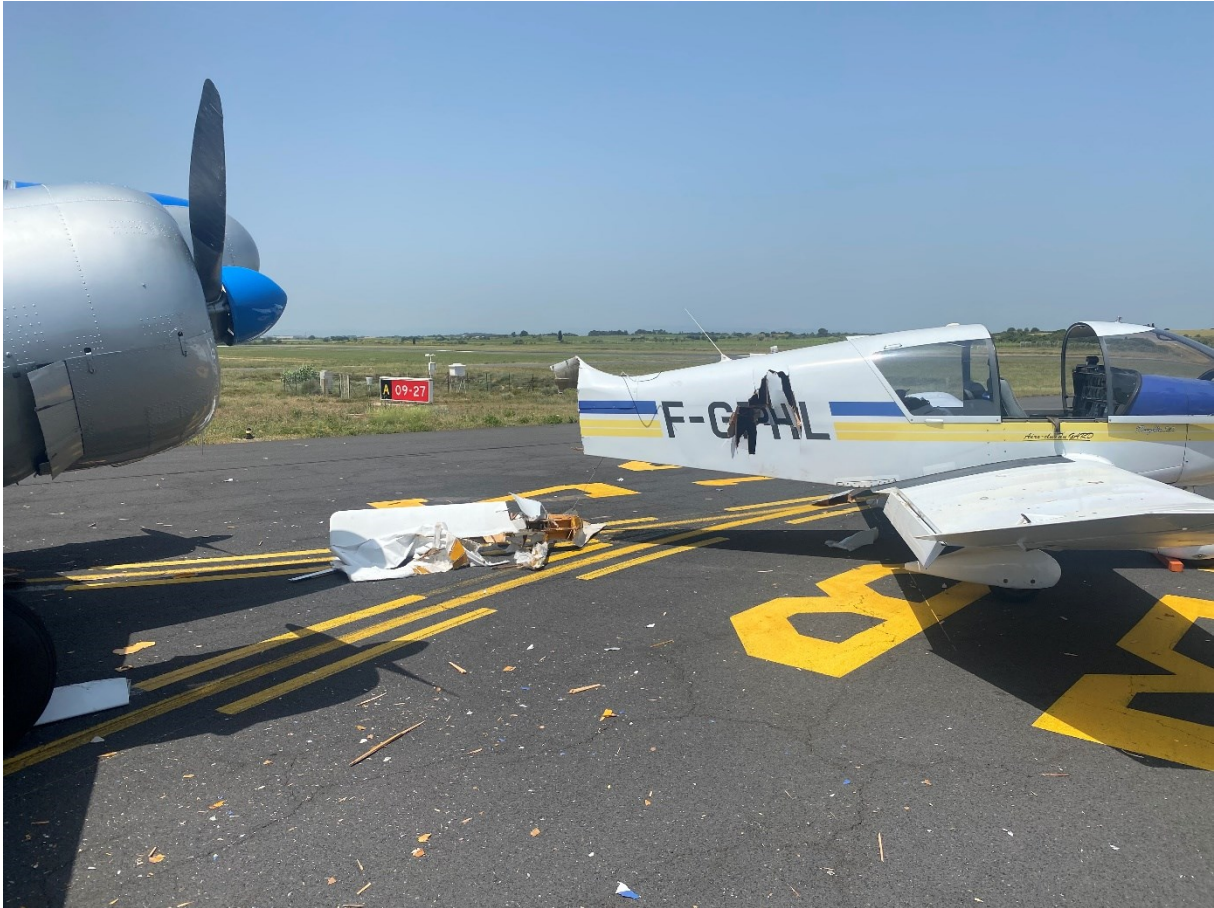
Figure 2: damage to F-GPHL (source: pilot of HB-GAC)

When the pilot of HB-GAC started taxiing to holding point A, he was aware of a DR400 at this holding point. He then lost sight of it while taxiing. When he turned on the taxiway, he saw a DR400 take off and thought it was this aeroplane. At the end of the turn, he did not have the holding point in sight due to the low forward visibility from inside the cockpit and did not make sure that the taxiway was clear by continuing the turn to look at the holding point from the left side of the aeroplane. Given the position of the DR400 registered F-GBUJ on the runway, there was no need to provide traffic information about this aeroplane and it is possible that the pilot of HB-GAC had a level of understanding of the French language which did not allow him to follow communications in French, and may have degraded his situational awareness. The propeller of HB-GAC severed the rear of the DR400 still at the holding point. The pilot braked quickly, limiting the consequences of the collision.

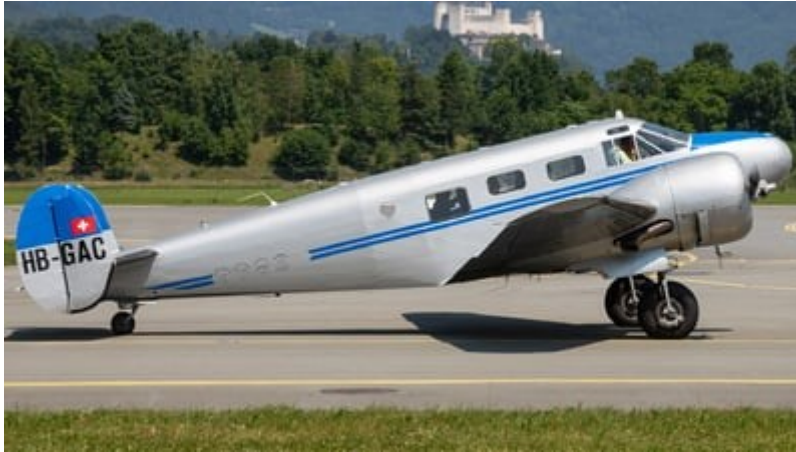
The Beech 18 registered HB-GAC, is a twin-engine aeroplane with conventional landing gear. The pilot was the co-owner. Due to the high nose-up angle of the fuselage with respect to the ground, the front of the fuselage screens part of the pilot's view forward. It is therefore common practice to zigzag in order to see forward by looking out of the side windows.

Figure 3: HB-GAC (source: jetphotos.com)

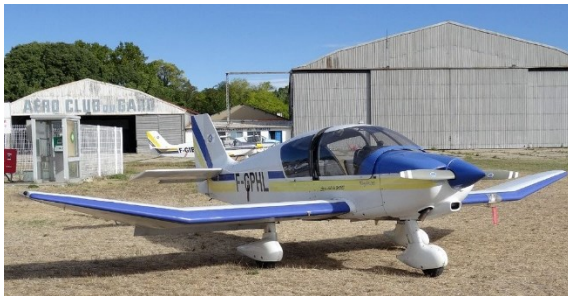
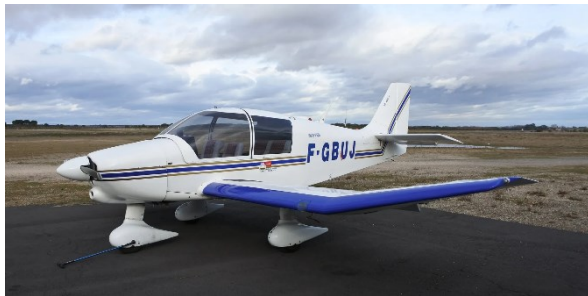
F-GPHL is a DR400-120 belonging to *Aéroclub du Gard*. F-GBUJ is a DR-400-120 belonging to *Aéroclub de Béziers Cap d'Agde*. The colours of these two aeroplanes are very similar.

Figure 4: F-GPHL and F-GBUJ (source: *aero clubs*)
