Accident to the ROBIN - DR400 - 140B
registered **HB-KBX**
on 8 July 2022
at Culoz

Engine shut-down in flight, forced landing, overturn

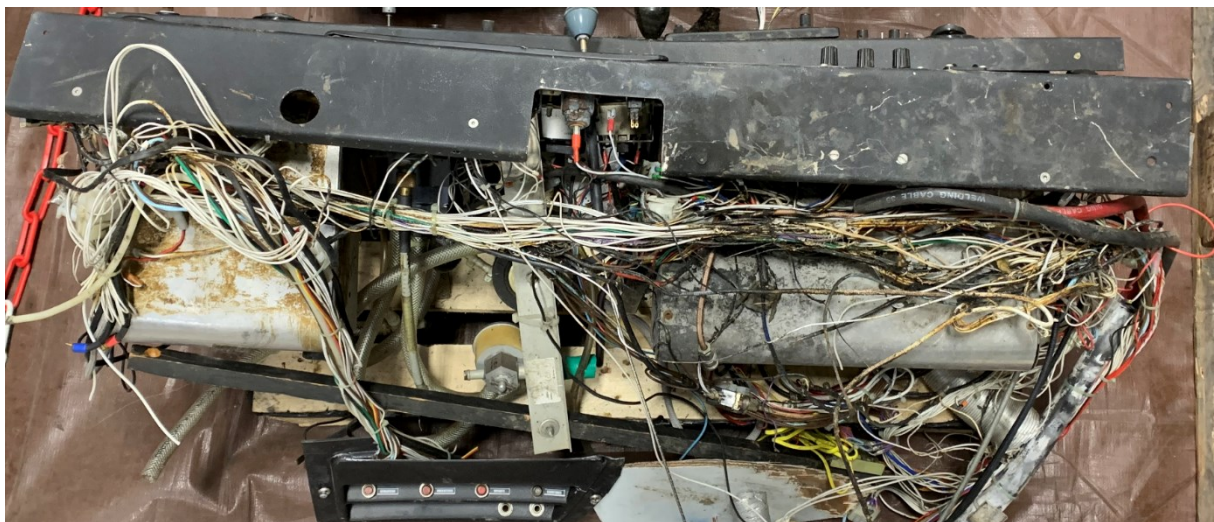
The examination of the instrument panel, carried out at the BEA facilities found substantial signs of overheating and fusion on the part of the protective sleeves covering the bundle of electrical wires running along the back bottom of the instrument panel (see *Figure 1*). These marks indicated an overcurrent in the aeroplane's electrical system. No other overheating mark was identified on the wreckage.

The runs of melted plastic corresponding to the electric cable sleeve were oriented to the bottom of the instrument panel. As the aeroplane had rolled onto its back after the collision with the ground, this direction of the runs shows that the overcurrent had started during the flight. What exactly caused it could not be determined.

Nevertheless, the examination showed that the overcurrent probably occurred on one of the cables connected to the main electrical bus which supplied all the electrical devices of the aeroplane. The condition of the cables linking the engine magnetos to the selector located on the front of the instrument panel showed that they were not responsible for the overcurrent.

During the flight, the fusion of the protective sleeves of the magneto cables and other cables of the bundle caused electrical continuity. In particular, the magneto cables became connected to the aircraft ground leading to the engine ignition system being cut off and then the engine shutting down.

Figure 1: back of the instrument panel and location of overheating marks (Source: BEA)
