**Accident** to the ROBIN - R3000 - 160  
registered **HB-KEQ**  
on Friday 11 November 2022  
at Megève

## **Approach below the approach slope, collision with trees on final**

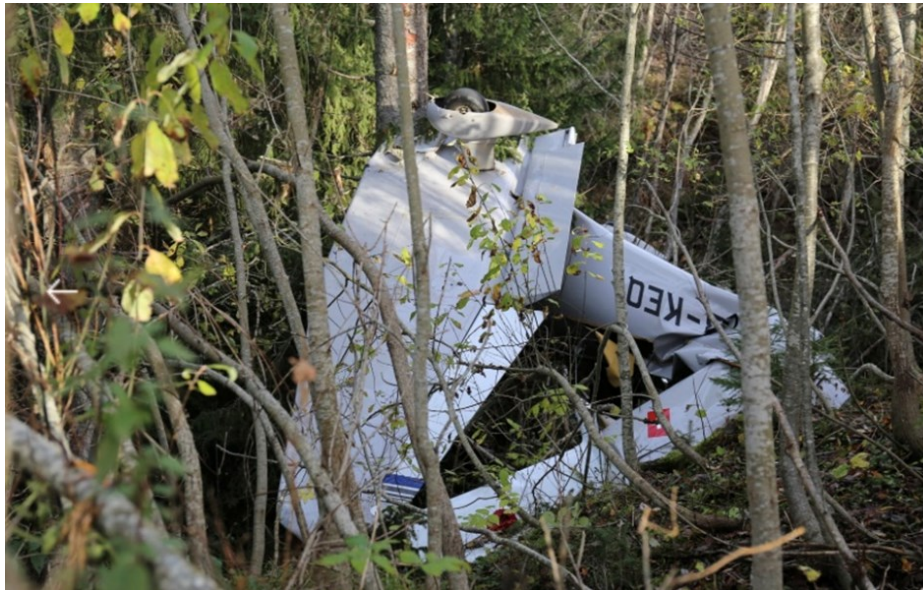
The aeroplane was destroyed. The wreckage was located in a wood approximately 400 m before the threshold of runway 15. It was laying on its back at an altitude of 4,573 ft.

The front section, including the front landing gear, the power unit and the instrument panel, was found a few metres from the main wreckage.

The right wing was ruptured in line with the root. The tailplane was substantially damaged. The flaps were extended in the landing position.

*Figure 1: view of the wreckage (Source: BEA)*

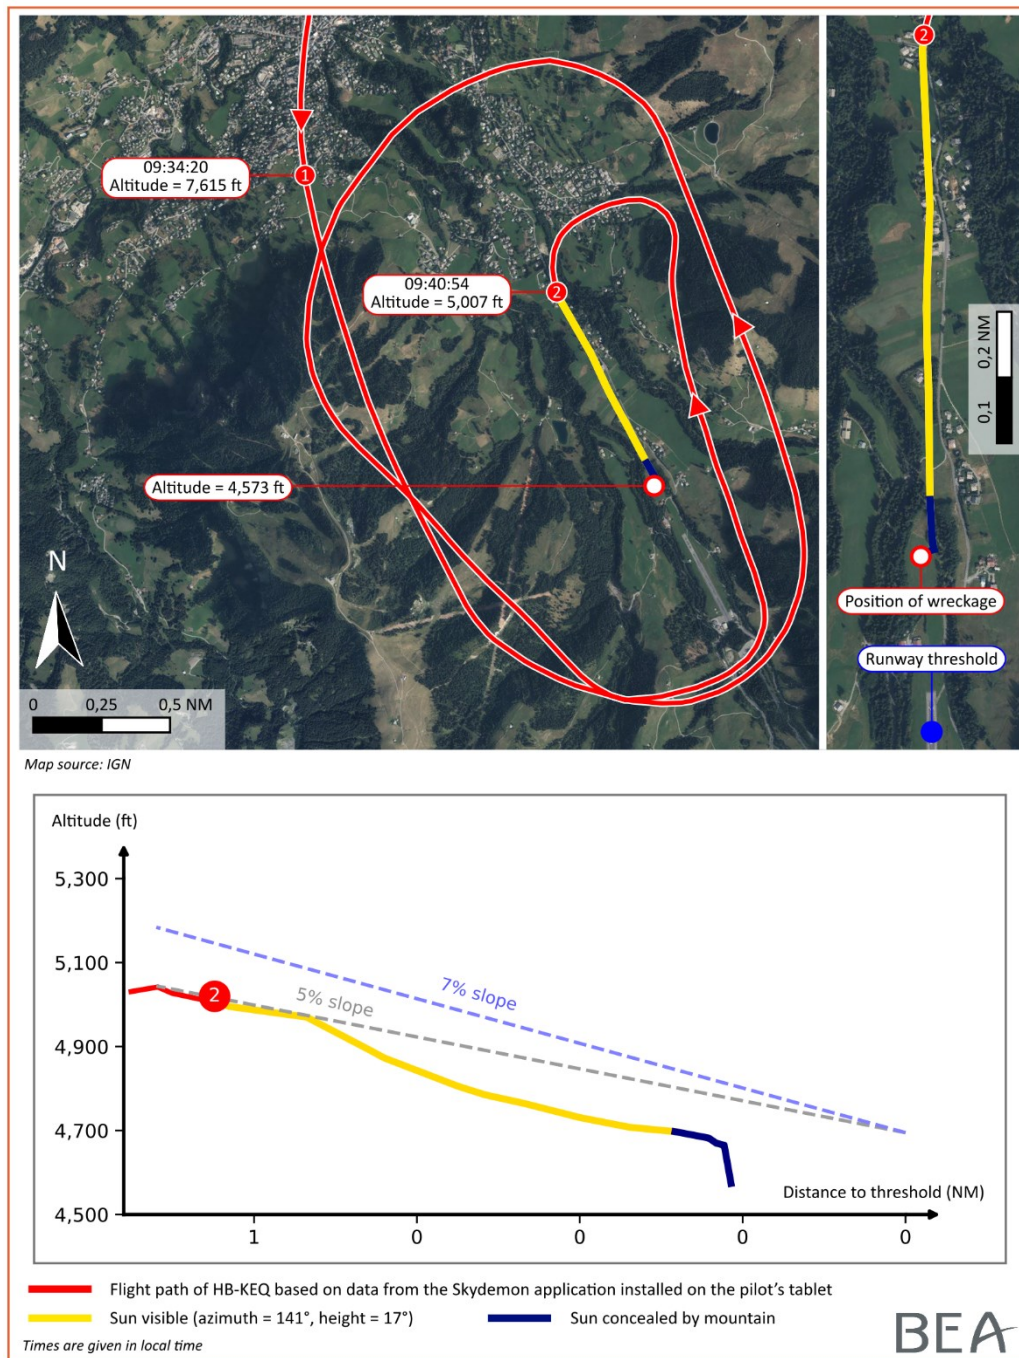
The read-out of data showed that the pilot started the descent in the final turn and did not stay level thereafter. He had therefore passed through an altitude of around 5,000 ft in descent when he intercepted the approach path; he was then on an approach slope of 5% leading to the threshold of runway 15.

At around 0.9 NM from the threshold, the pilot increased the glide slope up to 10%. At 0.6 NM from the threshold, the aeroplane was about 100 ft below the approach slope of 5%.

The aeroplane passed in the shadow of the terrain to the south of the runway, at 09:41:30 and 0.35 NM from the threshold. It passed below the altitude of the runway threshold 0.34 NM from the latter. The aeroplane then collided with the vegetation, with the last point being recorded at 09:42.

Figure 3: path of the aeroplane
