Accident to the JODEL - DR250 – 160 “Capitaine”
registered **HB-KFS**
on Saturday 8 April 2023
at Saulieu-Liernais aerodrome

Runway veer-off during take-off, strike with pedestrian

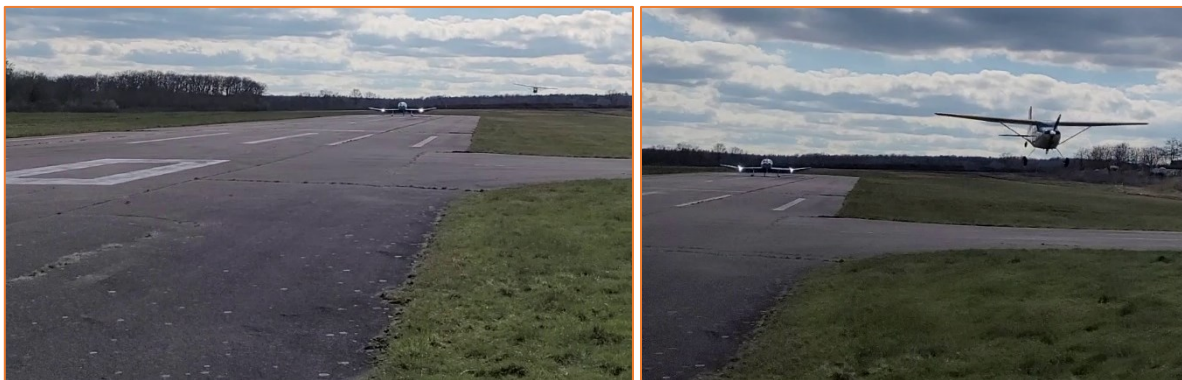
The pilot of HB-COE carried out a low pass on the LH side of the runway as the pilot of HB-KFS started his take-off.

Figure 1: excerpt from video recorded by pedestrian when pilot of HB-KFS started the take-off (LH side) and four seconds later (RH side)

During power-up and at the start of the take-off run, the video shows the start of a movement to the left, which is then quickly corrected.

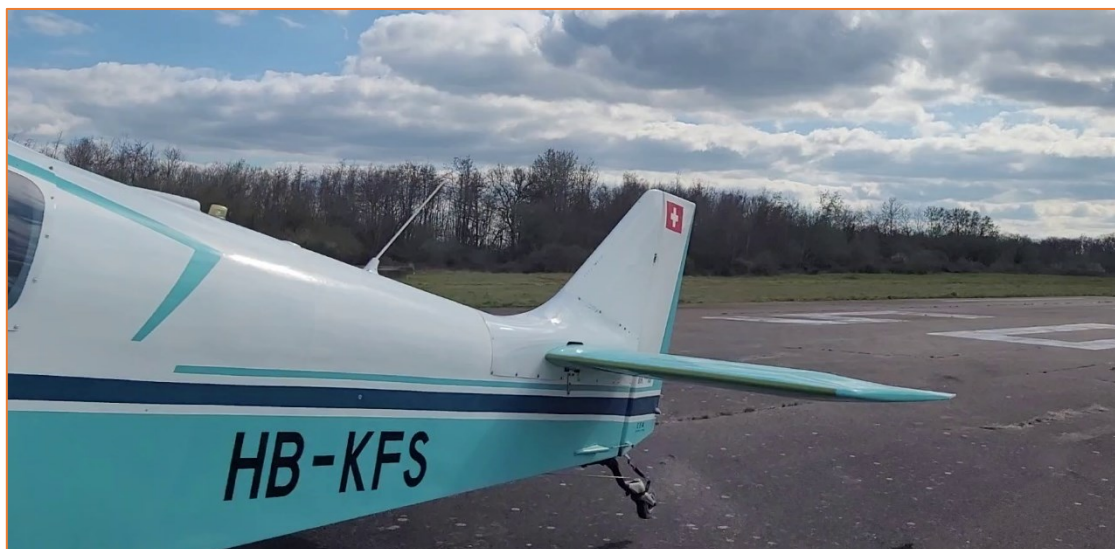
Another video file shows HB-KFS on its take-off run, abeam the taxiway, with the tailwheel raised. The aeroplane was already off-centre at this point on the runway, with the RH gear almost two metres to the LH side of the runway centreline.

The aeroplane continued to the left and approached the runway edge. The last images before the collision with the pedestrian show that the rudder was pointing towards the RH side of the aircraft.

Figure 3: excerpt from video recorded by pedestrian, just before impact

No reduction in power before the collision is perceived on the audio part of the recording.
