**Accident** to the CESSNA - T303 "Crusader"  
registered **HB-LUV**  
on 04 December 2020  
at Annecy-Meythet

**Runway overrun during landing  
on a wet runway**

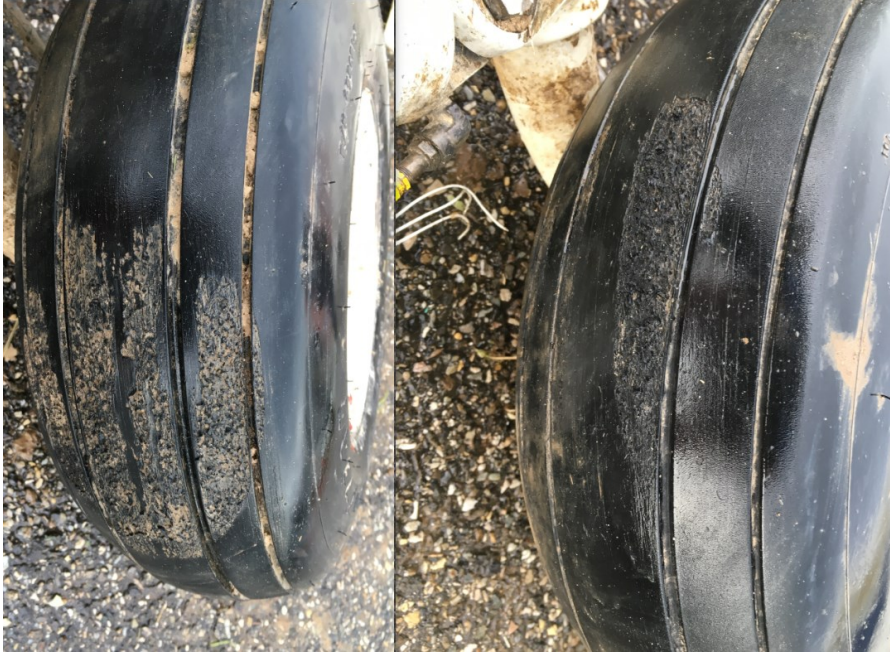
The examination of the damage to the main landing gear tyres confirmed a reverted rubber hydroplaning phenomenon<sup>2</sup> during landing.

**Figure 1: reverted rubber mark on left and right main gear tyres (Source: BEA)**

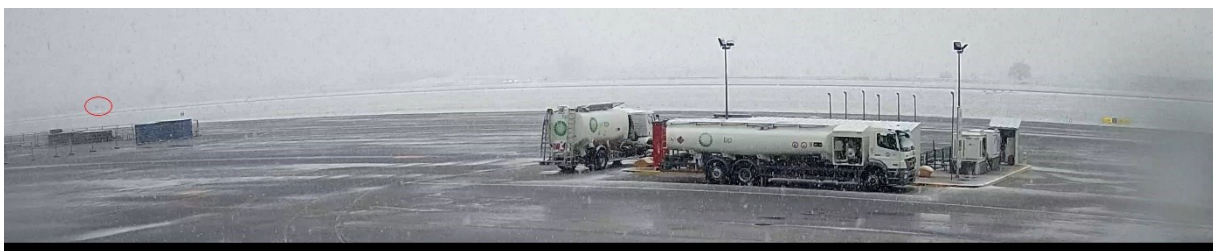
Figure 3: panoramic view from the surveillance camera

When the aeroplane was lined up for landing (red circle in Figure 3), the black asphalt of the runway surface was visible, the aeroplane parking areas were wet, and snow was visible on the grassy parts of the airport and on the sides of the runway. Snow was falling and can be seen in the picture.

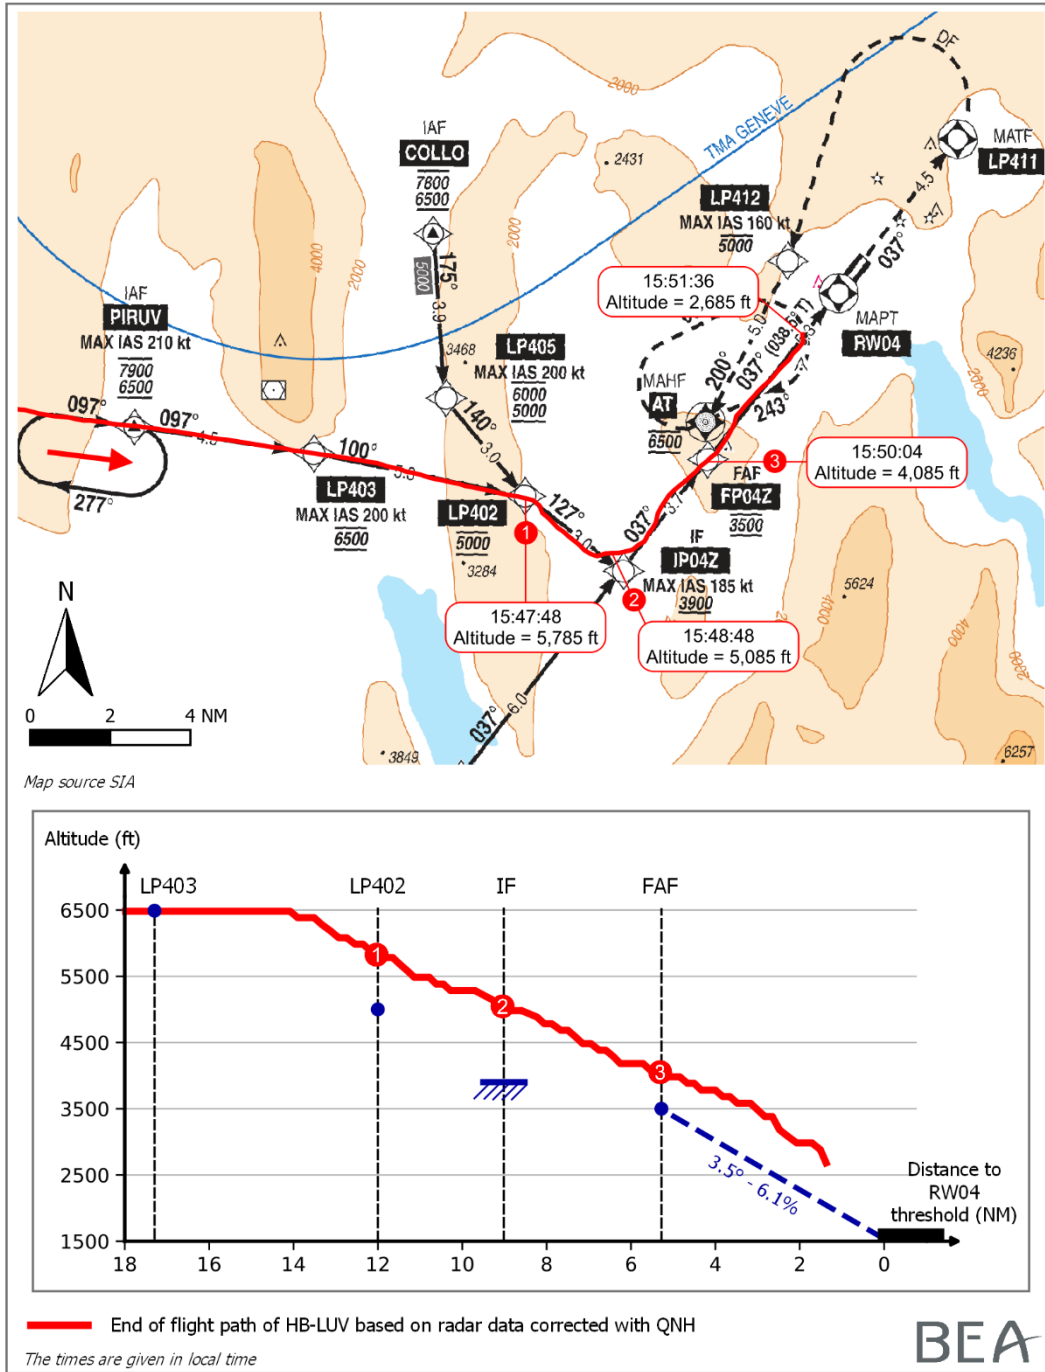
Figure 5: path taken by the aeroplane on the RNP Z 04 procedure

After passing the LP 403 reporting point, the pilot started to descend late and could not reach the required altitude of 5,000 ft on passing the LP 402 reporting point (point 1 on the path shown above). The pilot reached the FAF 3 500 ft higher than the required altitude of 3,500 ft and continued the descent. During this descent, the aeroplane was, on average, 500 ft above the approach path.

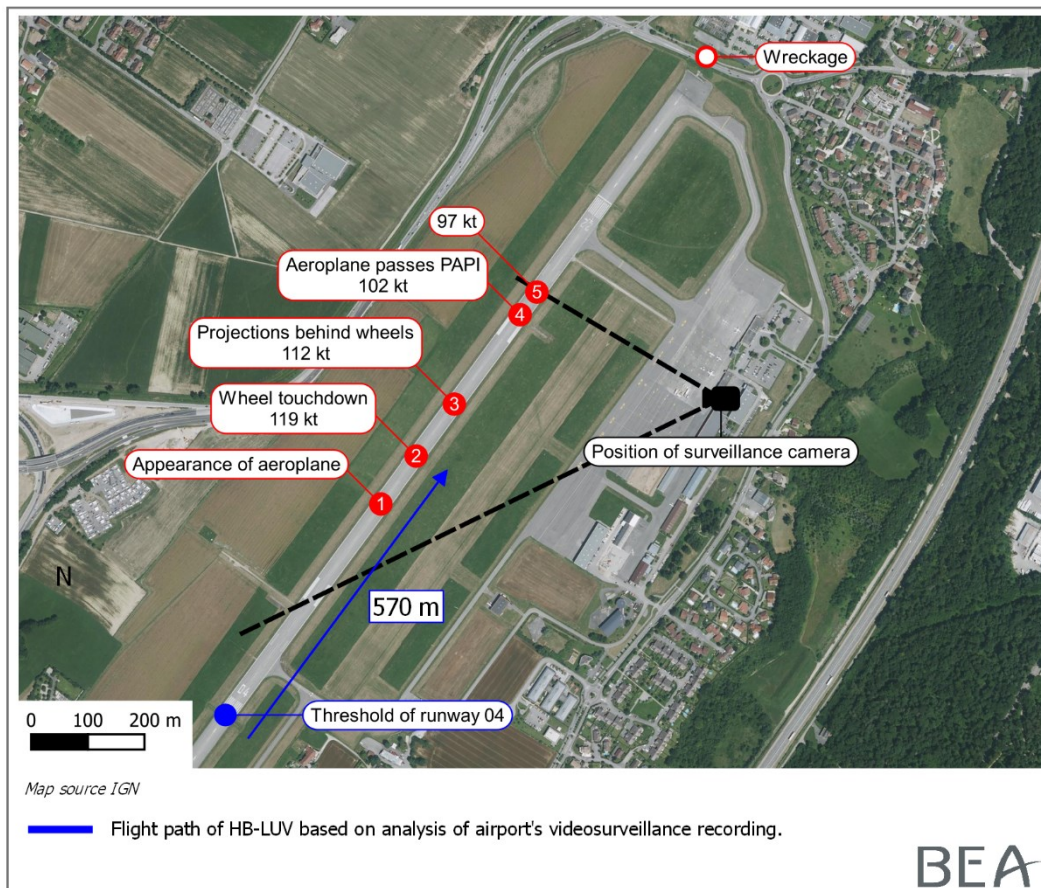
**Figure 6: aeroplane positions and ground speeds during landing, based on the analysis of the airport surveillance camera recording**

- the aeroplane touched down 570 m beyond the runway threshold (see Figure 6, point ②) with a ground speed of 119 kt<sup>7</sup>;
- between points ② and ⑤, the aeroplane speed slightly decreased (about 20 kt in 380 m);
- at point ⑤ (end of the camera's field of view), the aeroplane's ground speed was 97 kt and the remaining runway distance<sup>8</sup> was 400 m.
