Accident to the PIPER PA-28RT - 201T
registered **HB-PNP**
on Thursday 23 July 2020
on Bâle-Mulhouse airport

In-flight fire, emergency landing

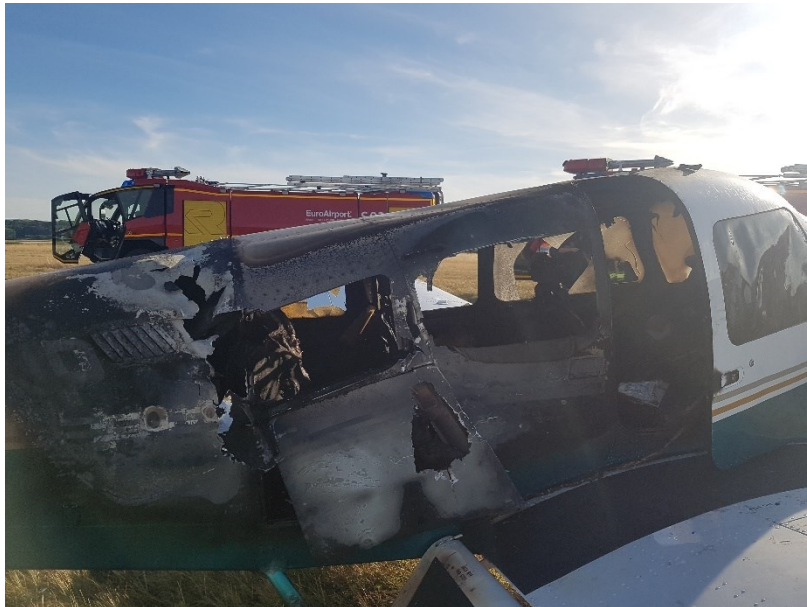
The visual examination of the damage observed on the wreckage (see Figure 2) and the assessment of its severity made it possible to determine that the source of the fire was located in the compartment situated behind the luggage hold. This zone holds the ventilation system, the hydraulic pump for the landing gear, the battery and numerous components of the general electrical system supplying the aeroplane equipment (see Figure 3).

Figure 2: general view of damaged area (source: BEA)

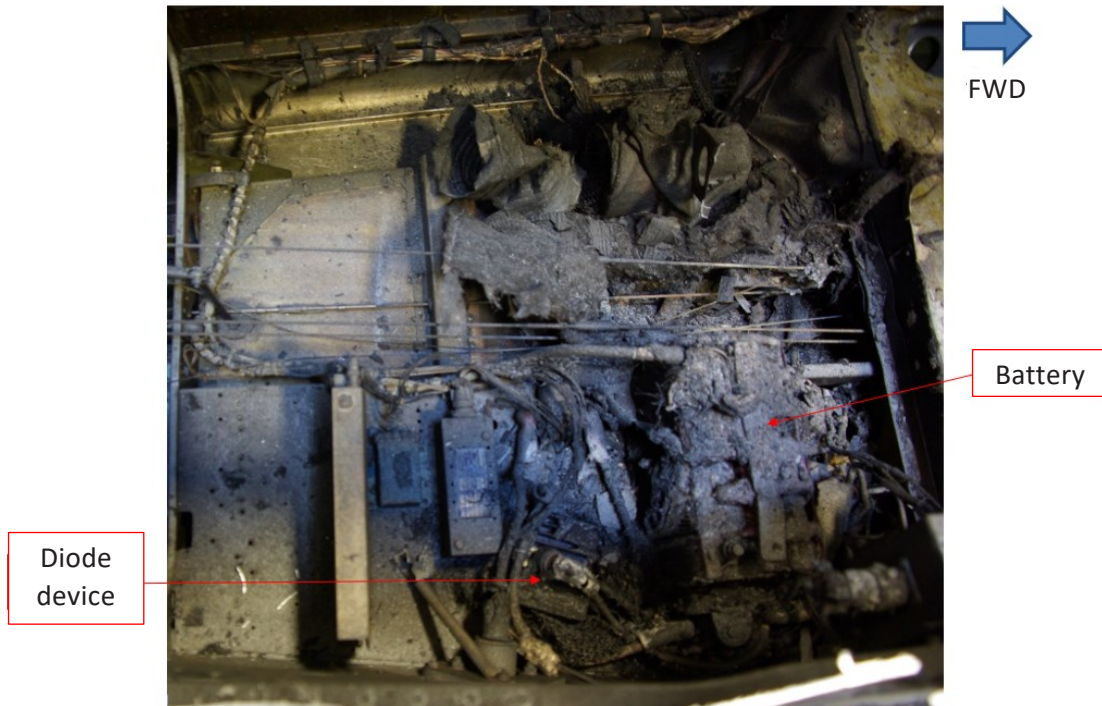
Figure 3: site of the fire (source: BEA)

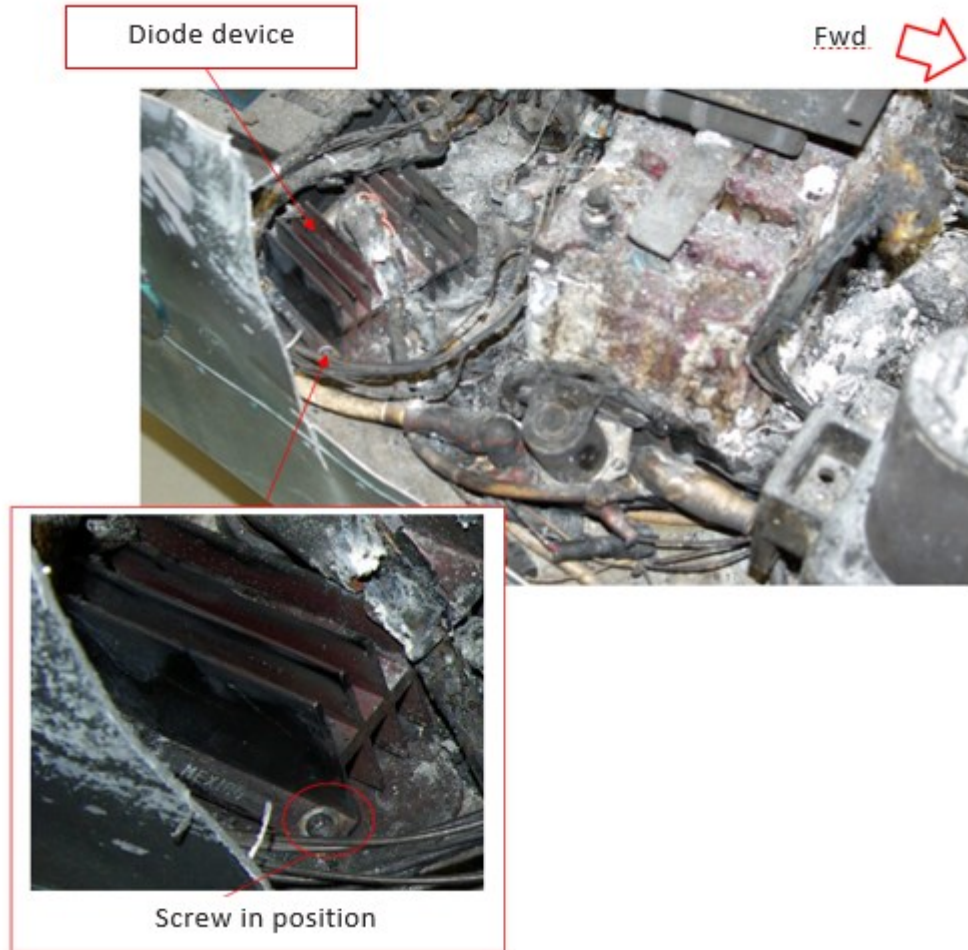
Figure 9: diode device in HB-PNP (source: BEA)

The diode device showed the following damage:

- The ABS cover was destroyed. Only the flanges of this cover were still partially present with their attaching screws in position and tightened. The melting point of the material composing the cover is 349°C.
- One of the four corners of the metal cooler was very damaged (thermal effect which had caused the aluminium alloy of which it is made to melt). The associated attaching screw and insulating washer were no longer present. The three other attaching screws and insulating washers in the three other attachment corners were in position (see Figure 10) and showed little damage. The melting point of aluminium is 660°C.
- The cooler also had a brown/purple discolouration. Initially, this cooler was black. This discolouration indicates that the cooler was exposed to a very high temperature.

These observations on the diode device indicate that the latter had been subject to a very high temperature in line with one of the four cooler attaching points that was sufficient to melt the aluminium alloy of the cooler. The distribution of this very localised damage does not seem to be the consequence of an external fire.

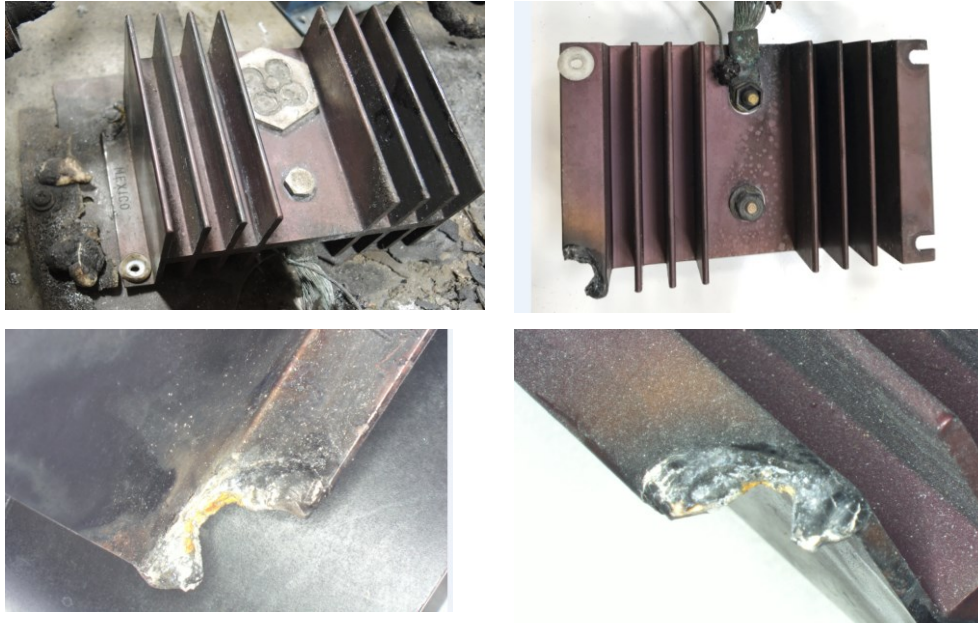
Figure 10: metal cooler of diode device after disassembly (source: BEA)

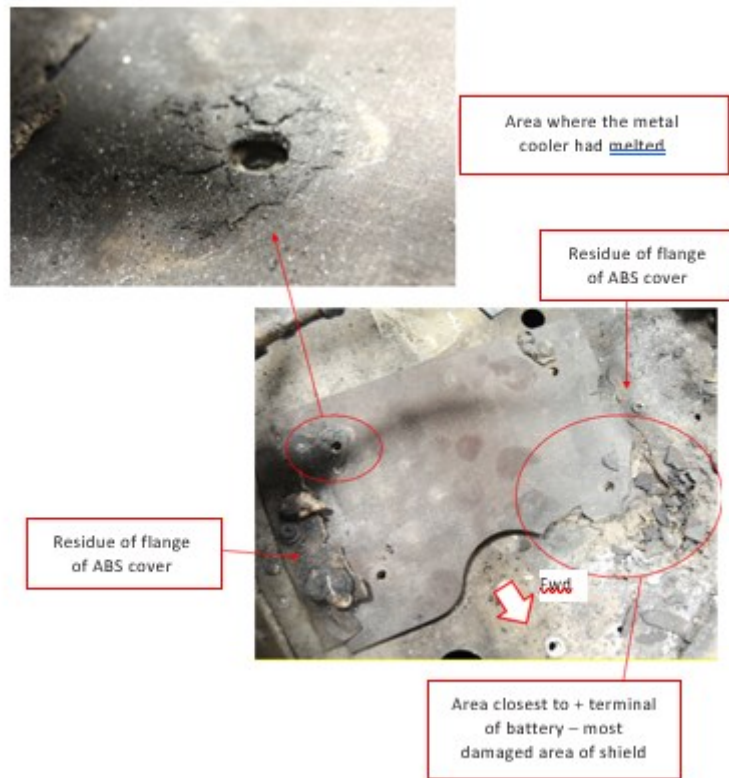
- The phenolic shield was in position under the metal cooler. It had a blackened appearance around the attaching point where the corner of the metal cooler had melted. It was also partially burnt in line with the front left corner situated the closest to the positive terminal of the battery (see Figure 11).

Figure 11: phenolic shield on aeroplane floor (source: BEA)

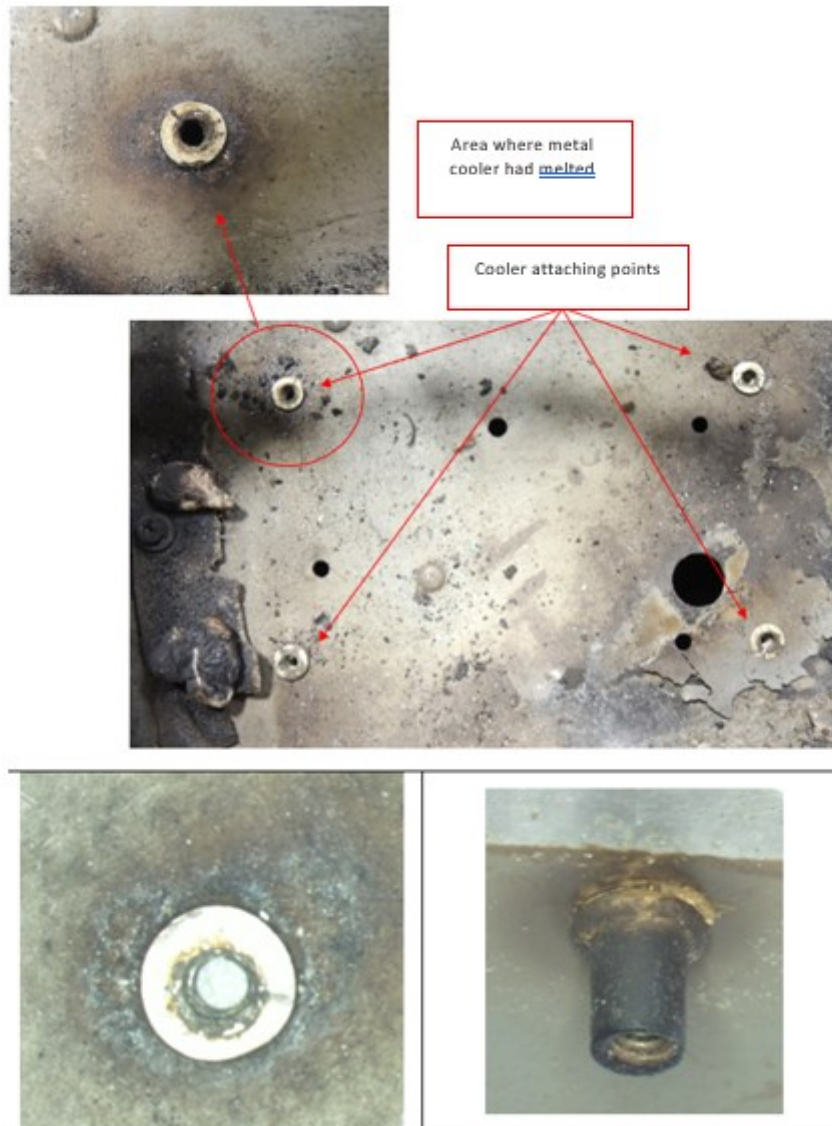
- The aluminium alloy plate making up the aeroplane floor had a blackened appearance around the attaching point where the cooler had melted. The anchor nut holding the attaching screw also had a dark appearance. This dark appearance was not observed around the three other attaching points (see Figure 12).

Figure 12: floor on which the cooler was fixed (source: BEA)

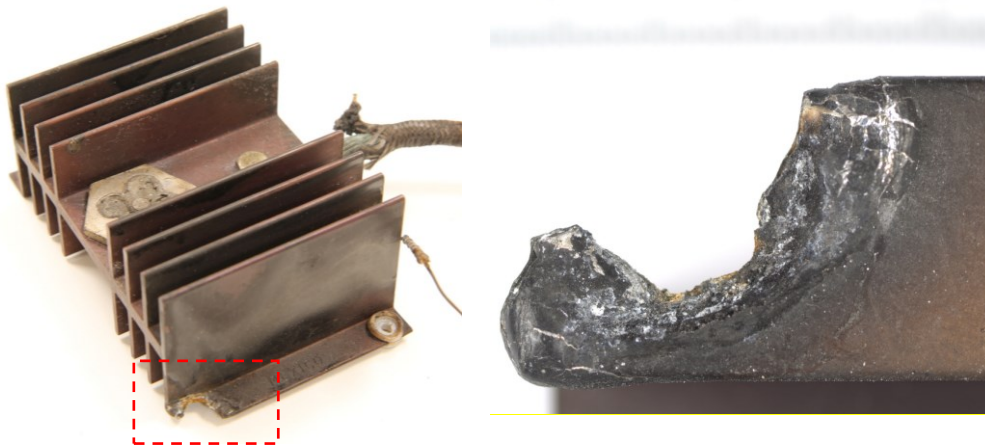
The corner of the cooler with thermal-effect damage was examined by the BEA laboratory. Sliced samples of the damaged area (see Figure 13) were taken, coated and then polished in order to carry out analyses of the chemical composition in the melted area using Energy Dispersive Spectrometry (EDS).

Figure 13: metal cooler of HB-PNP and detail view of damaged area (source: BEA)

The EDS analysis of the successive sections found the presence of iron (Fe) and fluorine (F) in significant quantities in the melted area of the cooler of HB-PNP. The aluminium (Al) is the material making up the metal cooler.

These EDS analyses of the melted area of the cooler show that the steel screw and fluorine washer were present when the overheating occurred and led to them melting.

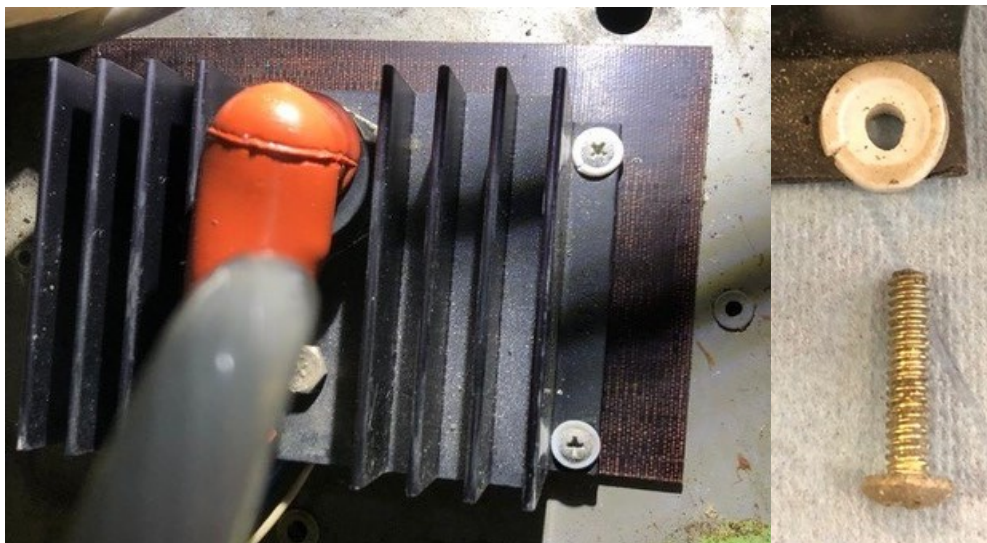
The Piper PA-28RT-201T registered HB-PPB is maintained by the same workshop as HB-PNP. Its electrical system is similar. The diode device of this aeroplane was removed and the four insulating washers examined. The upper flange of two of the four washers was cracked (see Figure 14).

Figure 14: diode device installed on floor of HB-PPB and cracked upper flange of one of the insulating washers (source: BEA)

- *Whereas the examination of this device on another PA-28RT-201T found the presence of wear on these washers in the form of cracks. These cracks could lead to the cooler coming into contact with the floor, thus creating a short-circuit and potentially causing a fire by igniting the ABS cover;*

- *Whereas Piper's maintenance documentation does not require a check of the condition of the insulation between the diode device cooler and the floor of the aeroplane;*

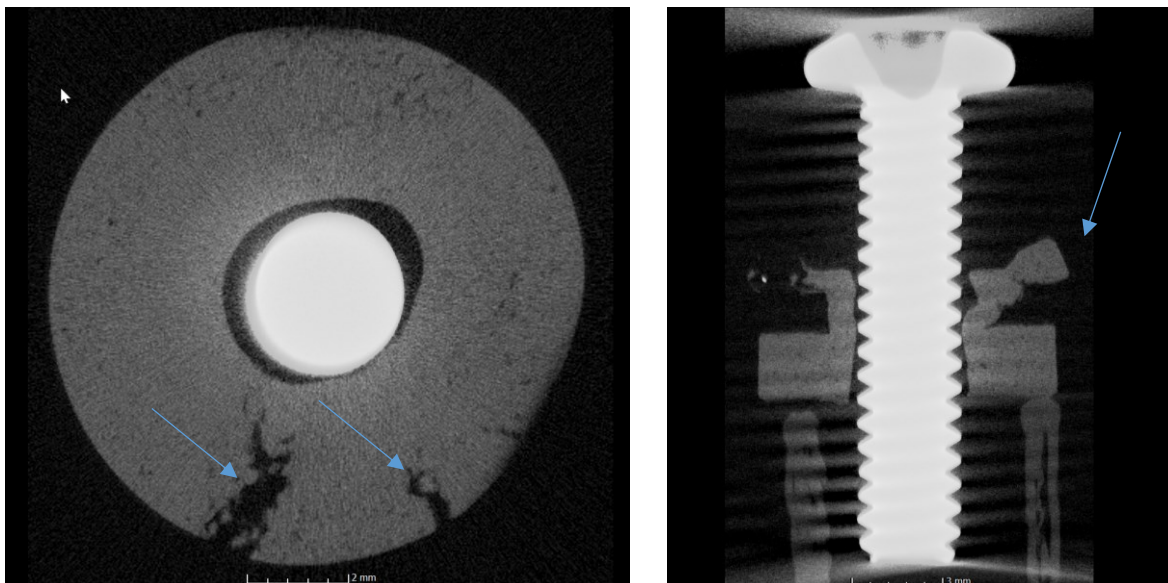
A detailed visual and tomographic examination of these cracked washers found the presence of permanent deformations.

Figure 15: example of screw and washer observed – the washer shows cracks (LH side) and plastic deformations (RH side) (source: BEA)

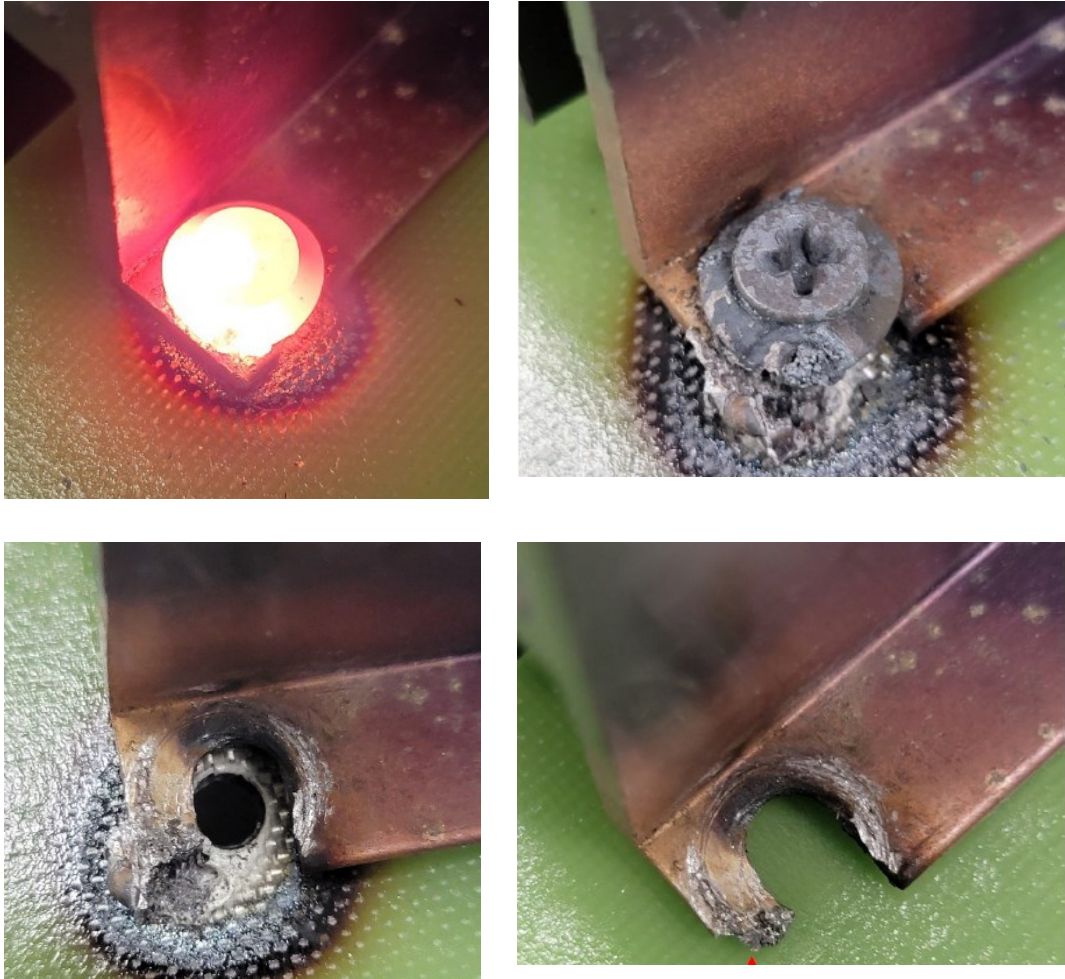
It was observed that the cooler attaching point without the insulating washer melted during the three tests. This melting occurred after different time periods of between 9 and 35 min. The results of these three tests show cooler damage similar to the damage observed on the HB-PNP cooler (see Figure 17)

*Figure 17: short-circuit test at one of the diode device attaching points
(Source: CONCORDE BATTERY CORPORATION)*

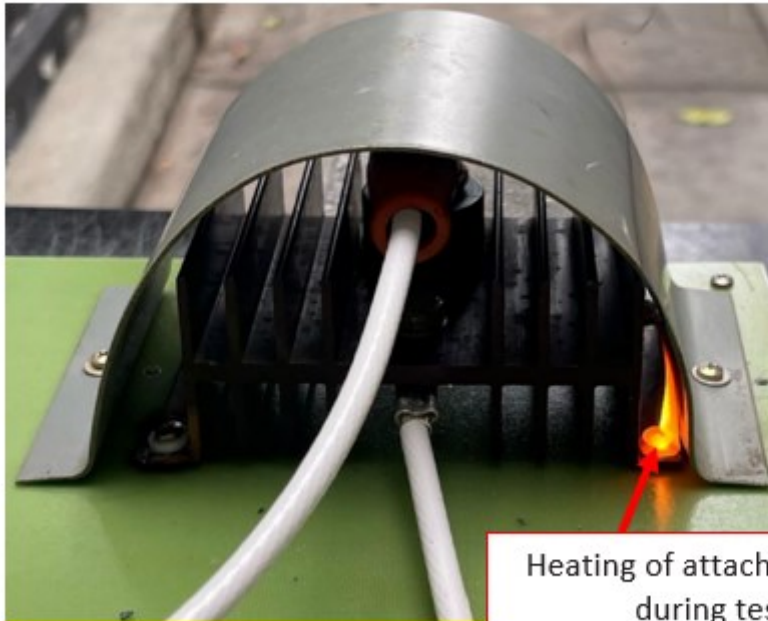
This test consisted of reproducing one of the previous tests with the ABS cover in position. The cover was positioned when the colour of the attaching point indicated intense heat. The ABS cover burst into flames around 20 s after it had been put in position. The cover completely burnt in around 13 min.

Figure 18: ABS cover in position with attaching point subject to intense heat (source: CONCORDE BATTERY CORPORATION)

Piper assess the need to replace the ABS cover with another system made of a material that limits the risk of a fire spreading [FRAN-2024-0016].

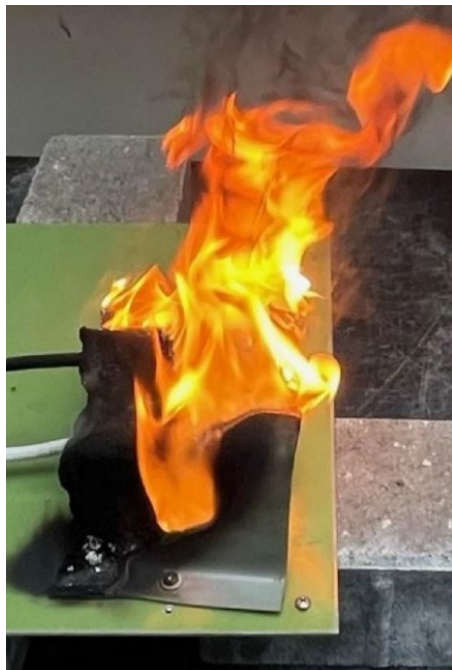
Figure 19: burning ABS cover (source: CONCORDE BATTERY CORPORATION)

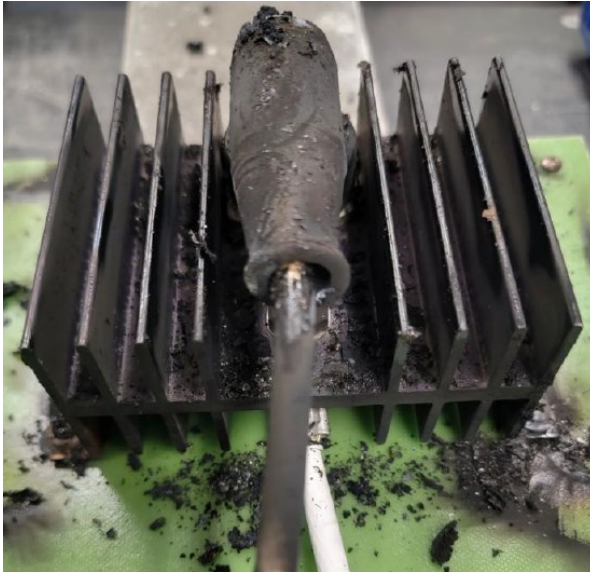
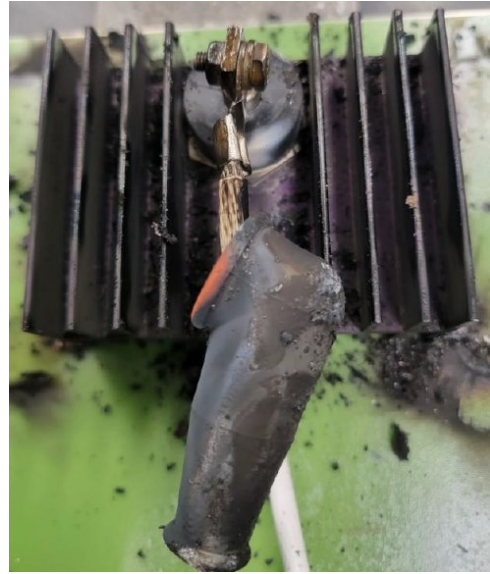
Figure 20: condition of diode device after test (source: CONCORDE BATTERY CORPORATION)

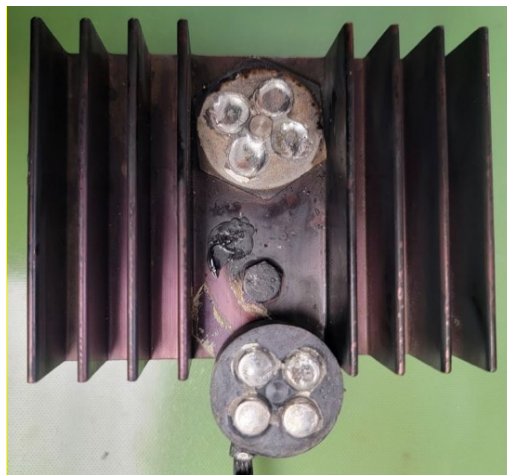
This test consisted of exposing the diode device to a hydrogen/oxygen flame. The diode device separated from the metal cooler after around 8 min of exposure to the flame. This separation was identical to that observed on HB-PNP. After this separation, the diodes were in a short-circuit as was the case on HB-PNP.

Figure 21: separation of diode bridge from metal cooler
(Source: CONCORDE BATTERY CORPORATION)

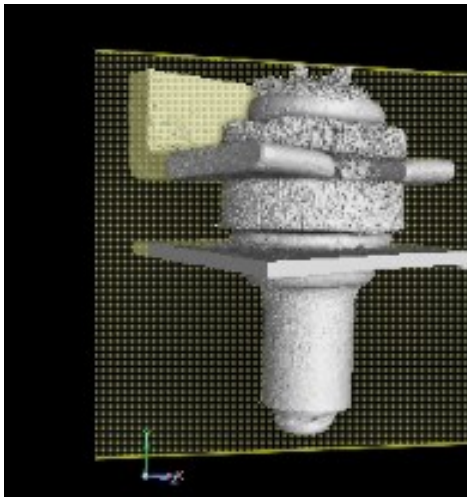
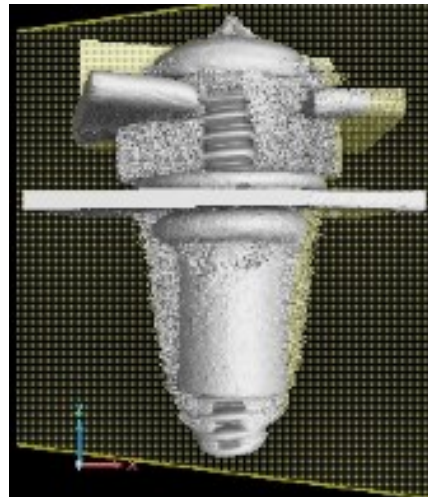
The examination of washers from another diode device equipping another PA28 found that the latter can be damaged and allow the screw head to come into direct contact with the cooler or lead to a reduction in the distance between these two components and the appearance of electric arcs.

Figure 23: tomographic view of an assembly with one of the washers cracked equipping an identical aeroplane (source: BEA)

For the above assemblies, the distance between the lower face of the screw head and the cooler was of around 1.5 mm when a washer in good condition was used and of around 0.5 mm when a partially cracked washer was used.
