Accident to the Airbus AS350 - B3
registered **HB-ZES**
on Wednesday 14 February 2024
at Niouc (Switzerland)

Collision with a high-voltage power line during an external sling load operation

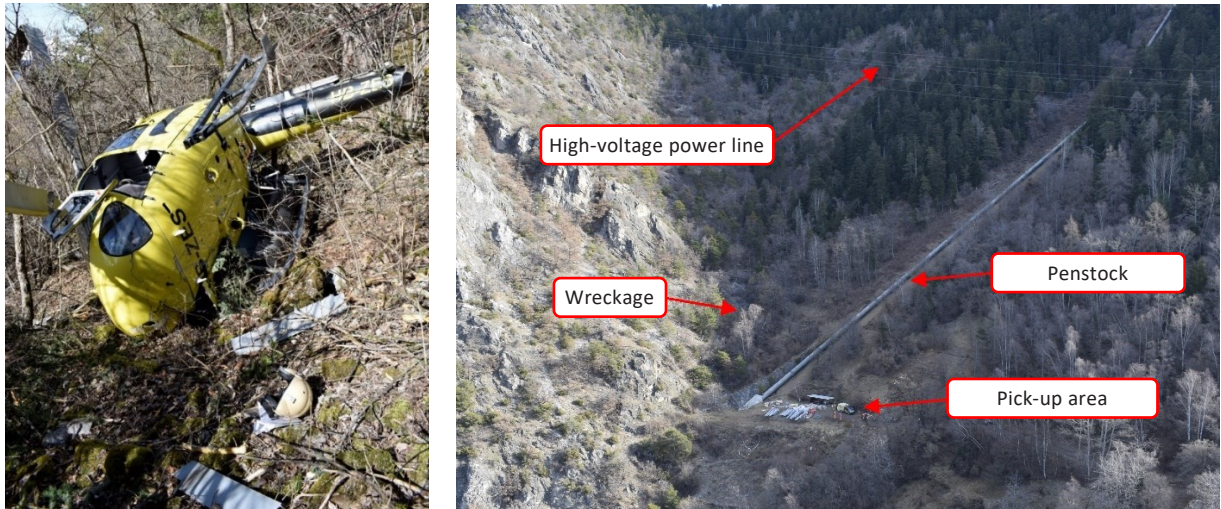
The accident site was on a very steep wooded slope. The wreckage was lying on its right-hand side, the tail boom had separated from the airframe. The transported load was found close to the helicopter, still attached to the sling. The sling was no longer attached to the helicopter.

Figure 1: accident site (source: STSB, annotations BEA)

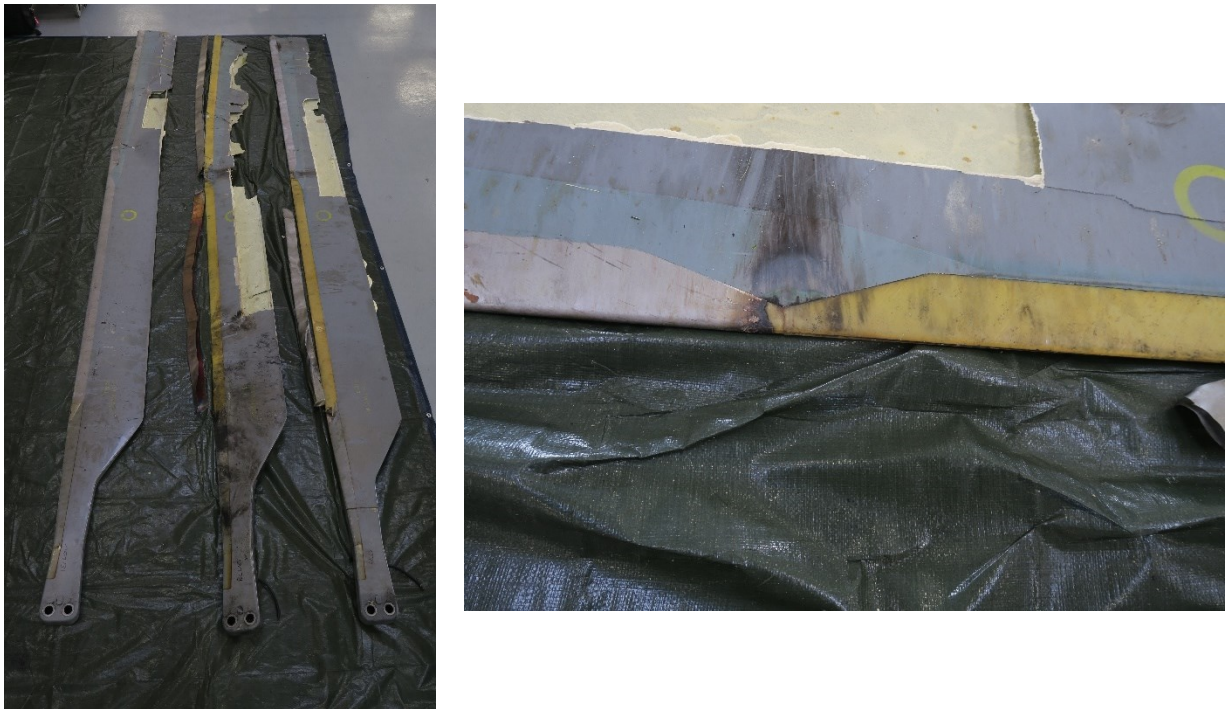
The blades showed signs of an impact with the power lines along with electric arc marks and heat damage.

Figure 2: detail of blades (source: BEA)

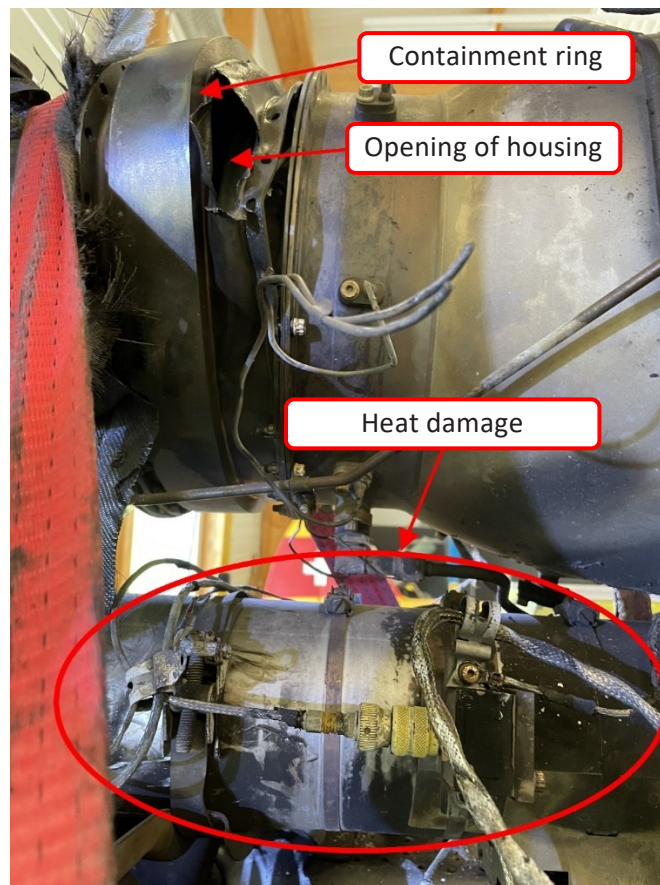
After the collision with the vegetation, the rupture of the drive shaft resulted in the free turbine overspeeding and the blade shedding protection³ coming into play. The deformation of the containment ring sufficiently deformed the housing for it to open and release hot gases which may have contributed to a fire breaking out in the environment of the engine.

The pilot evacuated the helicopter without activating the emergency cut-off valve. The heat damage was limited due to the engine shutting down probably following the unpriming of the fuel system due to the helicopter tipping over onto one side.

Figure 3: detail of engine (source: BEA)

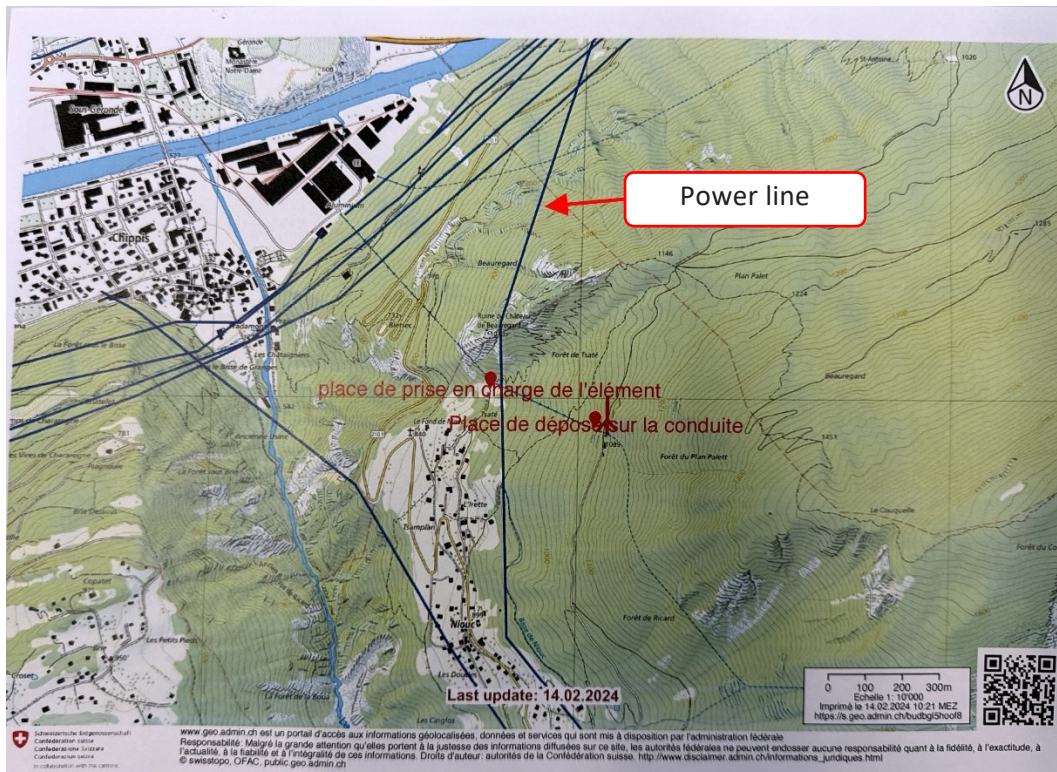
*Figure 4: excerpt of chart from flight preparation documents
(Source: Eagle Valais, the “power line” label and arrow were added by the BEA)*

It is correctly referenced and shown on the charts used to prepare the flight. Based on the pilot's statement and observations made on site, when in the pick-up area, the power line is difficult to see from the helicopter cockpit as situated overhead.

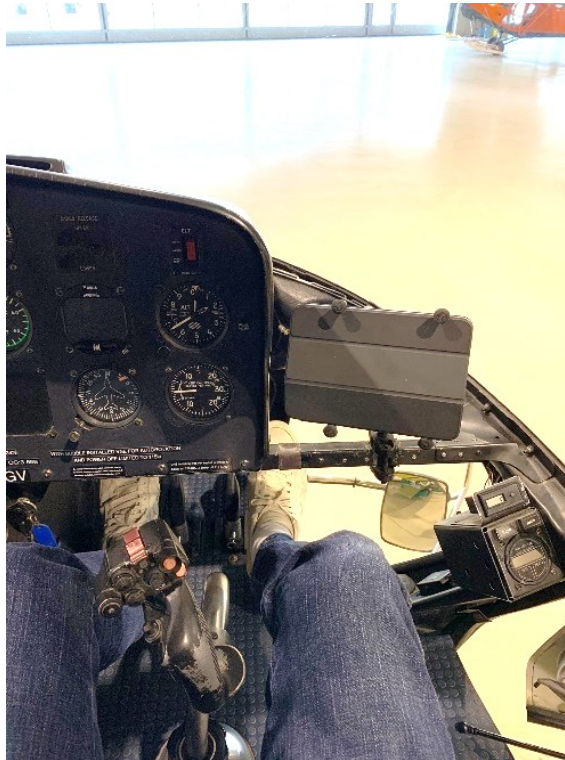
The Swiftcopters operations manual which is also the Eagle Valais operations manual recommends using a suction-cup mount or the helicopter’s chart mount. Eagle Valais had installed a tablet mount on the left-hand side of the instrument panel from where it could be seen for all the flight phases. This installation complied with the recommendations of an STC that the company had not acquired. When, in 2022, the Federal Office of Civil Aviation (FOCA) asked for the documentation with respect to this mount, Eagle Valais decided to remove it to bring itself into compliance and then installed a mount which did not require an STC (as illustrated in Figure 5). The latter, which the pilot considered hampered his field of vision and according to him, risked falling on the pedals if it was incorrectly attached, was not used.

Figure 5: mount used by Eagle Valais and removed by the pilot (source: BEA)

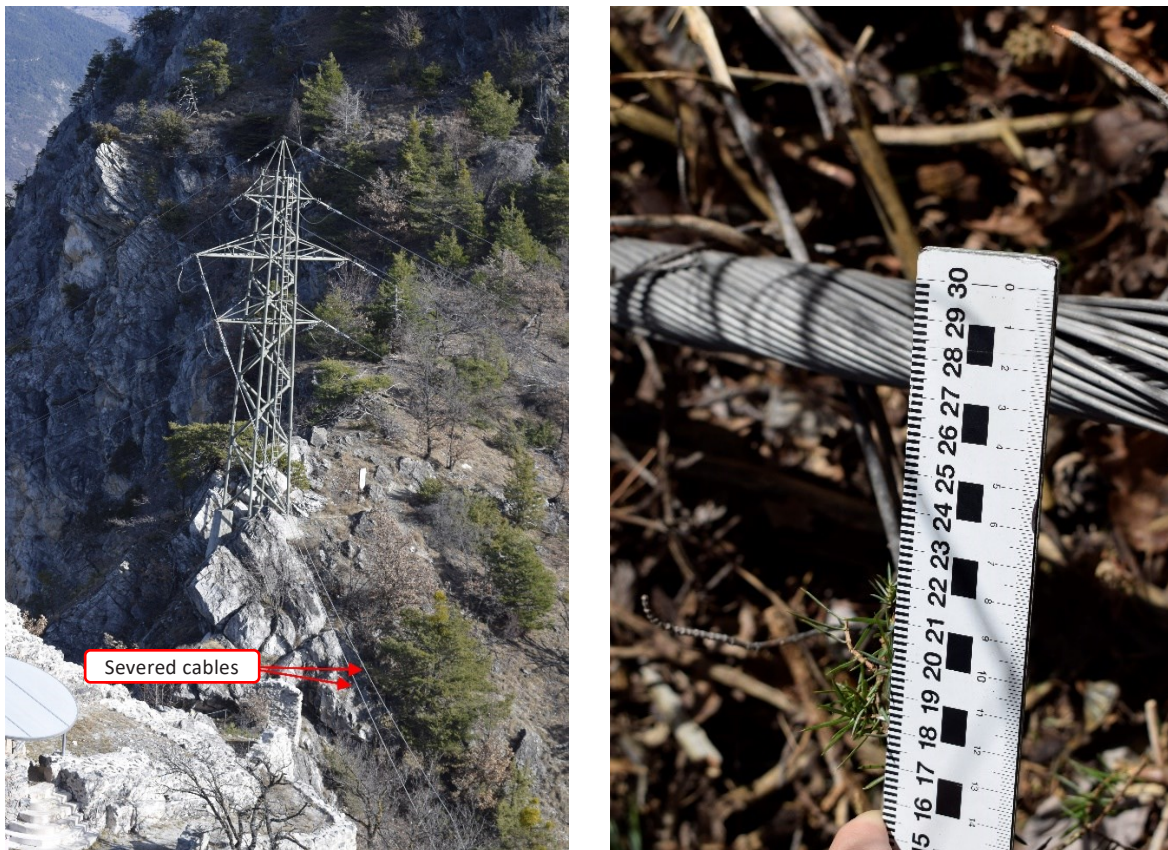
The helicopter struck and severed two conductor cables situated at a height of around 84 m.

Figure 8: left photo: pylon with two severed conductors, right photo: detail of conductor (source: STSB, annotated by the BEA)
