Accident to the PIPER PA23-250
registered **N14040**
on Thursday 26 December 2024
at Saint-Barthélemy airport

Time	Around 12:50 ¹
Operator	Private
Type of flight	Cross country
Persons on board	Pilot
Consequences and damage	Aeroplane substantially damaged

**Landing with landing gear retracted, runway veer-off,
collision with a sign**

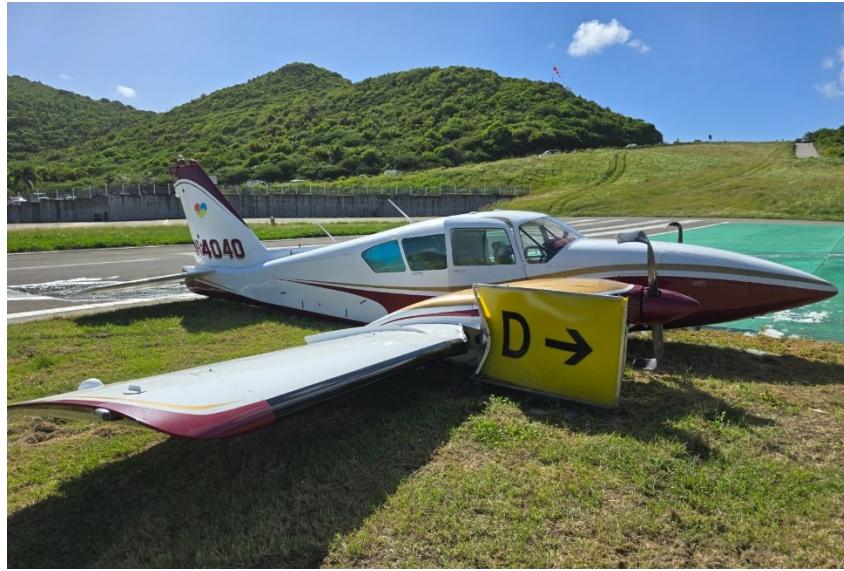
The aeroplane touched down on its underside and slid along the runway. It came to a stop after colliding with the taxiway D sign. The AFIS officer activated the emergency services. The pilot of the BN2 carried out a go-around, and seeing that the aeroplane had come to a stop, in his opinion, "just outside the runway safety area," asked if he could still land. The AFIS officer informed all traffic of the runway closure.

Given the circumstances, the BEA did not go to the accident site and did not conduct an examination of the PA23. The taxiway D sign was embedded in the aeroplane's wing, level with the right-hand engine. The left-hand engine showed signs of an oil leak, including a visible oil run on the exhaust pipe.

Figure 1: final position of PA23 in runway safety area (source: GTA)

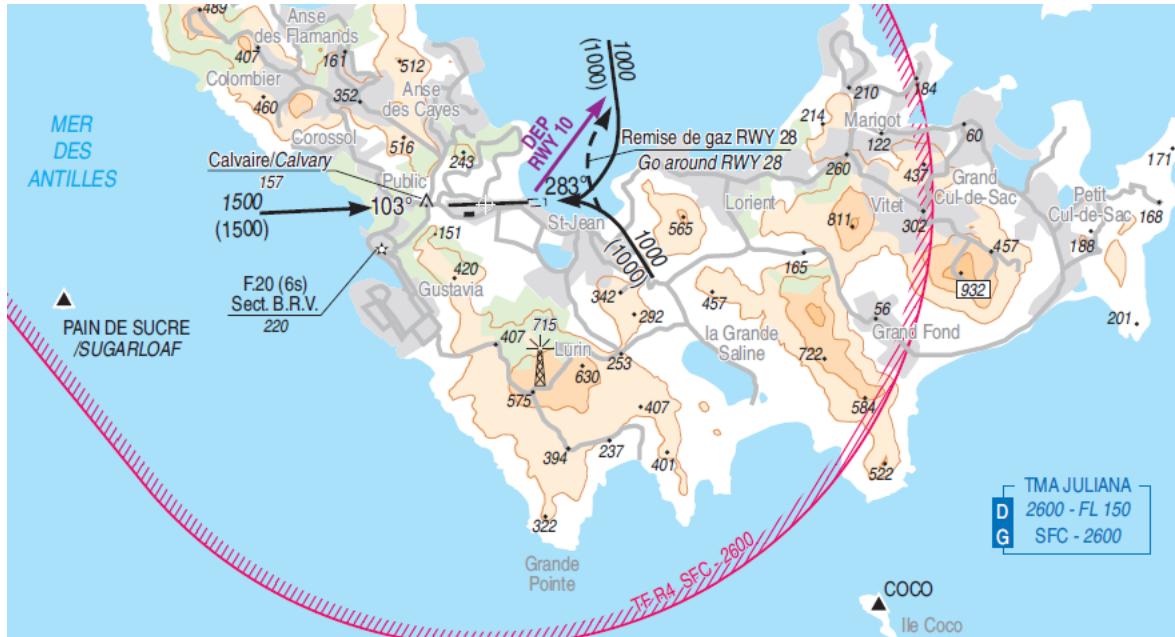
Saint-Barthélemy airport is a restricted-use airport with a paved runway 10/28, measuring 646 m long and 18 m wide. It is reserved for aircraft with appropriate characteristics and performance and for authorized pilots. This use restriction is notably due to the airport's geographical specificities: there is high ground to the north, west and south-east of the airport, and to the east, the runway is limited by the coast.

Therefore, take-offs from runway 28 are prohibited due to the terrain at the end of the runway, and for the same reason, according to the AIP, "*Go around QFU 283° approach restricted to a right turn before reaching decision point abeam "Eden Rock" (southern tip of land).*"

Figure 2: airport circuit and published go-around path for runway 28 (source: SIA)
