**Accident** to the PIPER - PA46 - 500TP "MERIDIAN"  
registered **N149C**  
on 29 May 2023  
at La Môle

<b>Time</b>	Around 10:30 <sup>1</sup>
<b>Operator</b>	FLY INVEST INC TRUSTEE
<b>Type of flight</b>	Own-account transport, cross-country
<b>Persons on board</b>	Pilot and passenger
<b>Consequences and damage</b>	Aeroplane destroyed

**Unusual acceleration performance during take-off run,  
take-off with insufficient speed,  
precautionary landing in a field**

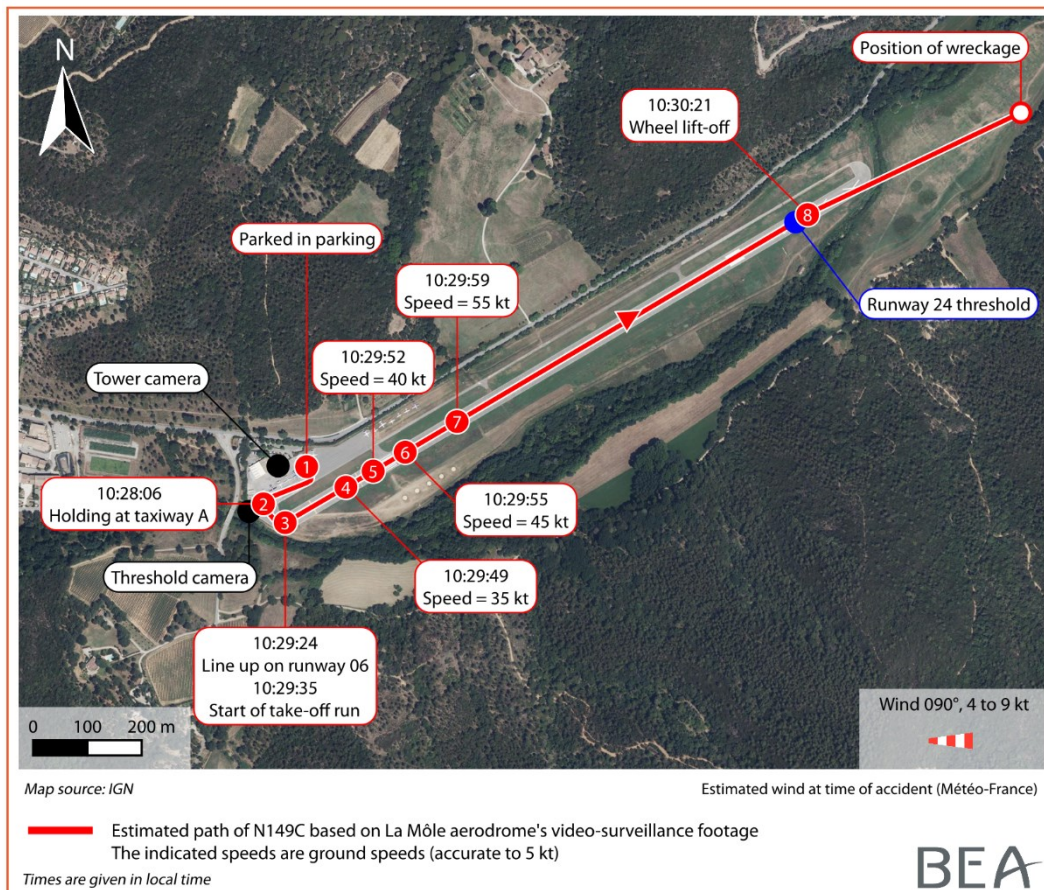
The pilot was carrying out a flight under VFR<sup>2</sup> from La Môle airport (Var) bound for Limoges-Bellegarde airport (Haute-Vienne). At approximately 10:30, he lined up on runway 06 and started the take-off. During the take-off run, the pilot felt that the aeroplane was not accelerating normally. He continued the take-off run up to the displaced threshold of opposite runway 24, where the wheels left the ground. The aeroplane was unable to gain height and struck small trees approximately 190 m further on. The pilot decided to carry out a precautionary landing and land in a field located just after the small trees. On contact with the ground, the landing gears collapsed. The aeroplane slid for around 30 m. The right wing hit a small tree, then the aeroplane spun making a U-turn before coming to a stop approximately 20 m further on (see **Figure 1**).

Figure 1: flight path of aeroplane

The images recorded by the airport's security cameras were retrieved. The analysis of the recordings showed that the pilot carried out the engine tests at holding point A (see **Figure 1**, point ②). He then lined up on runway 06 and stopped at the threshold, before the yellow strip (point ③). He next increased power with the brakes applied and 10 s later, started the take-off run. The ground speed after point ③ could not be estimated.

Based on the manufacturer's information (see paragraph 2.5.3), the rotation speed  $V_R$  of 82 kt should have been reached after a distance of 580 m and a run of 26 s. In reality, the aeroplane only covered a distance of 350 m in 25 s, between points ③ and ⑦. It then covered a distance of 750 m in 22 s, between points ⑦ and ⑧. It took off 57 s after the start of the take-off run, level with the stripes of the opposite threshold (point ⑧), after having covered a distance of 1100 m.

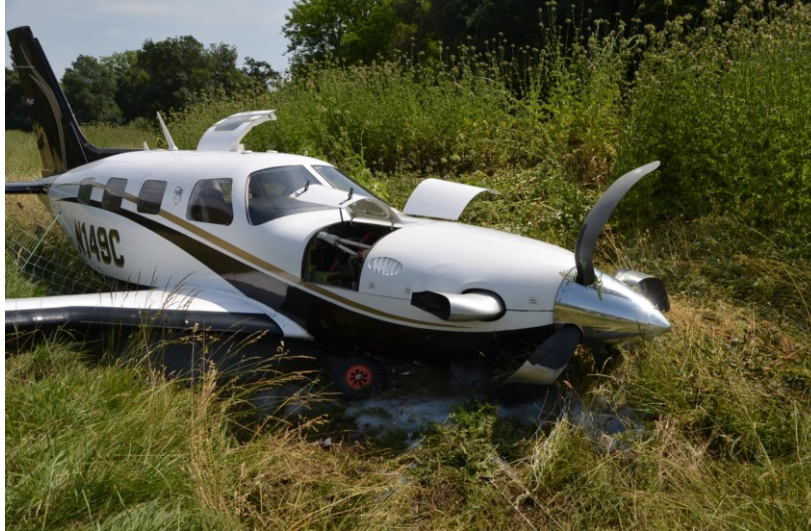
The wreckage was lying on its belly bearing on its wings (see **Figure 2**), about 300 m east of the end of runway 06. The aeroplane had crossed an embankment, knocking down a fence, then it had damaged small trees located at the beginning of the field. The wreckage was oriented on a 180° heading, it was complete and grouped together. The flaps were retracted.

Figure 2: position of wreckage

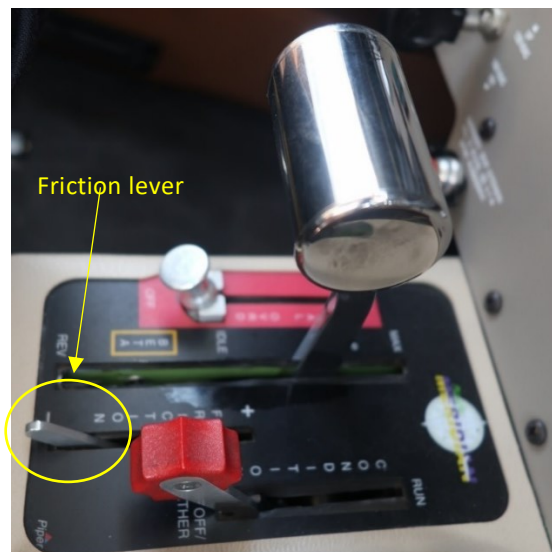
The throttle control was close to the maximum forward deflection (4/5 of travel), and the friction lever of the throttle control was set to the rear limit (minimum friction position) (see **Figure 3**).

Figure 3: position of controls after accident

He specified that he did not set the friction as this was not one of his habits, and that he did not know what the friction setting was at the time of take-off. He did not rule out the possibility that the throttle lever moved backwards after the brakes were released.
