Accident to the PIPER PA32-260
registered **N15902**
on Friday 1 December 2023
at Les Saintes - Terre-de-Haut (Guadeloupe)

**Collision with the surface of the water
shortly after take-off**

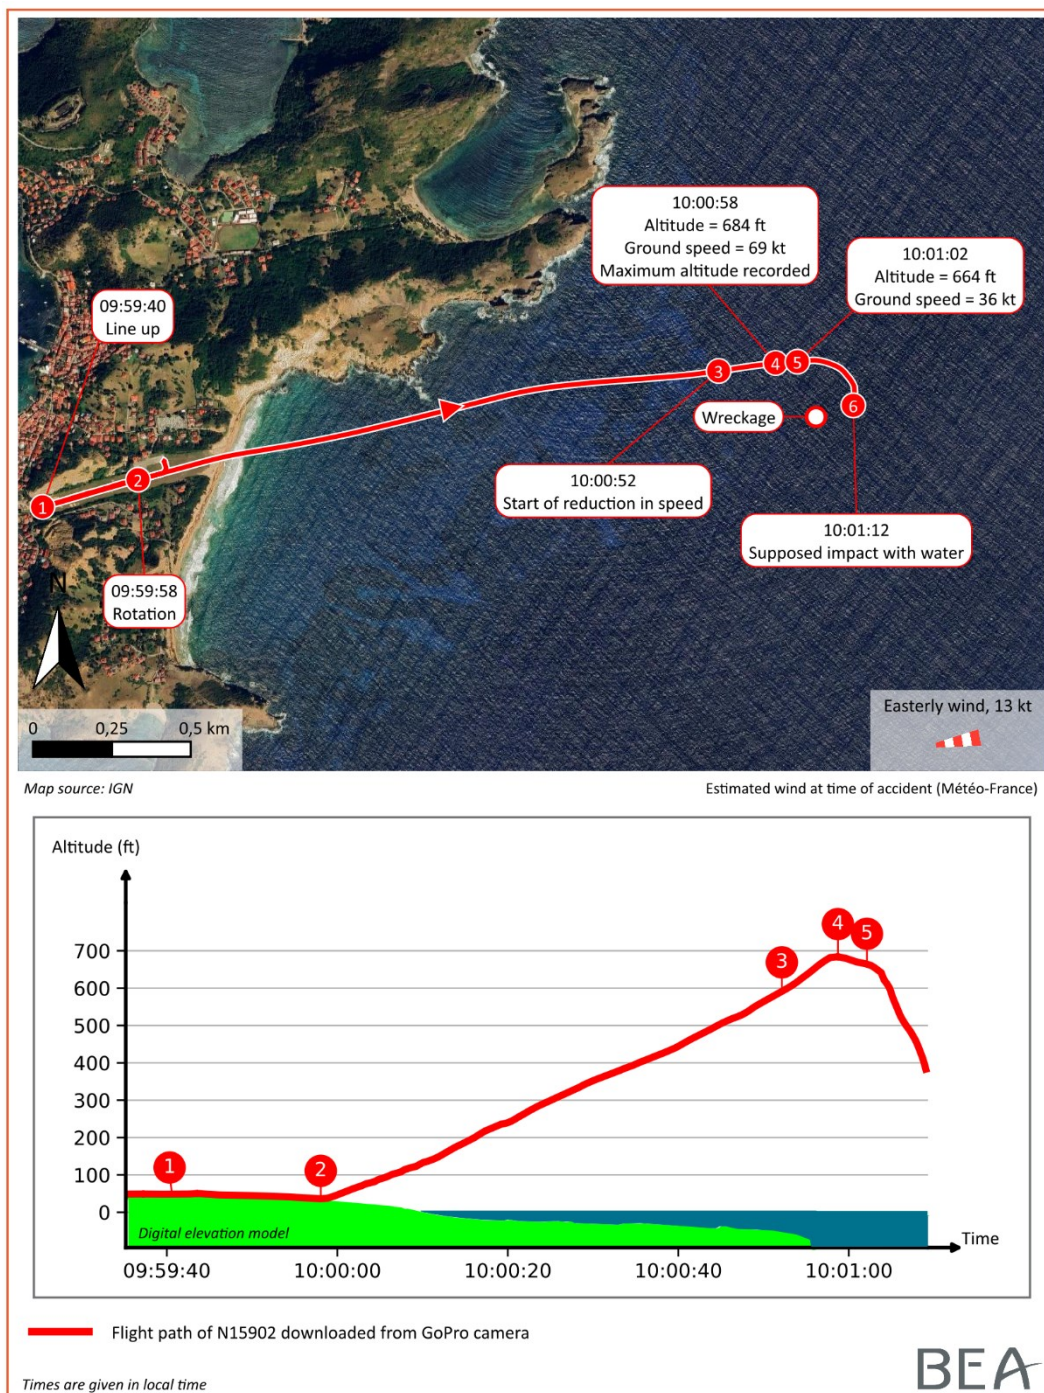
At 09:59, the pilot lined up and took off from runway 09 at Les Saintes aerodrome bound for Marie-Galante aerodrome. The read-out of the ADS-B and radar data showed that N15902 climbed to an altitude of 680 ft with a ground speed of around 70 kt. Approximately 1 min after take-off, the path of N15902 showed a stop in the climb and then the start of a right turn in descent. Vertical speed increased significantly before the transponder data transmission stopped. The last valid ADS-B detection was recorded at 10:01:06, around 2 NM off the coast of Les Saintes.

Figure 1: take-off of N15902 from runway 09 at Les Saintes aerodrome.

- a shift from the second flap detent position to the first flap detent position just after point ② (see **Figure 1**);
- a climb at constant (low) speed between points ② and ③, followed by a slight descent with no noticeable acceleration lasting 4 s, between points ④ and ⑤;
- a gradual increase in the aeroplane's attitude between 10:00:40 and point ⑤;
- the start of a right turn, followed by a loss of control during the turn and down to the surface of the water.

These observations are consistent with a reduction in engine power in climb, followed by an attempted U-turn, leading to a loss of control in turn.

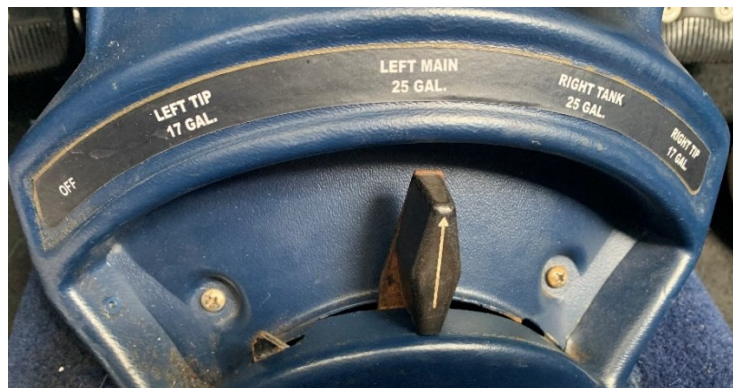
A 5-position rotary selector is used to choose the tank that supplies the engine or to shut off the fuel supply. The positions are as follows (from left to right on **Figure 2**):

- when the first (left) position is selected, the fuel supply is shut off;
- when the second (left) position is selected, the left auxiliary tank is selected;
- when the third (centre) position is selected, the left main tank is selected;
- when the fourth (right) position is selected, the right main tank is selected;
- when the fifth (right) position is selected, the right auxiliary tank is selected.

The information on the position of the tank selected (right/left) is therefore asymmetrical compared with a centred reading.

When the selector is between two positions, the fuel supply is shut off⁵.

Figure 2: photograph of the fuel selector on a PA32 (Source: BEA)

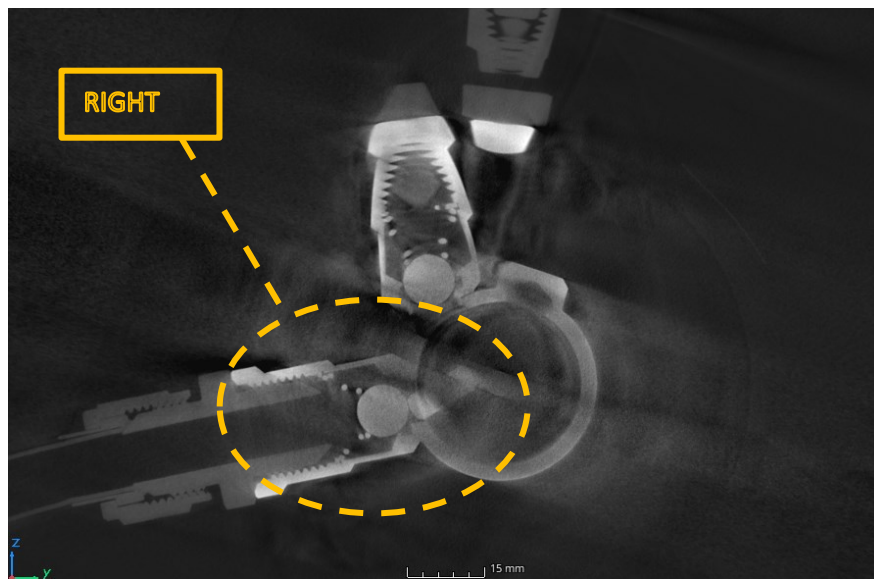
- the selector ports were open for the outlet to the fuel pump and for the inlet from the right auxiliary tank (RIGHT TIP);
- the ports of the other three inlets were closed.

Figure 3: 2D tomographic image of the fuel selector (Source: BEA)

At the time of the impact, the right auxiliary tank (RIGHT TIP) was selected. Given the design of the fuel selector, it is highly unlikely that it changed position during the impact.

Incorrect selection of the right auxiliary tank, which contained only a small amount of fuel, would have caused fuel starvation and an uncommanded reduction in engine power.
