Accident to the SOCATA - TB21
registered **N229GC**
on Wednesday 28 December 2022
at Barcelonnette - Saint-Pons aerodrome

Time	Around 11:00 ¹
Operator	Private
Type of flight	Cross-country
Persons on board	Pilot and three passengers
Consequences and damage	One passenger fatally injured, pilot and two passengers severely injured, aeroplane destroyed

**Non-stabilised approach, bounces, go-around, collision
with vegetation, fire**

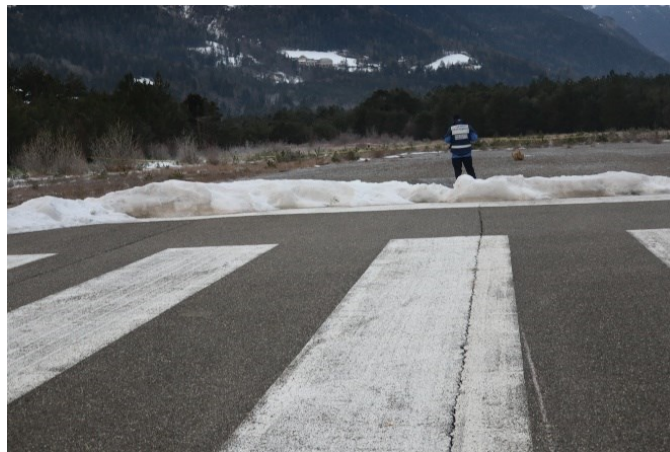
The black marks observed on the runway and attributed to N229GC were consistent with those left by tyres rubbing on the ground with braked wheels. The first mark was observed approximately 320 m after the displaced threshold. Two marks, about 1 m apart and offset in relation to the runway centreline, were visible on the upper part of the 50 cm-high mound of hard snow located at the end of runway 27.

Figure 3: mound of snow at the end of runway 27 (Source: BEA)

The distance between these marks was consistent with the distance between the left or right main landing gear and the front landing gear. Moreover, their shape was similar to the marks that tyres can leave. A broken tree, as well as marks in the snow and debris, were observed in an area clear of obstacles between the end of runway 27 and the slope, where the wreckage was found.

To avoid making a runway overrun and hitting a snowdrift some 50 cm high located at the end of the runway, the pilot decided to reject the landing. During the go-around, the landing gear hit the snowdrift, which probably destabilised the aeroplane. The pilot lost control of the aeroplane, which hit the vegetation to the left of the runway centreline before catching fire.

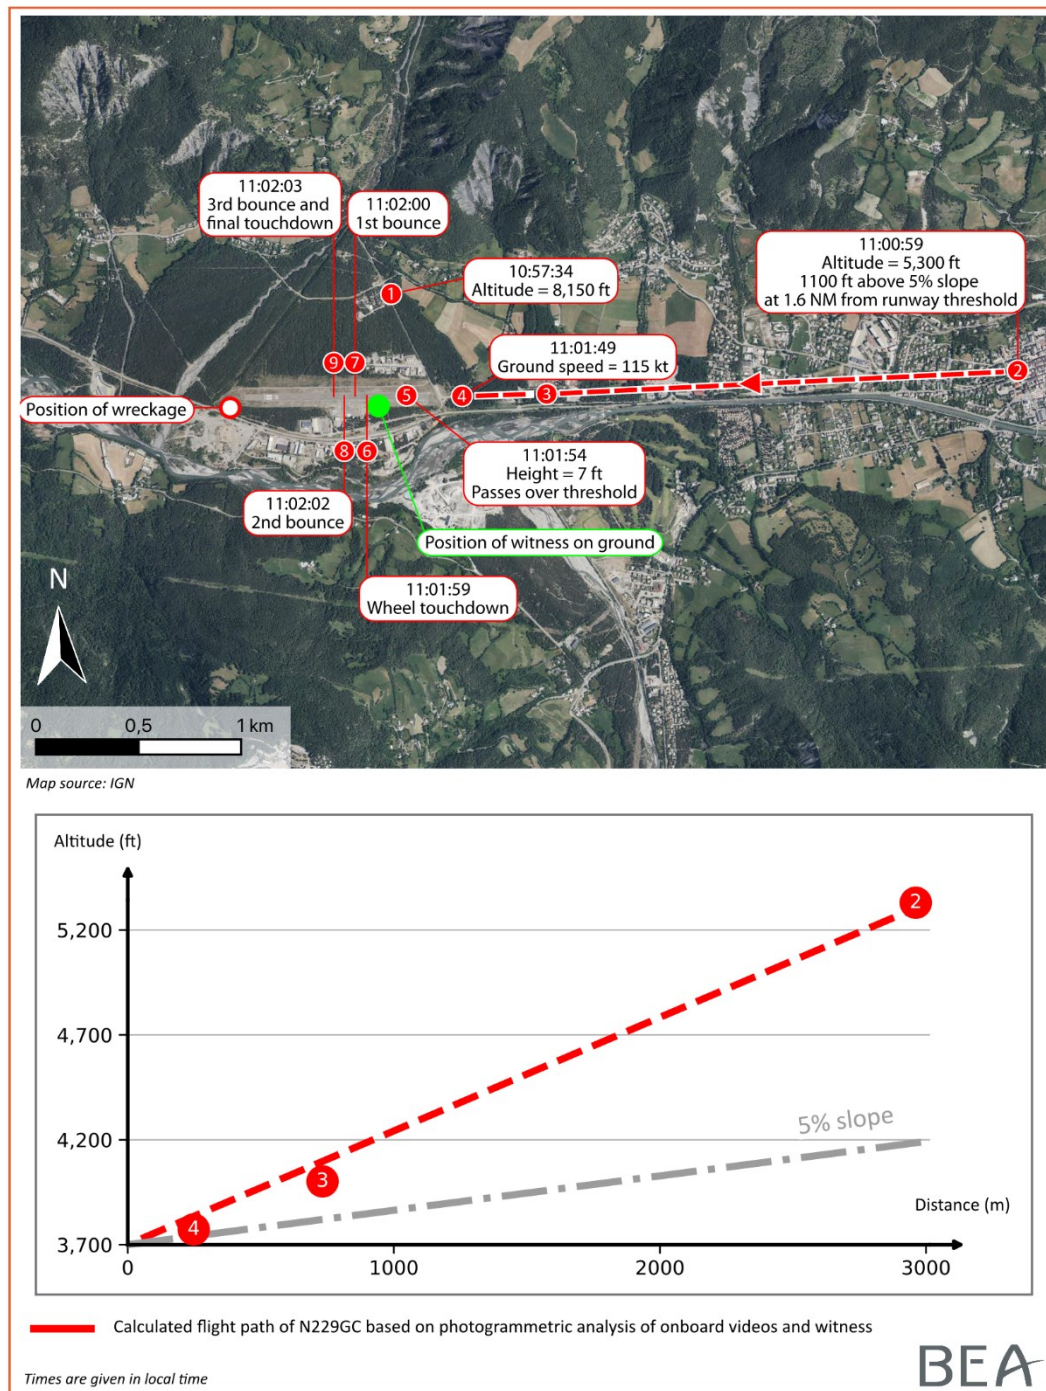
Figure 4: successive positions and final glidepath of N229GC based on video analysis
(Source: BEA)

The aeroplane's estimated height at point ②, obtained from the video recorded by one of the passengers, was used to calculate an average aeroplane ground slope on final of approximately 16%, between point ② and the displaced threshold. The aeroplane's estimated height at point ③, obtained from the video recorded by the witness on the ground, is consistent with this slope value. This slope is three times greater than the 5% recommended for an approach to Barcelonnette.

In addition to the positions, the aeroplane's ground speed at point ④ was 115 kt \pm 5 kt. This corresponds to an indicated airspeed of approximately 110 kt, taking into account the no-wind condition and the effects of altitude and temperature.

The aeroplane lost around 3,000 ft between its position overhead the aerodrome and the start of the long final. At 1.6 NM from the runway threshold (55 s before landing), the aeroplane was about 1,100 ft above the standard approach slope of 5%. This represented a slope of more than 15% to reach the runway. In addition, the pilot probably maintained engine power during the final. In these conditions, the aeroplane arrived on short final with the gears extended, the flaps in the landing position and an indicated airspeed of around 110 kt, i.e. 35 kt above the speed recommended for landing in the conditions of the day.

The aeroplane touched down approximately 215 m after the displaced threshold, which left a runway distance of 510 m. Due to the excessive energy of the aeroplane, it then bounced three times. The position of the last touchdown was 330 m from the opposite threshold.
