Accident to the CESSNA 340
registered **N340GJ**
on Monday 2 December 2024
at Pernand-Vergelesses

**Loss of external visual references, collision with tree tops,
fire, during a practical exam**

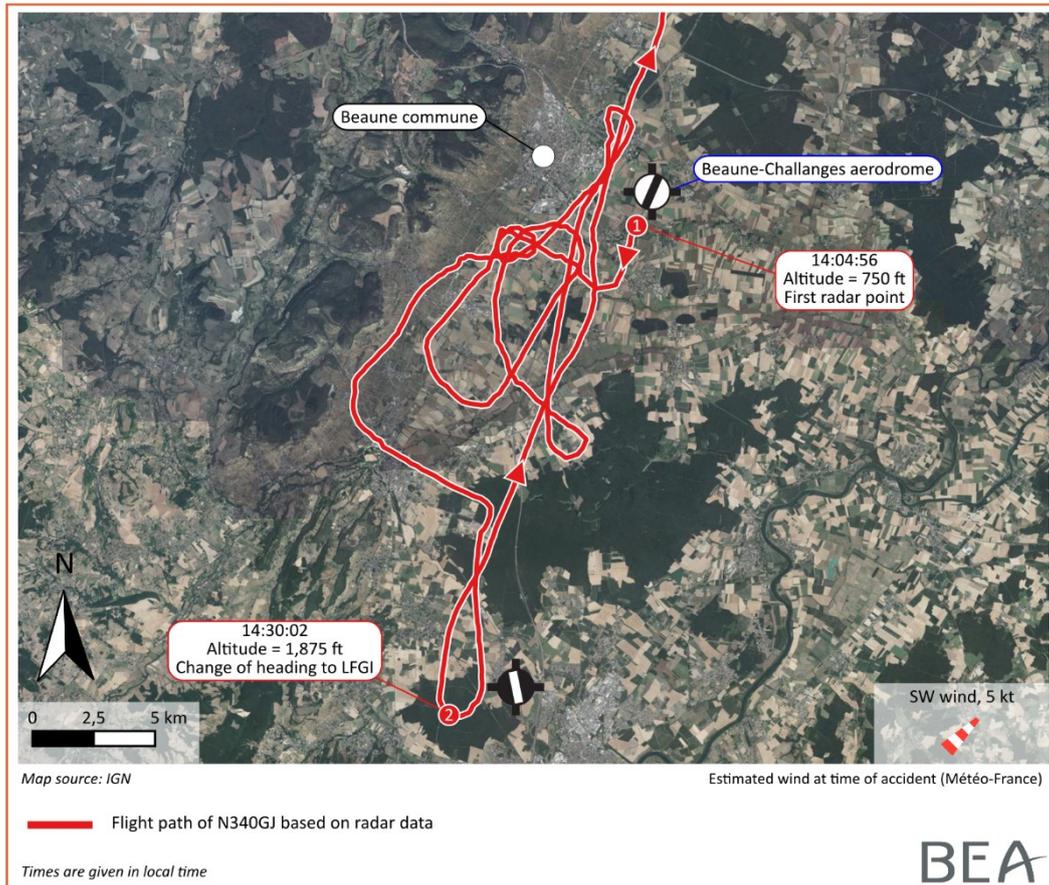
Figure 1: flight path of N340GJ part 1 (source: secondary radar, BEA annotations)

The candidate pilot and the examiner took off at 13:26 from Beaune – Challanges aerodrome for an examination flight with a view to obtaining a MEP² class rating. The flight was carried out under VFR. During the after take-off actions, the landing gear did not retract. They rejected the flight and landed at the departure aerodrome. The pilot indicated that once on the ground, the examiner descended to check the landing gear and observing that there was nothing blocking its movement, he decided to resume the examination keeping the landing gear down. They took off from Beaune - Challanges again at around 14:05 (see **Figure 1**, point **1**).

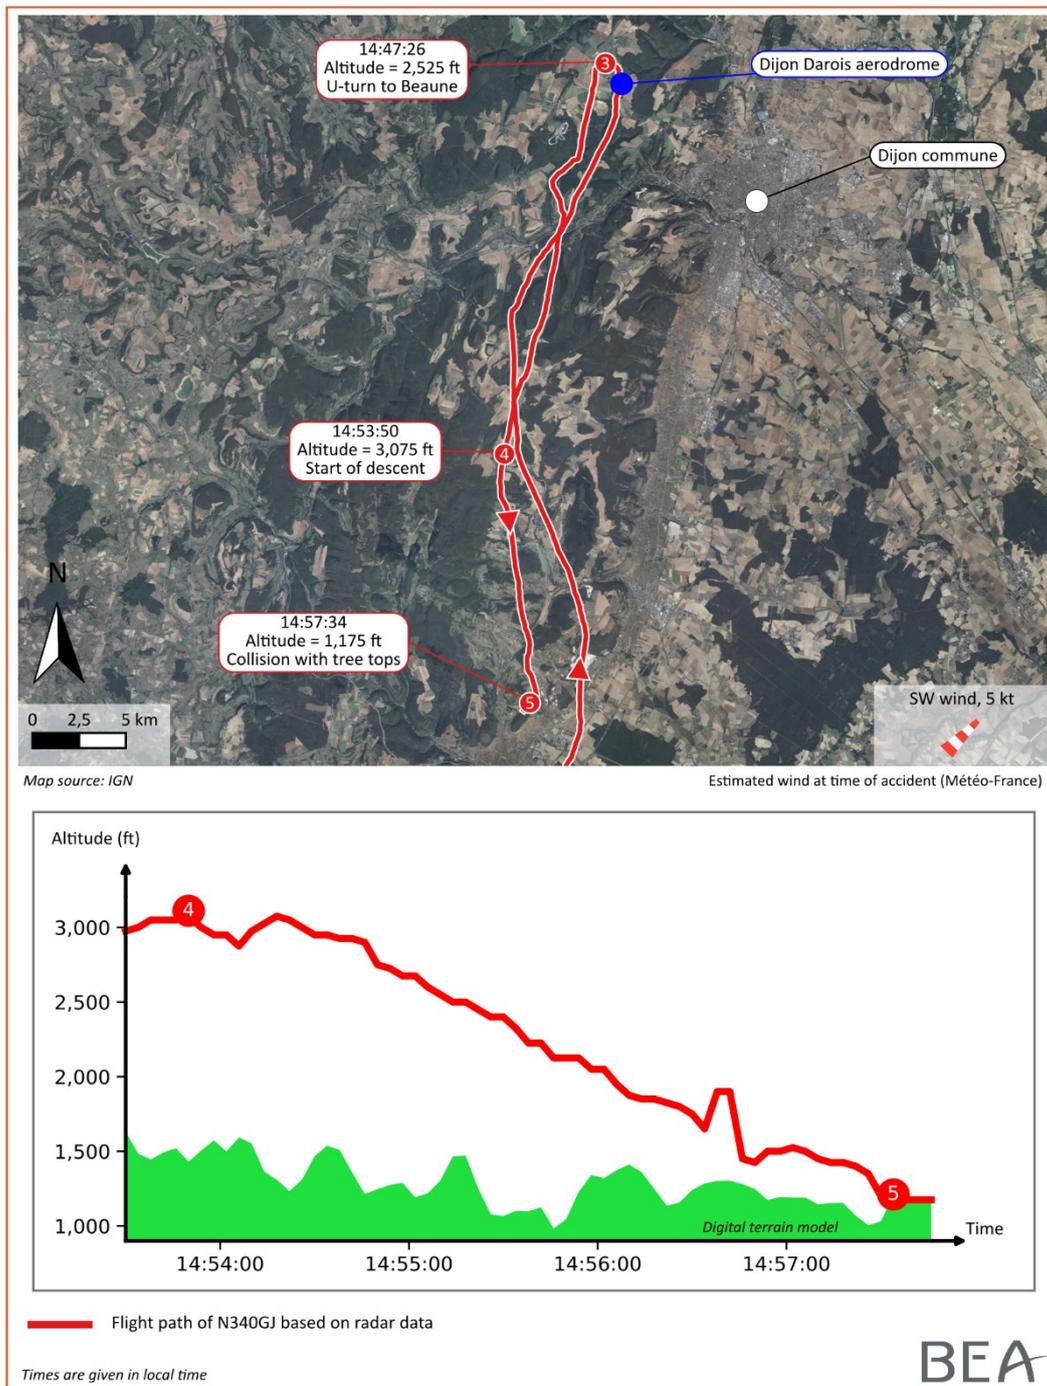
Figure 2: flight path of N340GJ part 2 and vertical profile
(source: secondary radar, BEA annotations)

The examiner asked the pilot to carry out a series of exercises. In particular, he initiated simulated engine failures, south-west of the aerodrome, aiming at breaks in the clouds. After flying for 30 min (point **2**), the examiner asked the pilot to head for Dijon - Darois aerodrome to carry out touch-and-go exercises. On arriving close to the aerodrome, the weather conditions did not permit the planned exercises to be carried out. The pilot and examiner turned around at 14:47 (see **Figure 2**, point **3**). The examiner took charge of the navigation and guided the pilot.

According to the pilot, on the return leg, the examiner informed him that they were two minutes away from the aerodrome. The examiner asked him to descend (point **4**). The pilot, knowing that the aerodrome was at 600 ft QNH, started the descent at around 1,600 QNH. He lost sight of

the ground before making out “green” ahead of him. He tried to level off the flight path but the aeroplane struck tree tops at an altitude of 1,175 ft at 14:57 (point 5) and finished its run in a vineyard.

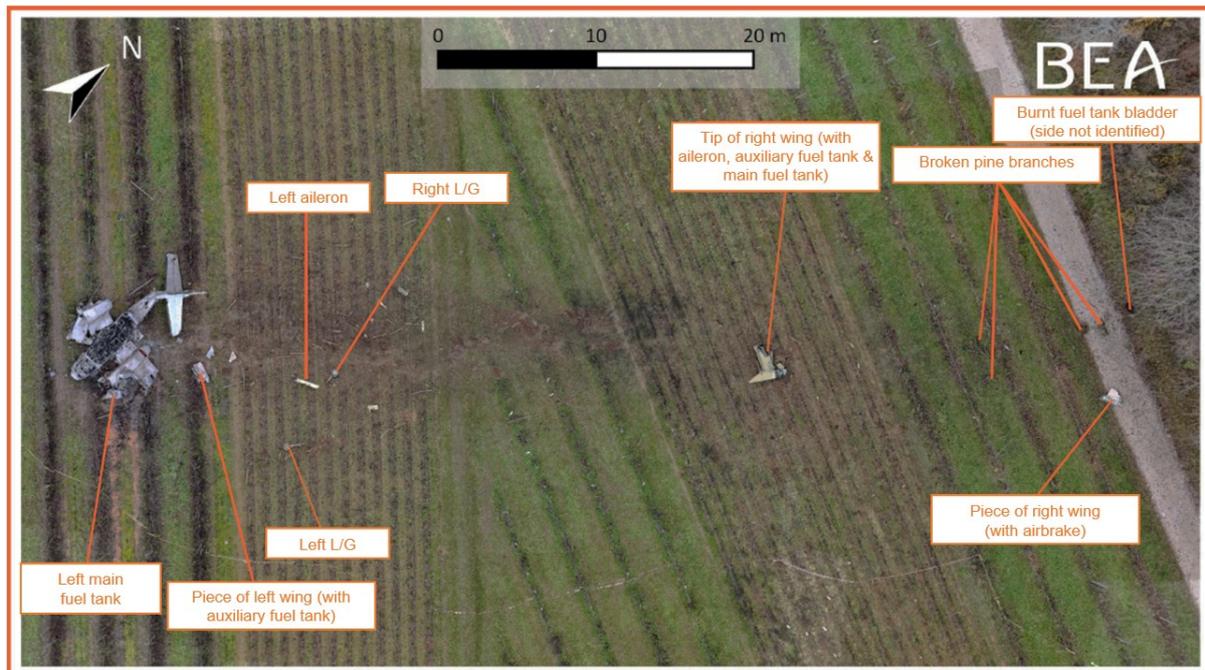
Figure 3: orthoimage of site (produced by means of BEA drone)

The marks in the vegetation and the debris collected indicated that the aeroplane struck the tree tops in straight horizontal flight over around 100 m in a south-westerly direction before the leading edge of the right wing struck a tree. The aeroplane then touched down 30 m further on and rapidly came to a stop as it was retained by the metal wires for trellising vines. A fire subsequently broke out.

The aeroplane was complete and the landing gear extended at the time of the collision with the vegetation and the ground.

The examination of the wreckage, which was only partial due to its destruction, did not reveal any anomaly which could explain the accident.

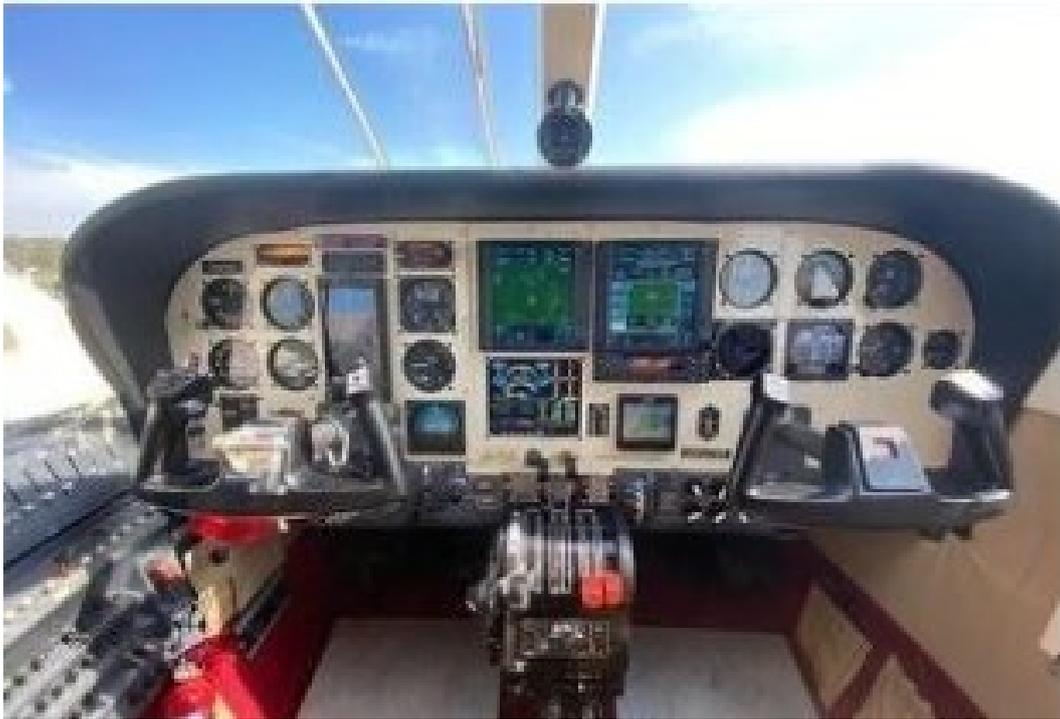
Figure 5: photo of N340GJ instrument panel (source: aeroplane owner)

According to the owner of the Cessna registered N340GJ, the radio-altimeter was not functioning on the day of the accident⁵. The pilot stated that he was not aware of this fault before the flight.

Based on statements from several experienced instructors gathered by the BEA during its investigation, the Cessna 340 is very different from the TECNAM P2006, particularly with regard to manoeuvring speeds, flight performance, cockpit instruments and procedures. These instructors thought that it would be difficult for a pilot trained on the P2006 to have a satisfactory level for a practical exam flight without prior training on the Cessna 340.
