**Serious incident** to the CESSNA – 340A  
registered **N340YZ**  
on Sunday 6 February 2022  
in cruise between Lille-Lesquin and Aix-les-Milles

**Pitch control difficulties in cruise in icing conditions,  
emergency descent and diversion**

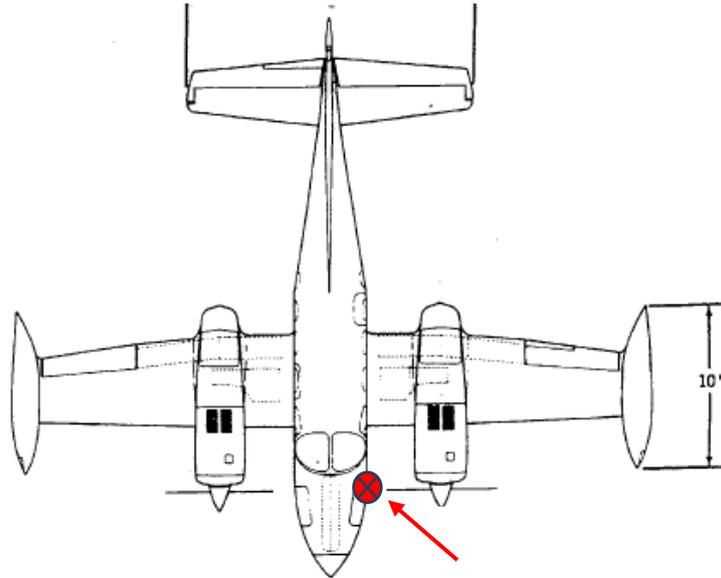
Damage to the fuselage was visible in line with the left engine (see **Figure 5** and **Figure 6**). The damage measured about six centimetres in diameter and one centimetre in depth. This type of damage can be caused by the projection of a piece of ice which has built up on one or more propeller blades when the aeroplane passes through an area of icing conditions.

Figure 5: position of dent on fuselage (source: Cessna 340A maintenance manual)

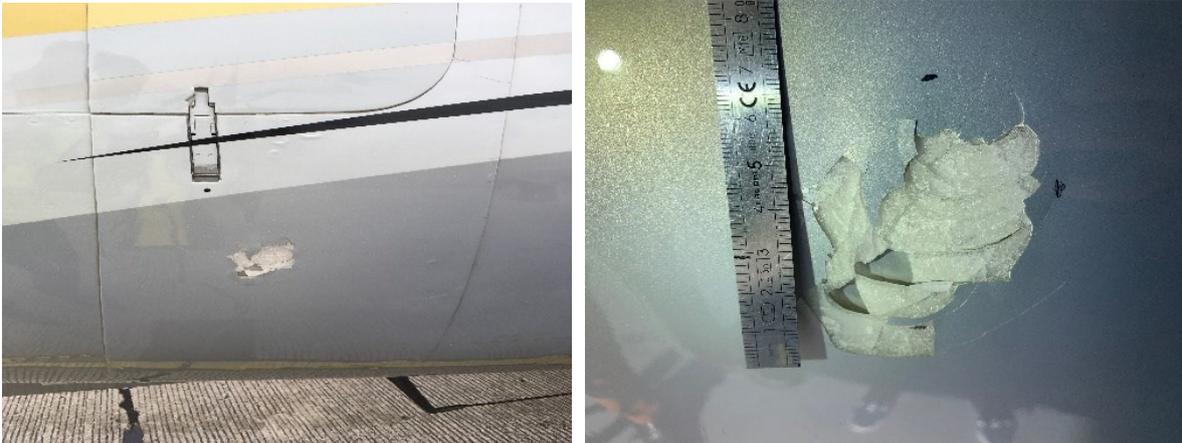
At 12:56, the pilot landed without further incident at Châlons-Vatry. A large dent in the fuselage level with the left engine was visible (see **Figure 6**).

Figure 6: photos of dent made by ice in fuselage level with left engine (source: BEA)

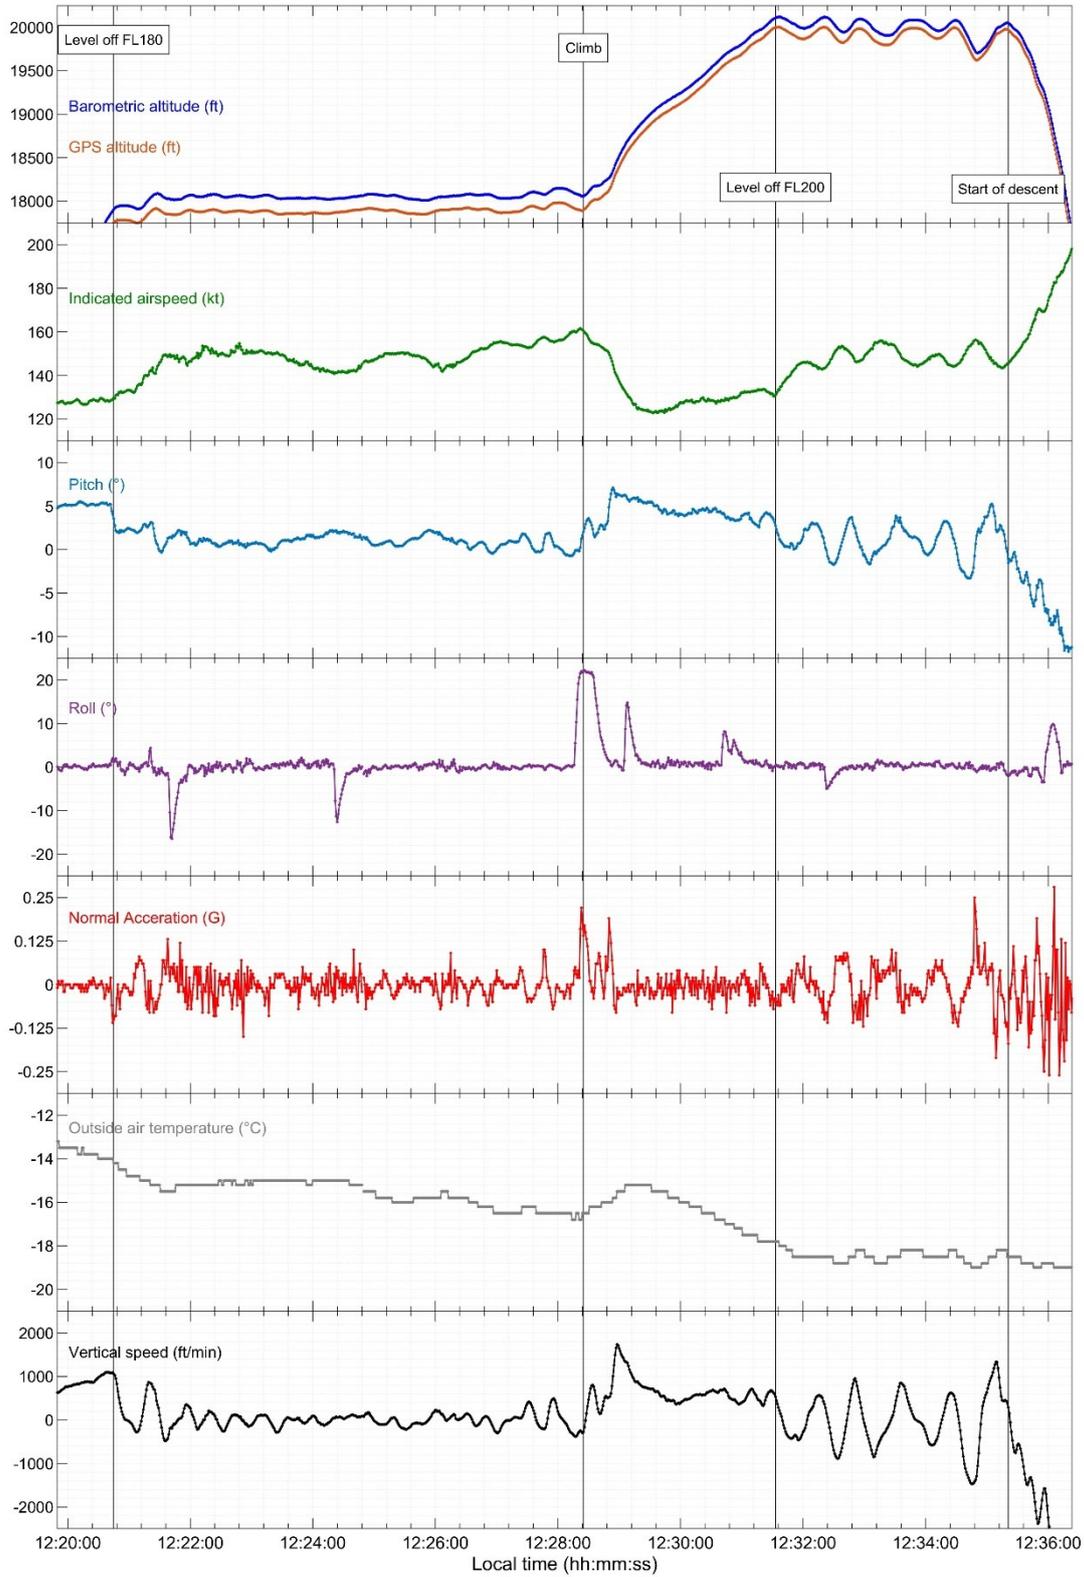
Figure 8: flight data recorded by Garmin TXI

From the moment the aeroplane reached FL 200, there were quite marked fluctuations in altitude, speed and pitch attitude. The autopilot's servo system no longer seemed to be effectively carrying out its damping function. However, the aeroplane manufacturer indicated that it is not possible to affirm with certainty, based on the available data, that this behaviour was indicative of a jammed elevator trim.

Such fluctuations were not observed during cruise flight at FL 180 a few minutes earlier. More generally, prior to the onset of these fluctuations at FL 200, the recorded data did not reveal any abnormal variations in flight parameters, such as a gradual diminution in speed or an increase in pitch attitude in level flight, for example.
