Accident to the CIRRUS SR22
registered **N456AR**
on Monday 7 October 2024
at La Bretonnière la Claye

Time	Around 08:25 ¹
Operator	Private
Type of flight	Cross country
Persons on board	Pilot and one passenger
Consequences and damage	Pilot and passenger fatally injured, aeroplane destroyed

Loss of external visual references after take-off, collision with ground

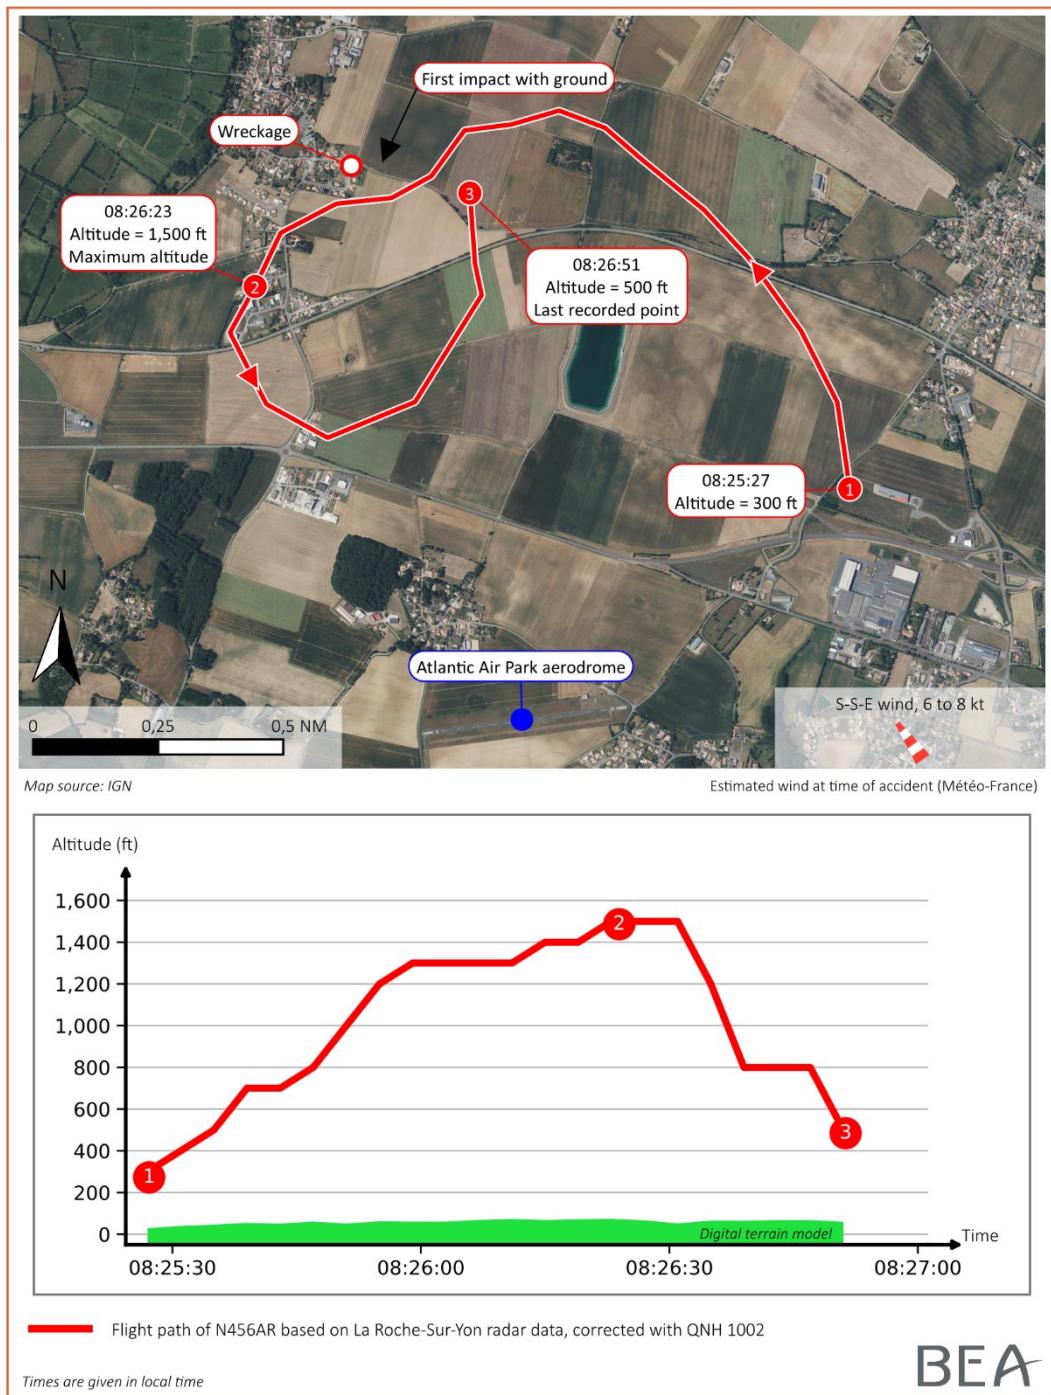
Figure 1: flight path of N456AR (source: BEA)

Shortly after taking off, the pilot turned left. Between 08:25:27 (see **Figure 1**, point **1**) and 08:26:23 (point **2**), the radar data shows that the pilot continued turning left in a constant climb until reaching 1,500 ft at point **2**.

At 08:26:23, the aeroplane started descending, still in a left-hand turn but with a higher rate of turn and a vertical speed close to 2,000 ft/min. The last recorded radar point at 08:26:51 indicated that the aeroplane was at an altitude of 500 ft. A few seconds later, the aeroplane collided with the ground.
