Accident to the CESSNA – 401 B
registered **N517HC**
on 30 October 2020
close to Toussus-le-Noble aerodrome

Fire in left engine during approach, forced landing in a field

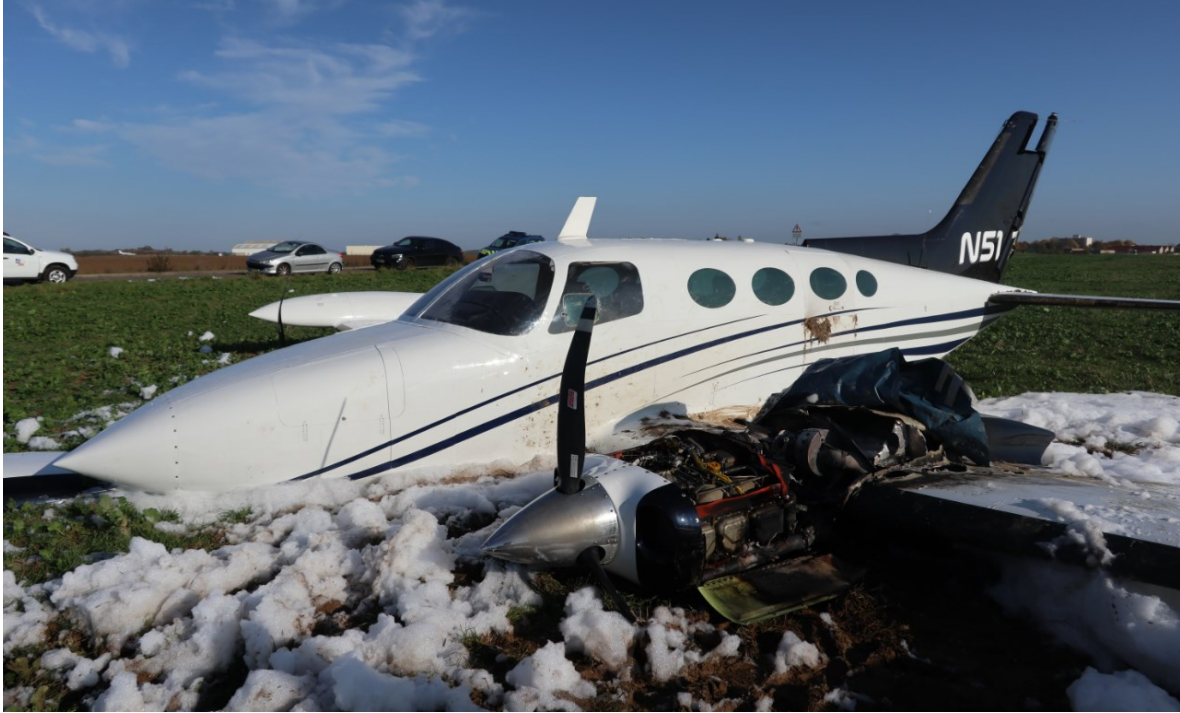
Figure 1: overview of wreckage on site

The aircraft suffered little damage during its emergency landing. The on-site examination focused on the left engine, which was removed and taken to the BEA for further examinations. Neither of the two propellers was found feathered.

The compartment aft of the left engine nacelle was severely damaged by the fire. The engine support spars were also almost completely destroyed by the fire.

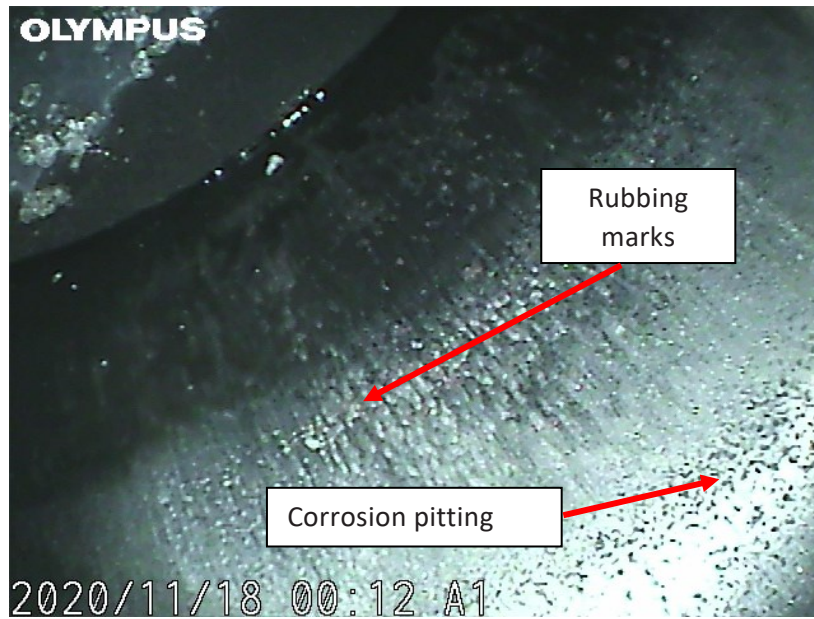
When the engine was examined around three weeks after the accident, signs of significant overheating were observed, particularly in the area of cylinders No. 2 and No. 4. The liners of all the cylinders in this engine were found to be heavily marked by corrosion and friction (see **Figure 2**). Given the extent of this corrosion and the piston wear marks that were observed, it is highly unlikely that the corrosion appeared after the accident.

Figure 2: borescope inspection of cylinder No. 4 (source: BEA)

It is very probable that the left engine had internal corrosion, the small amount of operating time over a long period being conducive to this damage, without this being detected during the inspections prior to the sale.

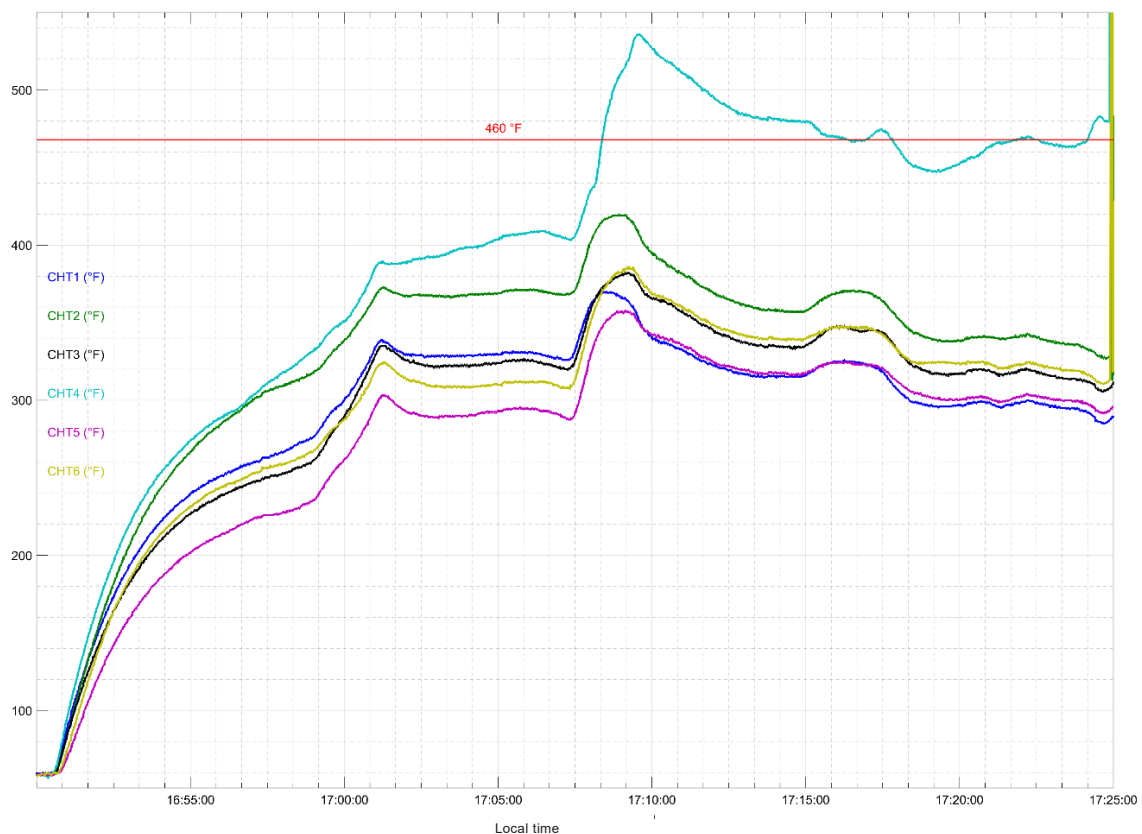
On analysing the recorded data, it was observed that certain ground tests showed that the temperature of the cylinder No. 2 and 4 heads of the left engine tended to significantly exceed that of the other cylinders of the left and right engines without, however, reaching the limit defined by the manufacturer (460°F)¹³. However, given the uncertainty about the conditions in which these tests were carried out, it was not possible to reach a definite conclusion about the existence of an engine malfunction prior to the accident flight. The other recorded parameters did not show a significant deviation from the norm.

The accident flight data was also read out. The data shows that as soon as power was increased on the ground, there was a rapid increase in the temperature of cylinder No. 4 and to a lesser extent, cylinder No. 2. The temperature of the cylinder No. 4 head reached 536°F¹⁴ which is in excess of the maximum temperature limit defined in the manufacturer's manual. According to the CGR 30 manual, this would have led to the corresponding CHT¹⁵ parameter being displayed in red on the screen of the CGR 30 and the illumination of the red light on the instrument panel. The temperature then decreased before increasing and exceeding the critical threshold again a few minutes later.

Figure 4: temperature of cylinder heads on left engine during flight of 30 October 2020
(source: BEA)
