Accident to the CIRRUS - SR22 (G2)
registered **N565CK**
on 21 December 2021
at Auxerre

Time	Around 17:55 ¹
Operator	Private
Type of flight	Cross country
Persons on board	Pilot
Consequences and damage	Pilot fatally injured, aeroplane destroyed
This is a courtesy translation by the BEA of the Final Report on the Safety Investigation published in December 2022. As accurate as the translation may be, the original text in French is the work of reference.

Collision with ground during night flight, fire

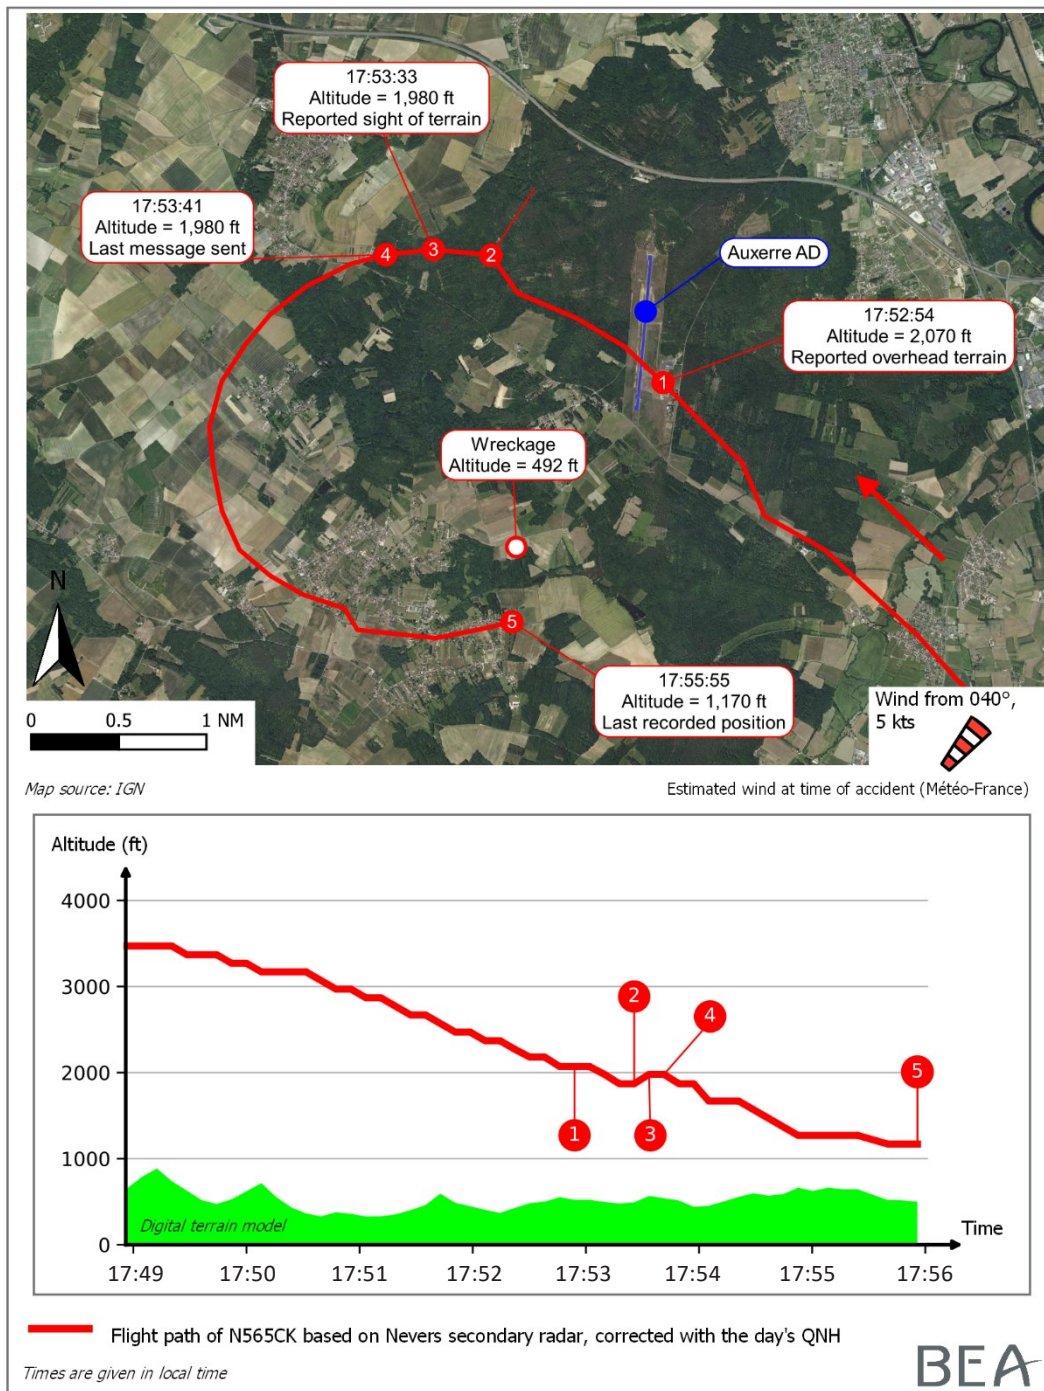
Figure 1: flight path of N565CK

When the pilot reported that he was on the downwind leg for runway 36 (see Figure 1, point 2), the AFIS officer asked him if he had sight of the runway. The pilot replied in the affirmative (see Figure 1, point 3). The AFIS officer asked him to call back on final for runway 36. The pilot read back (see Figure 1, point 4). This was the last radio message made by the pilot.

The flight path based on the radar data showed that the aeroplane flew over Auxerre aerodrome at 17:53 at around 2,000 ft QNH (see Figure 1, point 1) and then made a left turn in descent. The last recorded point was at 17:55 when the aeroplane was at 1,175 ft (see Figure 1, point 5).

The aircraft wreckage was found at around two kilometres south-west of the threshold of runway 36.

The radar flight path and the pilot's exchanges with the AFIS officer showed that the pilot probably lost the external visual references between the left-hand downwind leg and the final for runway 36. In a left-hand turn on a flight path that initially converged with the final for runway 36, the aeroplane collided with the ground.

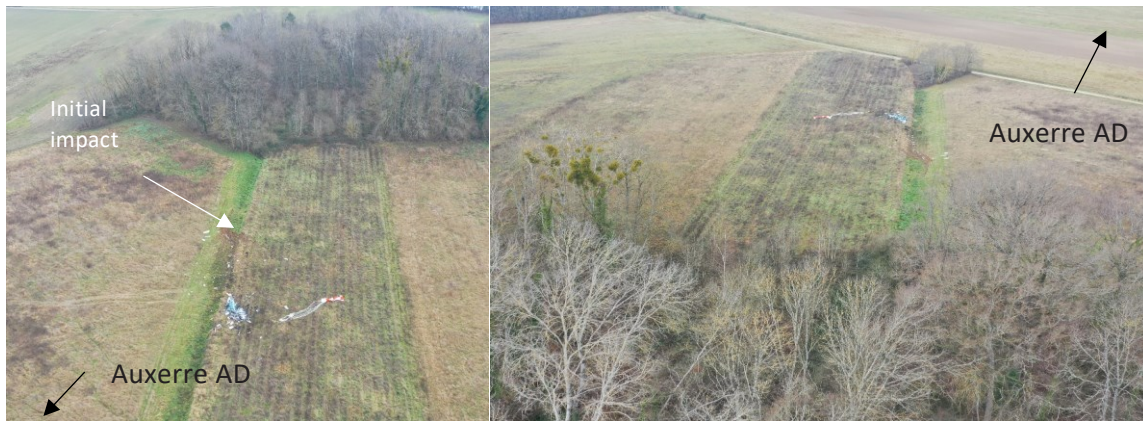
Figure 2: accident site
(source: gendarmery drone, annotated by the BEA)

The wreckage was situated on both sides of a bank by the edge of a field and a road. There was a group of trees around 20 m tall at the south end of the field. No collision mark with the tops of the trees in this group was observed. The initial point of impact with the ground was situated at around 50 m from the fringe of the trees.

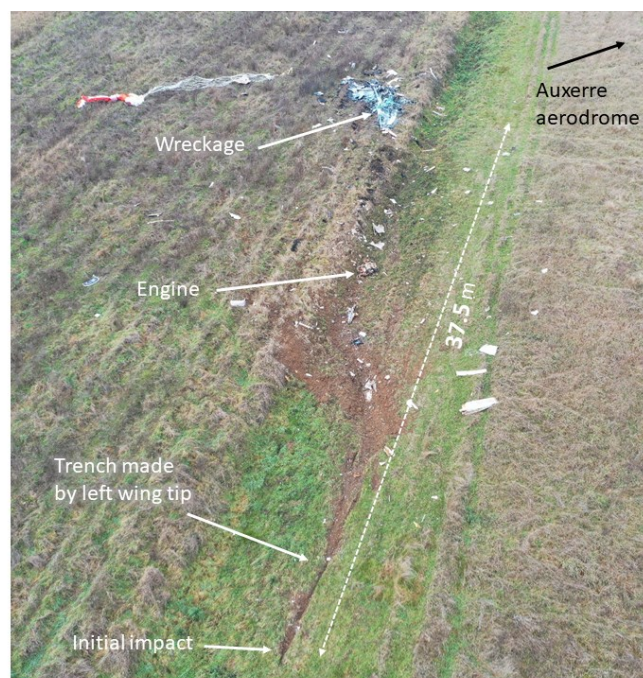
Figure 3: scars on ground at accident site
(source: gendarmery drone, annotated by the BEA)

The scars on the ground, the state of damage and the distribution of the debris indicated that the aeroplane struck the ground with high energy, a high left-roll angle and a low nose-down angle. When the tip of the left wing struck the ground, the aeroplane tipped forward, the engine separated and the aircraft then came to a halt on its back and caught fire.

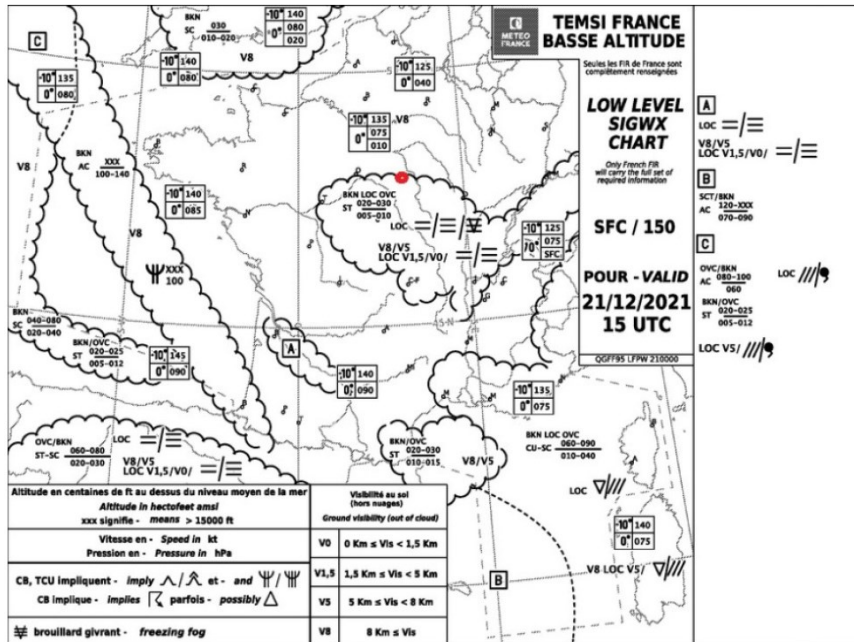
Figure 4: 16:00 Low Level SIGWX chart (source: Météo-France)

The investigation was not able to determine if, during the flight preparation, the pilot had sought and obtained information about the forecast meteorological conditions at the time of his arrival at Auxerre. The 16:00 SIGWX chart showed that Auxerre was at the north edge of an area of low clouds, mist and fog (see Figure 4, point ●.)

The Météo-France analysis indicated that in the area of and at the time of the accident, the conditions were conducive to the formation of mist and fog due to the presence of a very moist air mass and light wind. Sunset was at 16:52. The night was dark due to there being no moon and the presence of mist and fog.

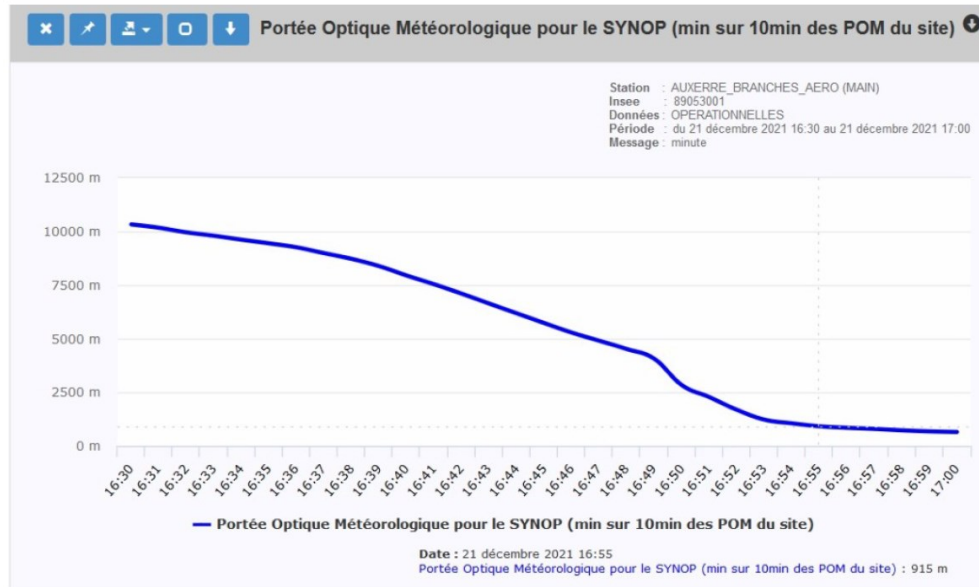
Figure 6: data recorded by Météo-France weather station at Auxerre aerodrome between 17:00 and 18:00 (source: Météo-France)

This data shows that the weather conditions were degraded between 17:00 and 18:00 due to the formation of fog. The data NBAS (lowest cloud cover) = 9 in the table above means that the sky was not visible. The table below indicates the minimum visibility measured over ten sliding minutes.

At 17:49 when the pilot made first contact, the indicated visibility was around five kilometres. At 17:55, the time of the accident, the minimum visibility measured over ten minutes was around 900 m.
