Accident to the CESSNA 210K
registered **N5767J**
on Thursday 25 July 2024
at Beblenheim

Time	Around 17:45 ¹
Operator	Private
Type of flight	Cross country
Persons on board	Pilot, passenger
Consequences and damage	Aeroplane destroyed, persons on board seriously injured
This is a courtesy translation by the BEA of the Final Report on the Safety Investigation. As accurate as the translation may be, the original text in French is the work of reference.

Fuel exhaustion, forced landing in a field, overturn

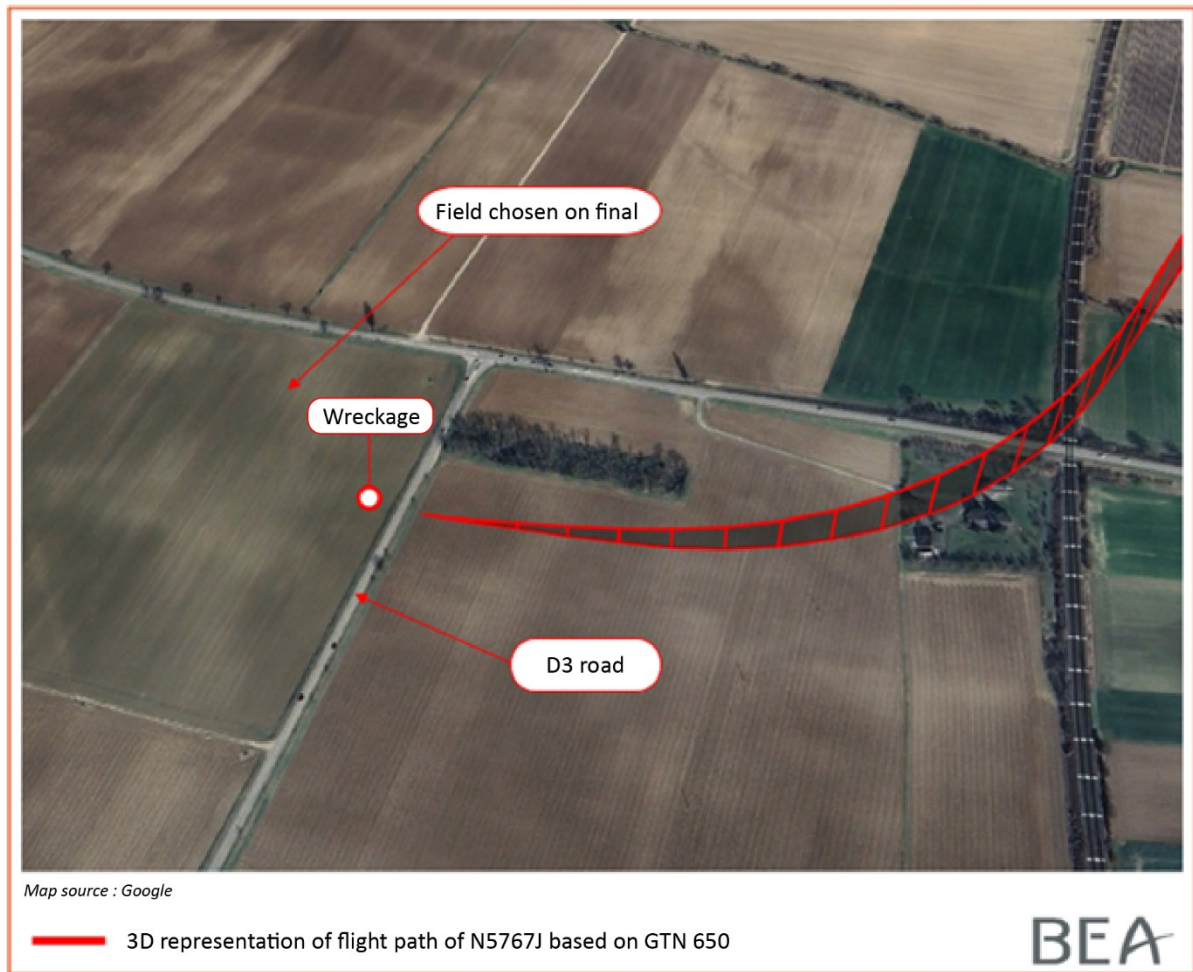
Figure 2: 3D representation of end of flight path (source: BEA)

The last point recorded by the on-board GPS was at 17:45:35, when the aeroplane was on final at a low height. The landing gear came into contact with the vegetation of a field and then a road (D3) situated before the field chosen for the landing (see **Figure 2**). The aeroplane bounced, turned over onto its back and came to rest in this field.

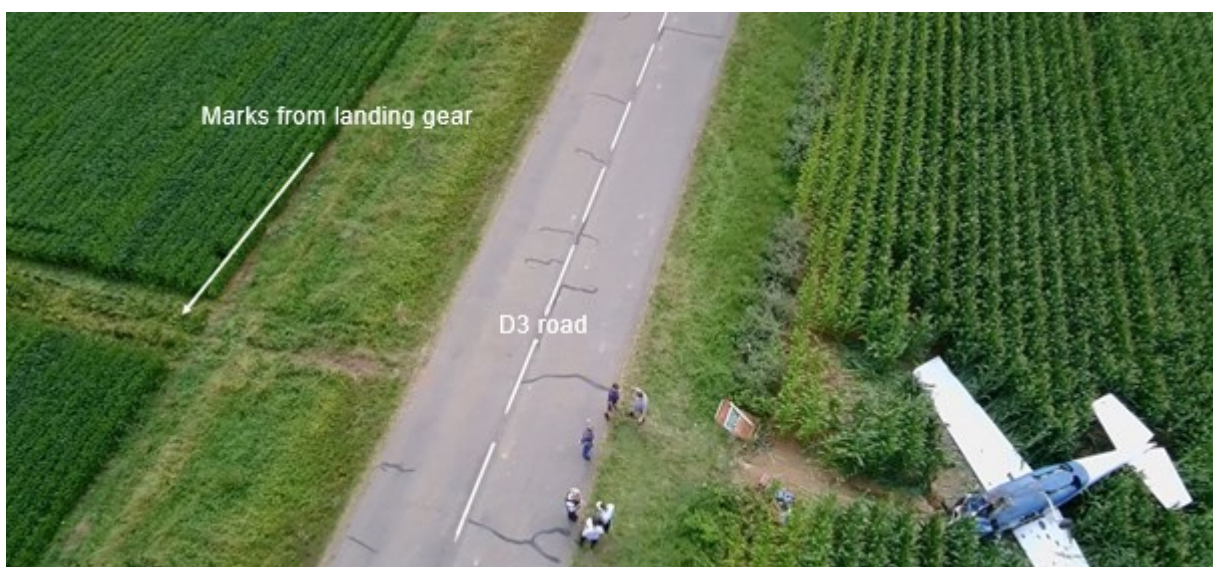
Figure 4: aerial photo of accident site (source: BEA)

Marks left by the landing gear were visible in the field before the road (D3). The wreckage was lying on its back in a cornfield on the other side of the road. The damage was concentrated at the front of the aeroplane and was consistent with the accident. Two blades were bent backwards, while the third showed no significant deformation. The deformations observed indicated that no engine torque was being transmitted during the sequence that caused these deformations.

The first people to arrive at the accident site reported that they did not smell any significant odour of fuel. Approximately 300 ml of fuel was recovered from the left-hand tank and approximately 600 ml from the right-hand tank.

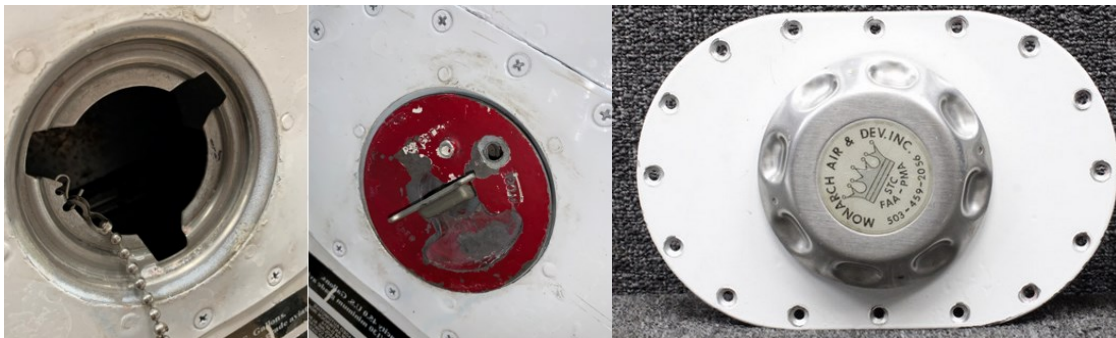
Figure 5: comparison of fuel caps: LH side and middle, recessed fuel caps installed on N5767J, RH side, raised fuel cap (source: BEA, baspartsales.com)

It also recommends replacing the fuel tank caps with raised fuel caps. The raised fuel caps allow the pilot to visually check that the fuel tanks have been replenished as when the fuel is flush with the cap, it is also flush with the top of the fuel tanks. This is not the case with the recessed fuel caps⁵ (see **Figure 5**). If the caps are not changed, a placard shall be affixed next to each wing fuel filler opening, indicating:

- no raised fuel caps (see **Figure 5**);
- no placard affixed to the wings;
- no placard in the cockpit concerning the fuel gauges;
- no mention in the maintenance documents (before the AD and up to one year after the effective date of the AD) of the calibration of the fuel gauges.

⁵ The replacement could be carried out as per **Cessna Service Kit SK210-136**, referenced by **Cessna Service Bulletin SEB91-10**, dated 25 October 1991, or as per **Supplemental Type Certificate SA2456CE** for fuel caps manufactured by Monarch Air & Development, Inc., Assembly No WW-100-2.

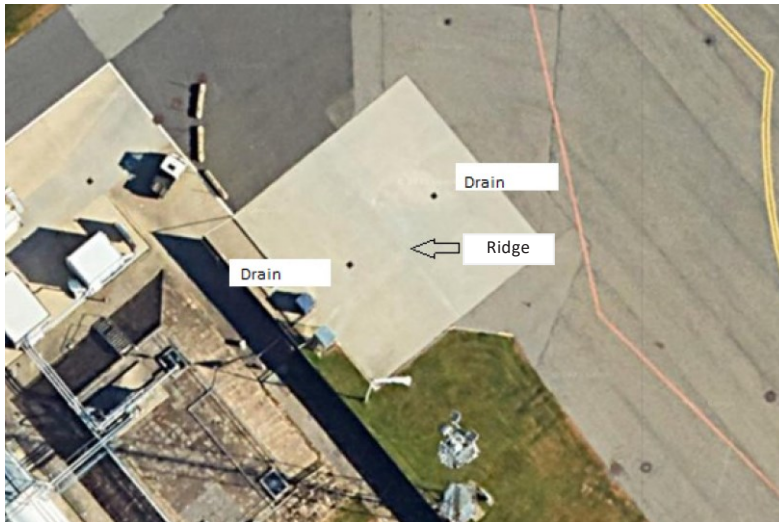
Figure 6: aerial view of the refuelling area (source: Google Maps, annotations BEA)

Before the flight, the pilot refuelled the aeroplane at Aalborg airport. The refuelling area is a 15 m x 15 m square shown in the figure below. This area is not flat and has a ridge in the centre and two slopes, each with a drain.

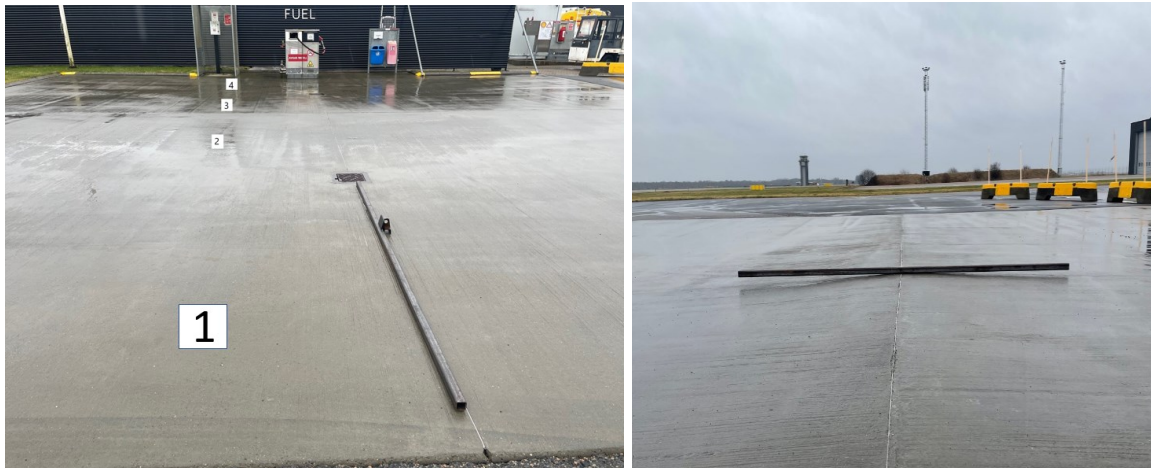
Figure 7: measurements taken in the refuelling area of Aalborg airport (source: BEA)

The steepest slope was measured at the position marked 1 in **Figure 7** and was 2.6°.
