Serious incident to the PILATUS PC12
registered **N668TW**
on Tuesday 16 January 2024
on Saint-Barthélemy airport

Time	Around 12:45 ¹
Operator	Tradewind Aviation
Type of flight	Ferry flight
Persons on board	Captain (PF ²) and co-pilot (PM)
Consequences and damage	Aeroplane slightly damaged
This is a courtesy translation by the BEA of the Final Report on the Safety Investigation. As accurate as the translation may be, the original text in French is the work of reference.

Destabilisation during final approach, vegetation strike

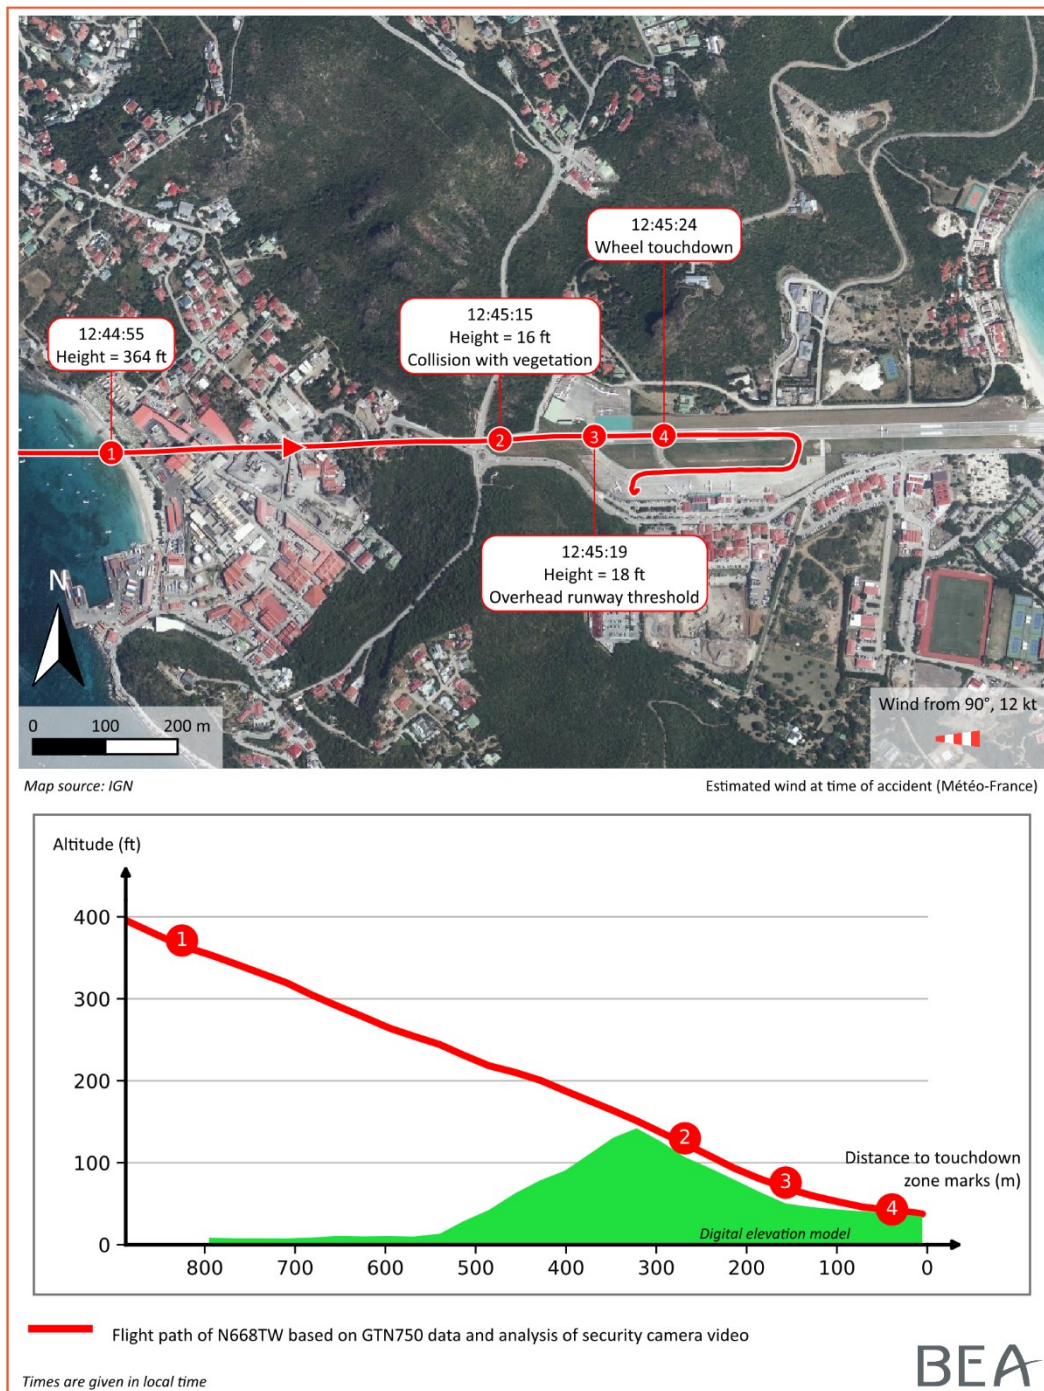
The crew were carrying out a ferry flight without passengers between Luis Munoz de San Juan international airport (Porto Rico) and Saint-Barthélemy airport. The captain was the PF and the co-pilot was the PM. While flying over the Col de la Tourmente (the highest vertical point on Figure 1) during the approach to runway 10 at Saint-Barthélemy airport, less than 300 m from the runway threshold, the aeroplane was destabilised by turbulence and suddenly rolled to the left-hand side. The left-hand wing sheared the branches of a tree. The PF countered this left-hand bank by making right-hand stick inputs which resulted in bringing the right-hand wing to within approximately two metres of the ground. He continued the approach and landed without further incident.

Figure 1: flight path and vertical profile followed by N668TW (source: BEA)

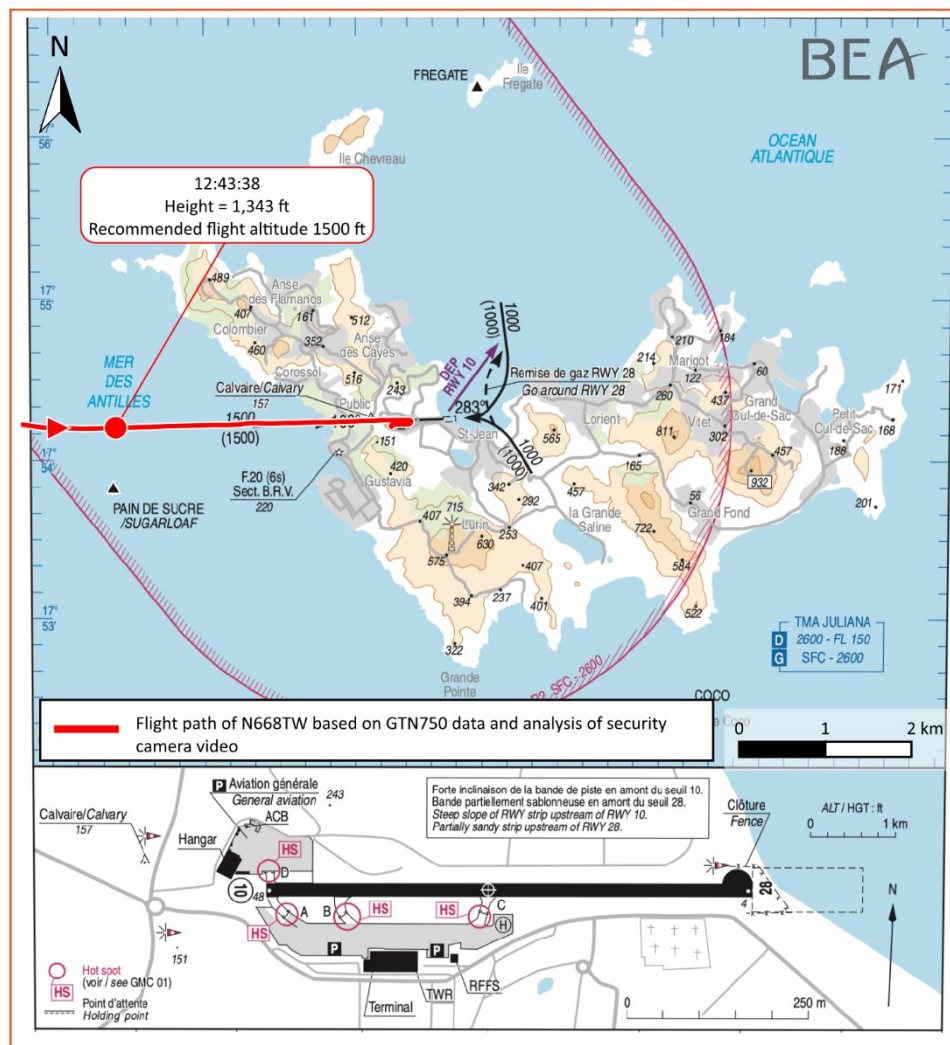
Figure 2: excerpt from Saint-Barthélemy airport VAC (source: SIA, annotations BEA)

The approach path to runway 10 passes over Col de la Tourmente pass situated at an altitude of around 130 ft⁴. The pass is situated at 310 m from the touchdown zone markings which are at an altitude of 34 ft. Due to this particular topography, the pilot has to follow a steep final approach slope. A wayside cross is situated near the pass reaching an altitude of 157 ft as indicated on the VAC.

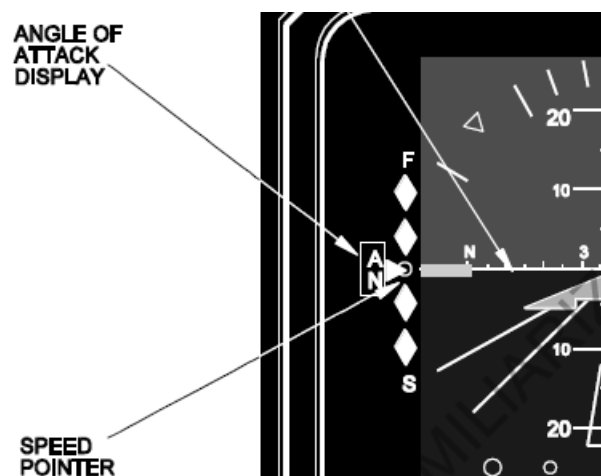
In addition to the usual airspeed indicator, the PC12 of the incident has an angle of attack (AOA) indicator on its EFIS. This tape, controlled by the AOA measurement system, is composed of a pointer indicating if the speed of the aeroplane is too fast (close to F indication) or too slow (close to S indication). If the pointer is in the middle of the tape, the aeroplane is flying at 1.3 times the stall speed⁵.

Figure 3: AOA indicator

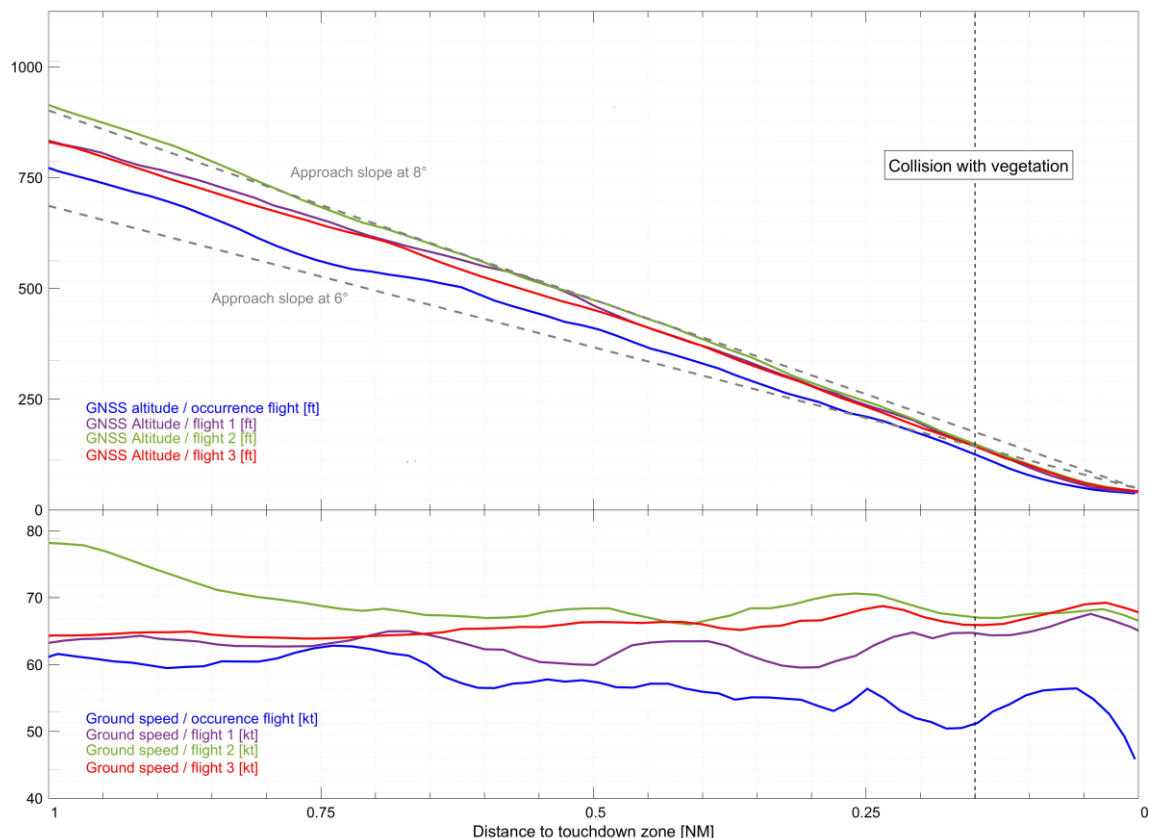
Figure 4: comparison of approach slopes and ground speeds for different flights¹⁰ (source: BEA)

These comparisons highlight that the lowest of the flight paths studied is that of the serious incident.

Based on the ground speed, heading and mean wind over ten minutes data provided by Météo-France, airspeed values on final were estimated for the various flights studied. These estimates indicate that, when passing over Col de la Tourmente pass, the airspeed of the incident flight was approximately 10 kt lower than that of the other flights.
