**Accident** to the PIPER PA30  
registered **N8663Y**  
on 12 August 2021  
at Cannes

## Engine problem in flight, U-turn, water landing

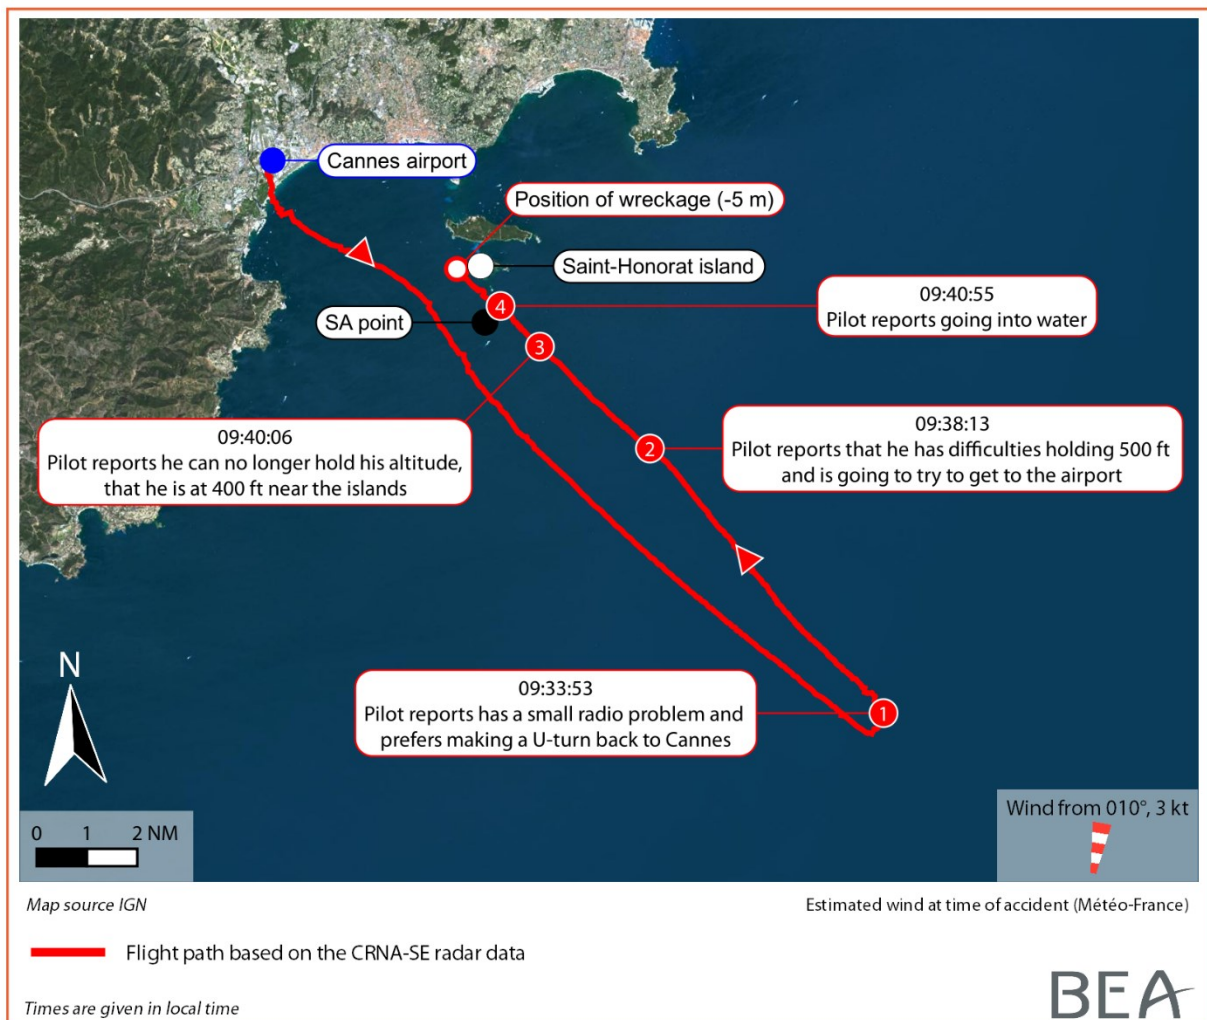
**Figure 1: flight path of N8663Y**

As a precautionary measure, a few minutes later, the pilot decided to turn around and land at Cannes, informing the Nice flight information controller that he had a small problem with his radio<sup>3</sup> (see Figure 1, point ①). The pilot was then approximately 16 NM from the airport. He put all the aeroplane's levers in the forward position<sup>4</sup> - the electric pumps had been operating since the beginning of the flight. He maintained the aeroplane in level flight at 1,000 ft. The pilot indicated that the aeroplane could not exceed 110 mph, which is the best rate of climb speed on a single engine (or *blue line*).

He announced to the Cannes tower controller that he was going into the water (see Figure 1, point 4).

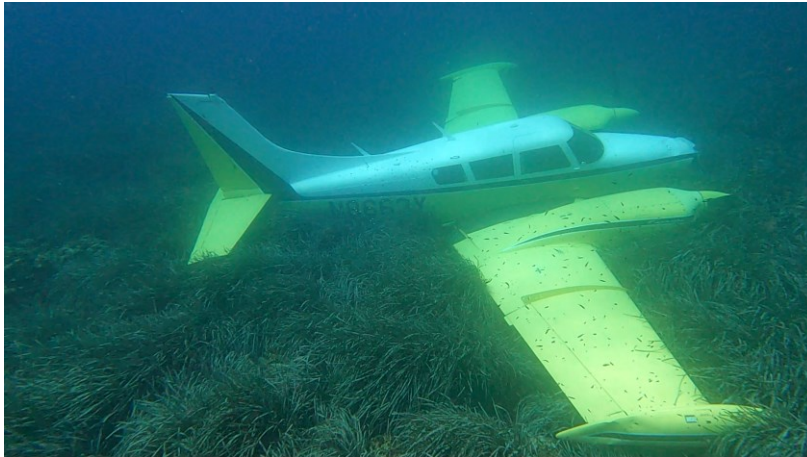
*Figure 2: wreckage of N8663Y (source: Gendarmerie)*

The wreckage remained underwater at a depth of approximately five metres for four days before being raised (see Figure 2).

The wreckage was examined shortly after being raised; no anomaly likely to have contributed to the accident was found.

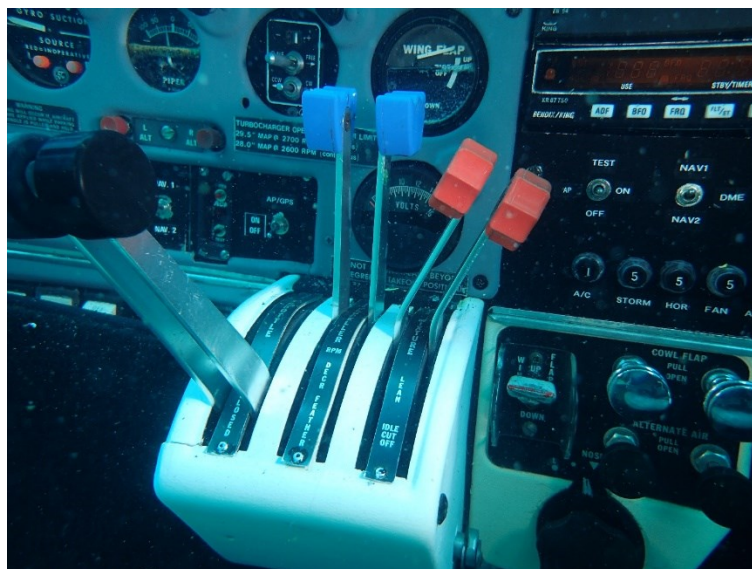
- The rudder trim position was close to neutral.
- The power controls were set to the idle position, the propeller speed controls were close to the full low pitch position and the mixture controls were positioned at the halfway point.

*Figure 3: inside view of the N8663Y cockpit  
Photograph taken while N8663Y was submerged (source: Gendarmerie)*
