**Accident** to the PIPER - PA46 - 350P (Malibu Mirage)  
registered **N9190X**  
on Wednesday 14 September 2022  
on Amiens - Glisy aerodrome

### **Stall on short final, hard landing, during a passenger transport flight for remuneration**

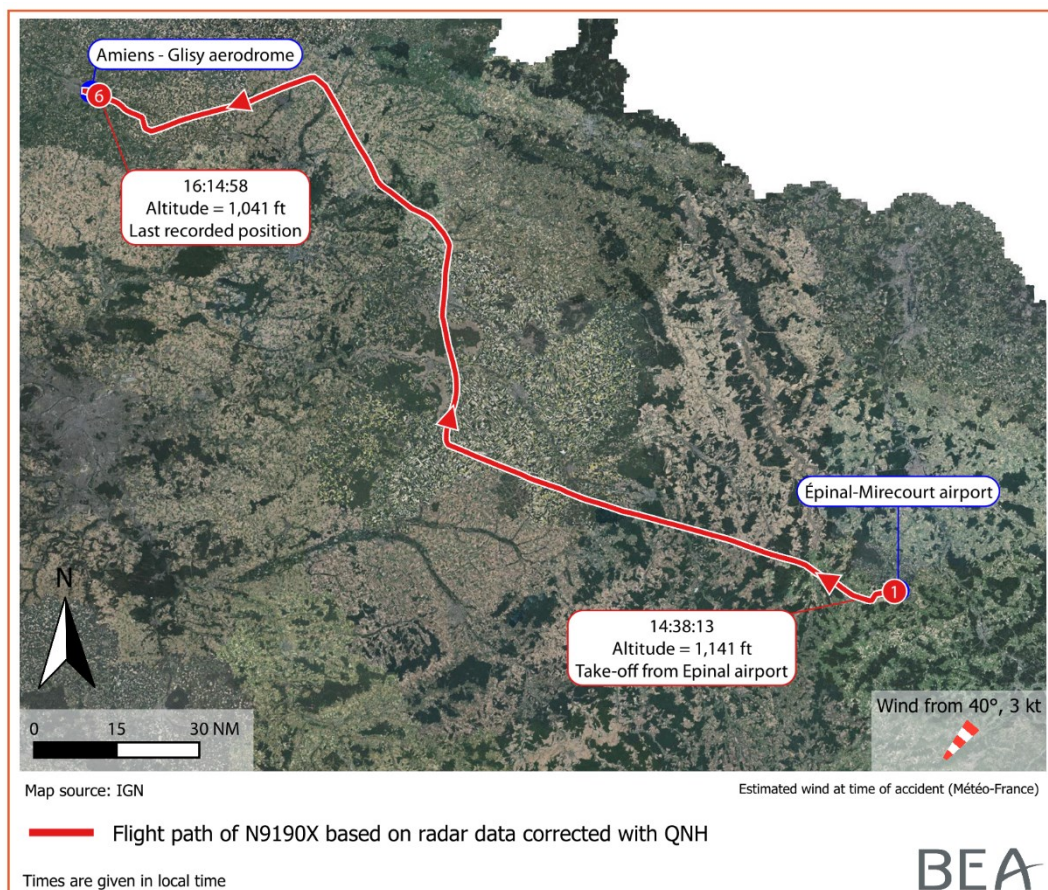
Figure 1: flight path of N9190X

After the three passengers had boarded at Épinal, the pilot took off at around 14:30 (see **Figure 2**, point ①) bound for Amiens under an IFR flight plan.

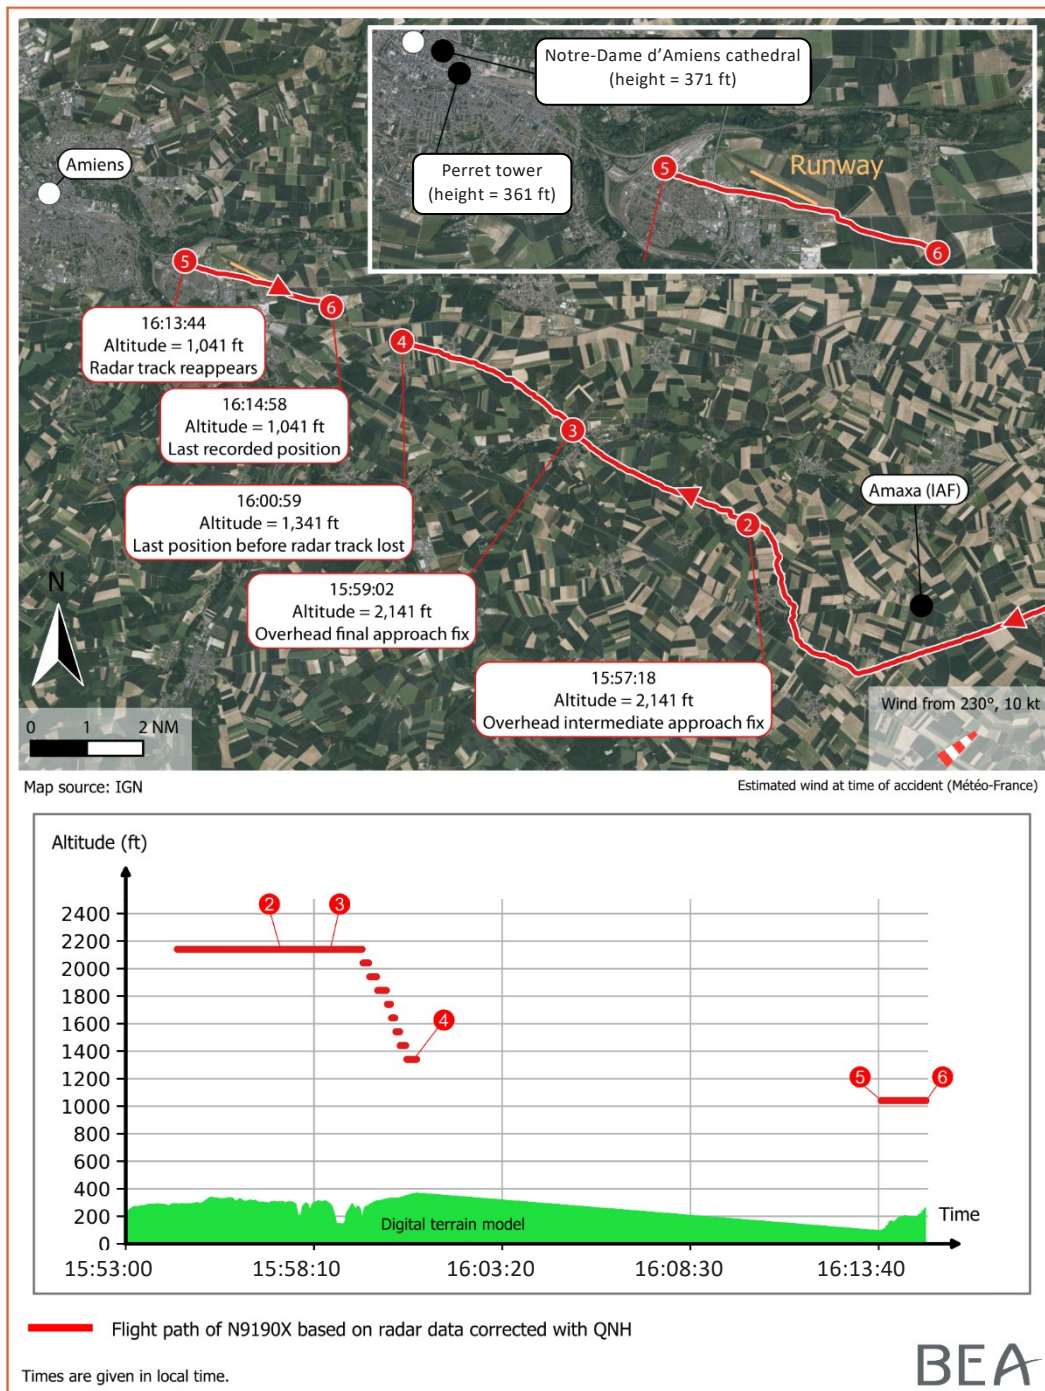
Figure 2: end of flight path of N9190X

The radar recordings stopped<sup>6</sup> at 16:00 (point 4) when the aeroplane was on final for runway 30 at an altitude of 1,341 ft and a distance of 2.6 NM from the aerodrome.

For the fourth approach, the pilot carried out a RNP approach again. On short final, at a very low height and low speed, he perceived the runway on his LH side and made a tight turn to align with it. At 16:23, the aeroplane stalled and touched down hard on the runway.

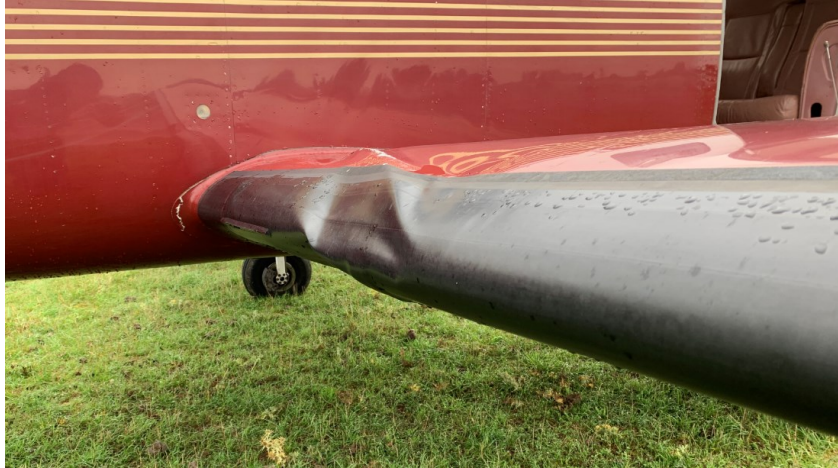
The examination of the aeroplane found that the main landing gear and both wings were damaged. The damage was mainly the result of the wing skin buckling and deforming. Cracks were also observed in the wing roots. This damage was caused by the hard landing.

*Figure 3: damage to wing roots of N9190X (Source: BEA)*

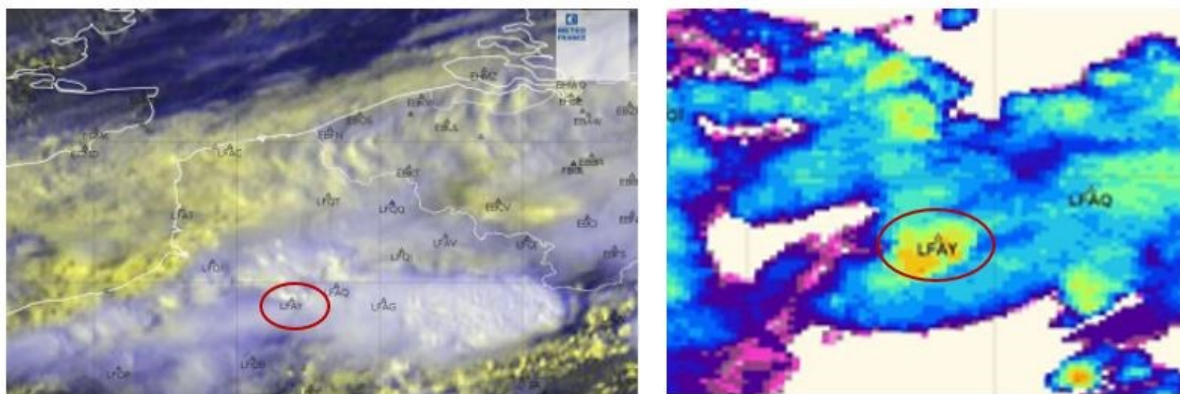
The 16:30 infrared image (IR-HRV) shows the presence of unstable cumulus congestus (TCU) and cumulonimbus (CB) cells (see **Figure 6**, spots of varying size from luminous yellow to white). One of these cells was over Amiens - Glisy aerodrome (LFAY) attesting to the presence of a CB. The 16:20 radar reflectivity image (see **Figure 6**) shows a heavy downpour at the time of landing at the aerodrome. Visibility was not measured at the aerodrome; Météo-France estimated that it was less than 2,000 m.

*Figure 6: estimated weather conditions at the site of the accident on 14 September 2022 at around 16:30 (Source: Météo-France)*
