Accident to the SCHEMPP HIRTH DISCUS 2C
registered **OE-5751**
on Sunday 16 July 2023
at Méolans-Revel (Alpes-de-Haute-Provence)

Mountain flight, collision with ground

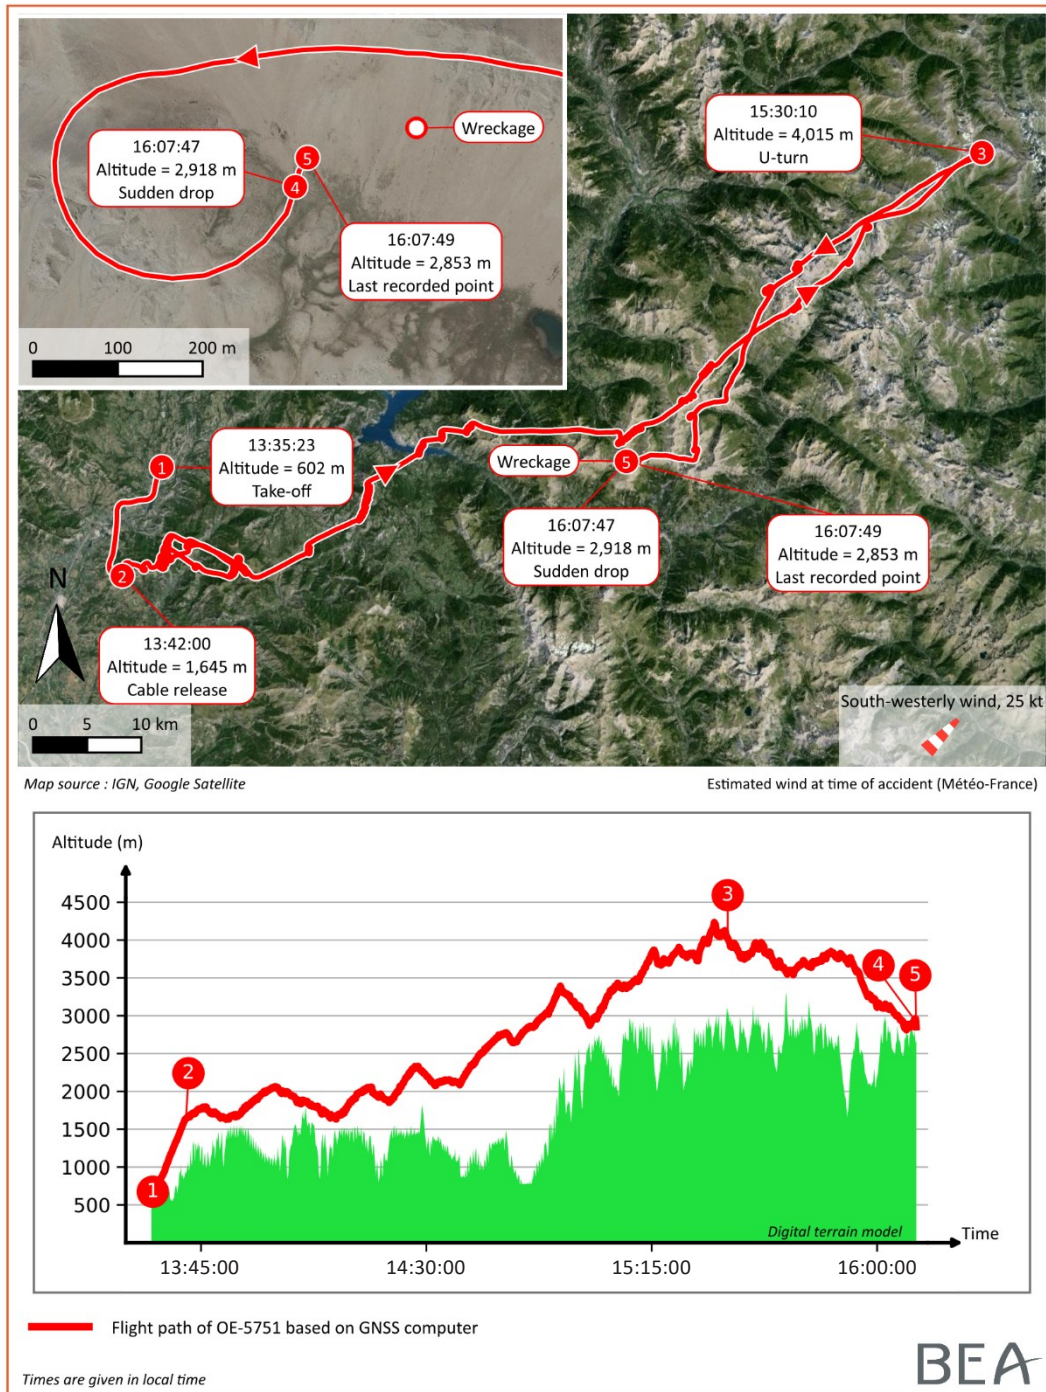
Figure 1: flight path (source: BEA)

The flights started the day after the arrival of the group of pilots. At 13:34, the pilot of OE-5751 carried out a towed take-off. At 13:42, the glider pilot released the cable at an altitude of 1,645 m (see **Figure 1**, point **2**). The pilot used thermal lifts and continued his route eastwards. At 15:27, he reached the altitude of 4,200 m. At 15:30, at an altitude of 4,015 m and at a distance of 82 km from Gap Tallard aerodrome, the pilot performed a U-turn towards the south-west (point **3**). He was able to benefit from a few thermal lifts, and then at 15:54, started tracking with an average rate of descent of 1 m/s. At 16:07:47, when the pilot was at an altitude of 2,918 m and a height of 263 m, the glider suddenly dropped (point **4**). The last calculated rate of descent was 32 m/s. The glider collided with the slope of the mountain, 130 m to 150 m below the last recorded point, which corresponds to a fall on a gradient of 50°.

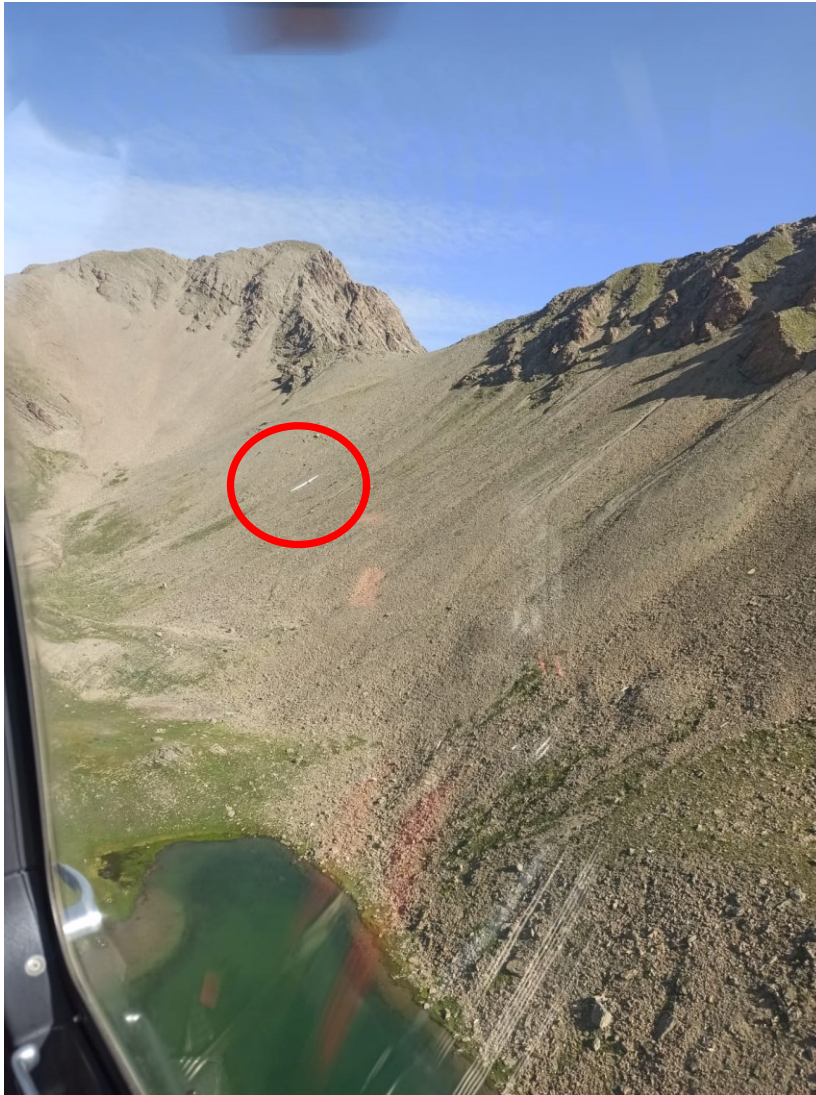
The glider was resting on the side of the mountain which has a slope of around 30°. The grouped wreckage was situated at an altitude of 2,690 m close to the peak La Tête de l'Aupet.

*Figure 3: position of wreckage
(source: Jausiers Gendarmerie Mountain Rescue Unit (PGHM))*

The speed brakes were found extended. The investigation was not able to determine if the speed brakes were extended before the impact or if their deployment was the result of the collision with the mountain.

The damage showed that the glider had collided head-on with the mountain. The forward section and the leading edge of the wings were destroyed. The rear section was in a relatively good condition.

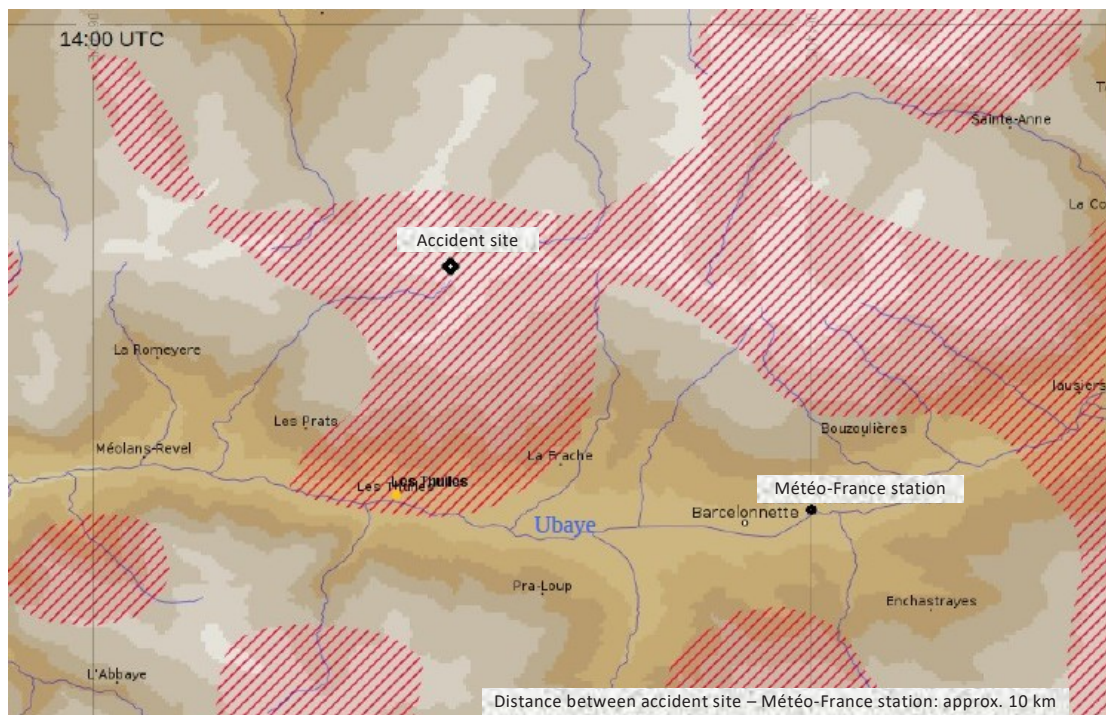
According to the Météo-France AROME model, there were gusts of more than two to three times the mean wind speed indicating turbulence in the lower layers (See **Figure 4**). This turbulence was due to the strong thermal lifts over the terrain and the strong slope and valley breezes (significant daytime heating, temperature of 30°C in the Ubaye valley).

Figure 4: 16:00 turbulence chart (source: Météo France, AROME model).
The red hatching shows the areas of moderate to strong turbulence.
