Accident to the BRM AERO Bristell B23
registered **OE-AMK**
on Thursday 9 May 2024
at Chambéry - Challes-les-Eaux

Winch cable strike in initial climb, loss of control, collision with ground, fire

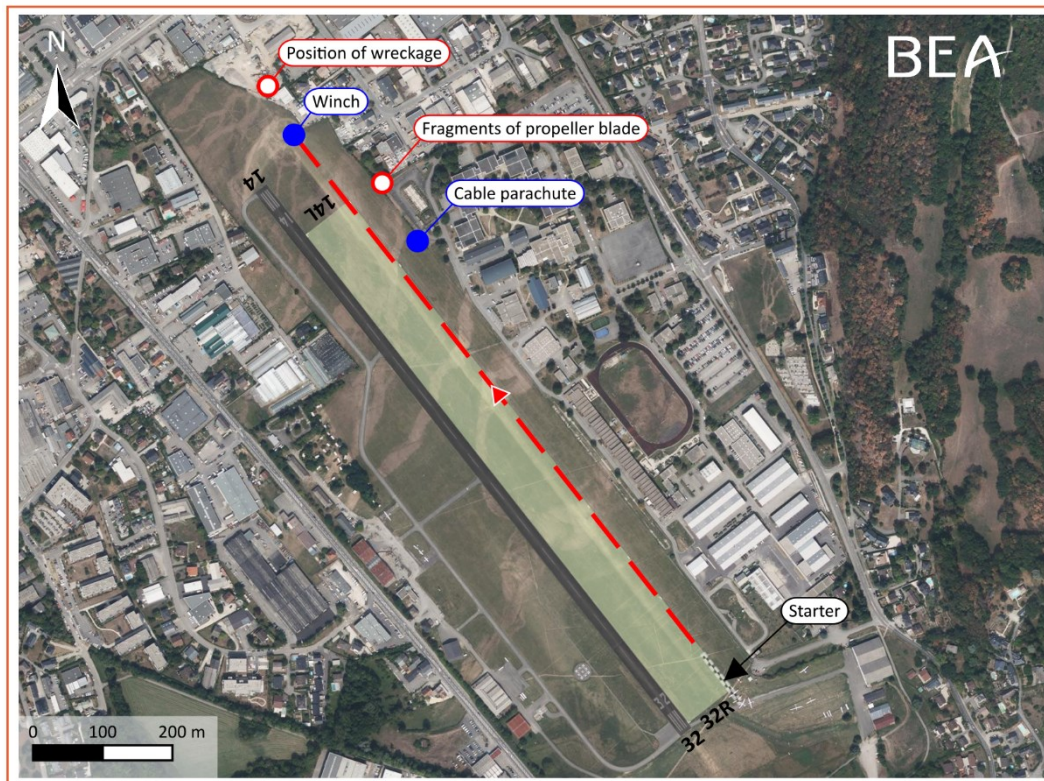
Figure 1: accident site

The wreckage was found at around 160 m from the threshold of runway 14, on the axis of the grass runway.

The technical examination was limited due to the damage caused by the post-impact fire. In particular, it was not possible to determine the continuity of the aileron and rudder controls, the integrity of the flap system, the position of the trims, the condition of the propulsion system and the condition of the cockpit before the accident.

A section of winch cable was partially found in the debris of the wreckage. It was cut in several places at around 10 m from the wreckage. This section was situated at a distance of around 65 m from the area where the cable was sliced by the “guillotine”, an emergency system operated by the winch operator to cut the cable.

Fragments of at least one propeller blade were found at around 220 m before the wreckage. This damage was probably the consequence of the in-flight impact with the winch cable.

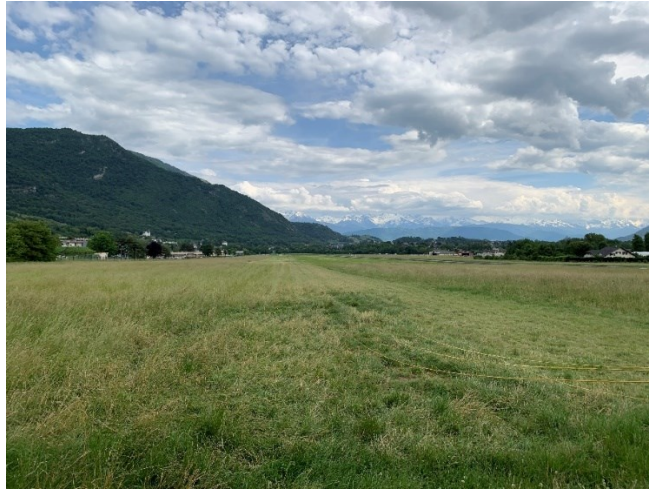
Figure 3: view from winch situated behind threshold 14 looking towards threshold 32 (source: BEA)

Winch launching takes place on the north edge of grass runway 32 (winch launch axis shown by a line of red dashes on the VAC, see **Figure 2**). The lateral distance between the centreline of the paved runway and the winch cable is therefore around 85 m. The winch and the winch operator are positioned behind the threshold of runway 14 (see **Figure 3**).
