**Accident** to the Rolladen-Schneider LS6-B  
registered **OH-726**  
on Thursday 25 April 2024  
at Seyne-les-Alpes aerodrome

Time	Around 12:30 <sup>1</sup>
Operator	Private
Type of flight	Cross-country
Persons on board	Pilot
Consequences and damage	Pilot severely injured, glider damaged

**Manoeuvre to avoid vegetation, stall at low height,  
hard landing**

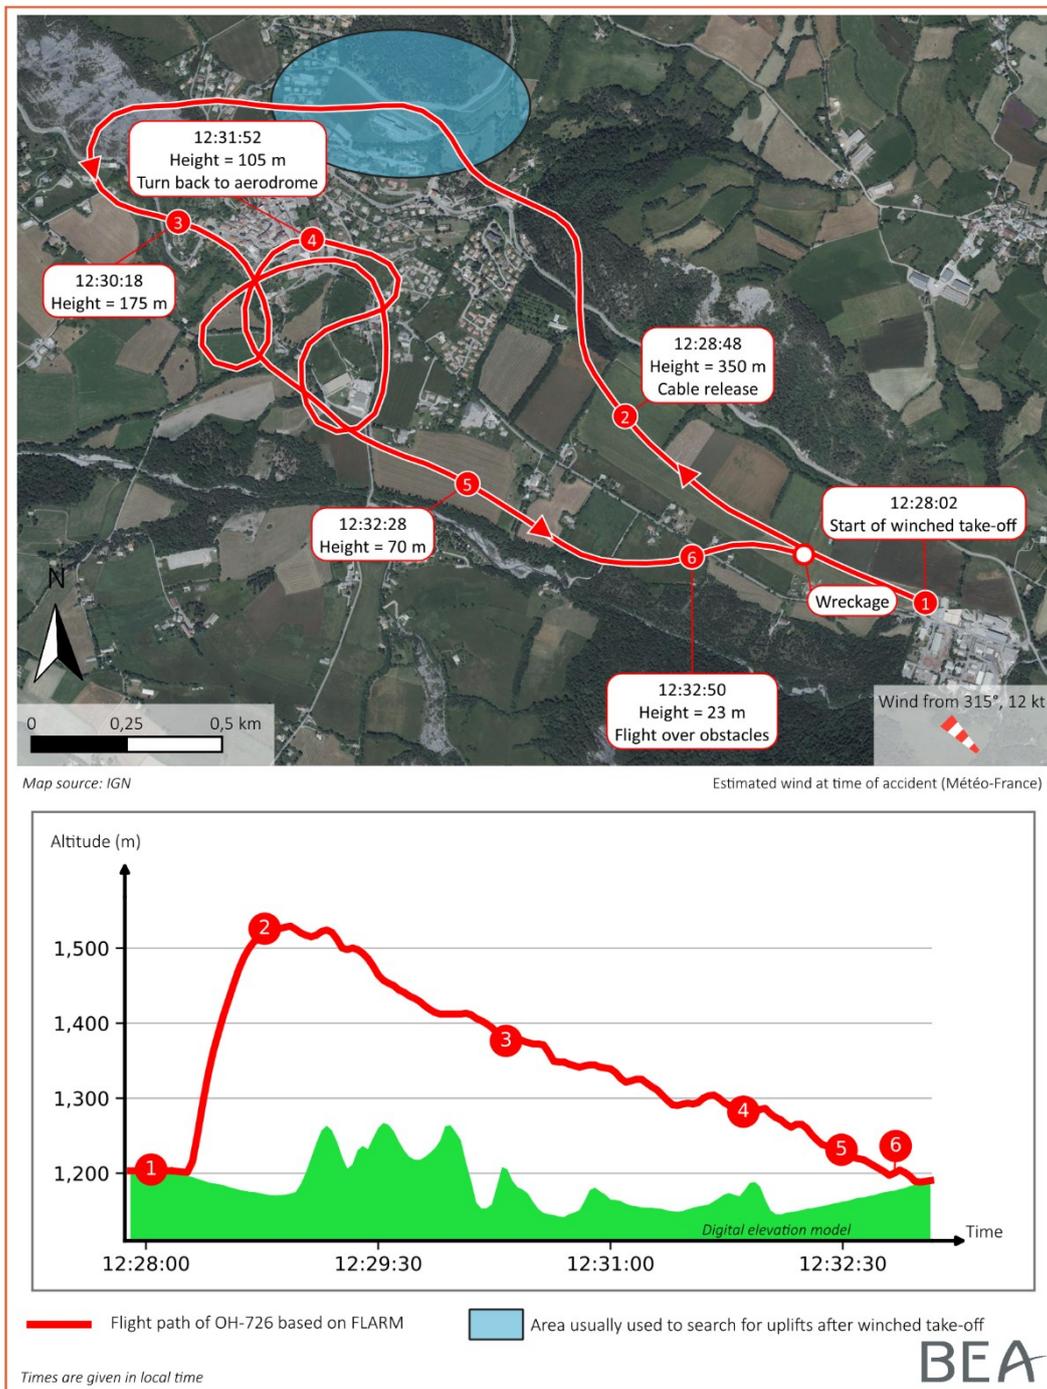
Figure 1: glider flight path

The next day, the pilot prepared for a return flight to Fayence. At 12:28, the pilot started the winch take-off (see **Figure 1**, point **1**), then the pilot released the cable at a height<sup>2</sup> of approximately 350 m (point **2**).

He bypassed the town of Seyne<sup>3</sup>, then he searched for uplifts by making spirals. His altitude was constantly decreasing. At 12:32, at a height of approximately 100 m (point **4**), the pilot decided to return to Seynes-les-Alpes aerodrome. At the start of the left-hand downwind leg for runway 31, he estimated that he was too low and decided to land on runway 13. The pilot indicated that due to trees on his path (point **6**), he then made a nose-up input to fly over them. This input caused the glider to stall and then to land hard on the runway.

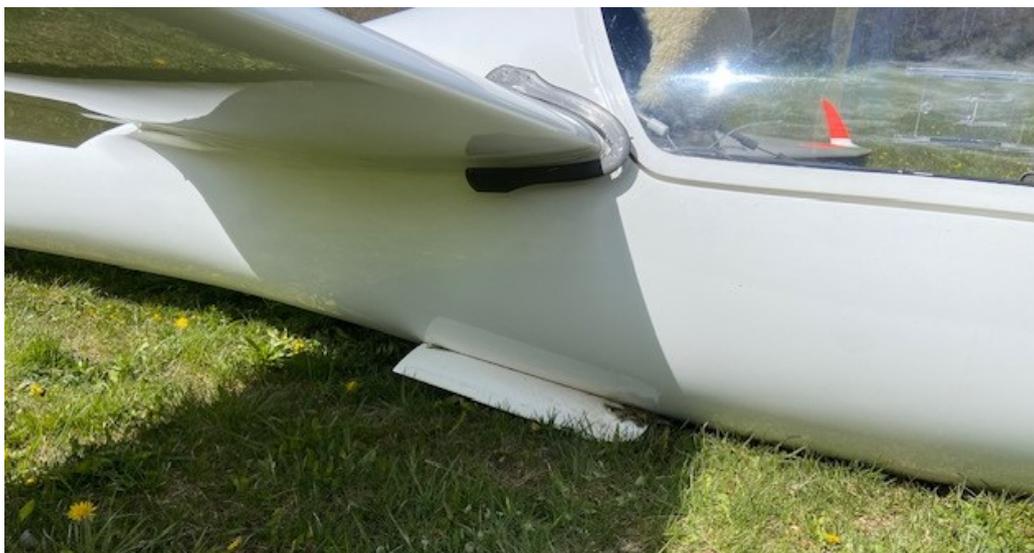
Figure 2: glider after the accident (Source: BGTA)

Given the circumstances of the event, the BEA did not go to the accident site and did not examine the glider. Based on the pilot's statements and the observations made by the French air transport gendarmerie brigade (BGTA), the damage was limited to the landing gear. The flaps were found in the landing position.
