Accident to the PILATUS PC-12
registered **OO-PCN**
on Saturday 17 February 2024
at Courchevel (Savoie)

Time	10:25 ¹
Operator	European Aircraft Private Club
Type of flight	Cross-country
Persons on board	Pilot-in-command and co-pilot
Consequences and damage	Aeroplane substantially damaged
This is a courtesy translation by the BEA of the Final Report on the Safety Investigation. As accurate as the translation may be, the original text in French is the work of reference.

**Bank strike before runway during landing, runway veer-off,
in mountain flight**

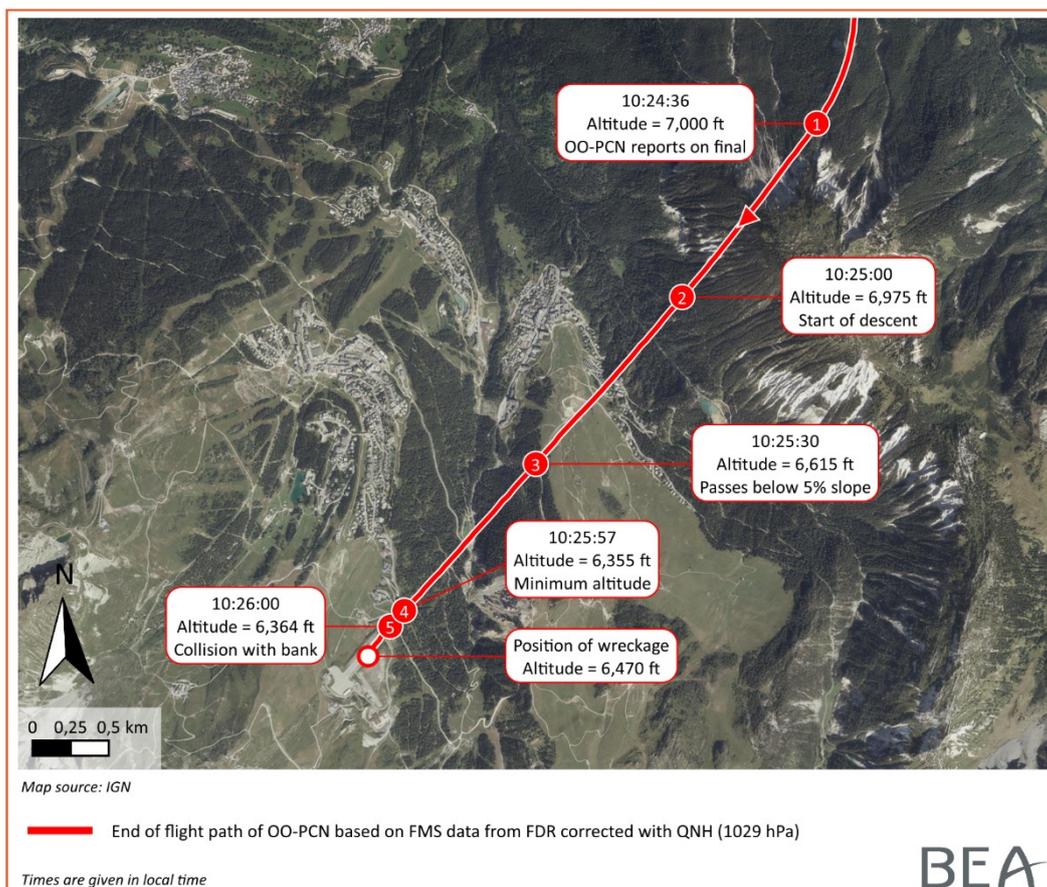
Figure 1: final approach path (Source: BEA)

The aeroplane was aligned with the runway centreline 2.4 NM from the runway threshold, in level flight at 7,000 ft (see **Figure 1** and **Figure 3**, point **1**), with a calibrated airspeed of 109 kt. The co-pilot announced to the AFIS officer that he was on final.

At 10:25, the pilot-in-command started the descent 1.6 NM from the runway threshold (point 2), reducing engine power from maximum to idle. The aeroplane was above a 5% slope. The vertical speed was approximately -700 ft/min. The pilot-in-command extended the flaps to the landing position (40°) and adopted the recommended speed for landing in the absence of wind of 85 kt. The co-pilot read the landing checklist at the pilot-in-command's request.

At 1.3 NM from the runway threshold, while the flaps were being extended, the pilot-in-command increased power. At 0.75 NM from the threshold of runway 22, the aeroplane passed below the 5% slope in descent (point 3). The vertical speed gradually decreased to -300 ft/min.

At 0.13 NM from the threshold, the aeroplane passed below the runway threshold altitude (6,371 ft) and descended to an altitude of 6,354 ft at 0.1 NM from the threshold. The airspeed was 84 kt. The pilot-in-command then substantially increased the aeroplane's attitude by reducing engine power to idle (point 4). The main landing gears and the nose landing gear collided with the bank located below the runway threshold (point 5, also Figure 2). The left main landing gear partially failed during the impact. The aeroplane bounced several times on the runway and gradually veered to the left of the runway centreline. The left wing tip hit the snowdrift located next to the runway (see Figure 2, point 6). The aeroplane entered the snowdrift and spun 180° to the left before coming to a stop in the snow.

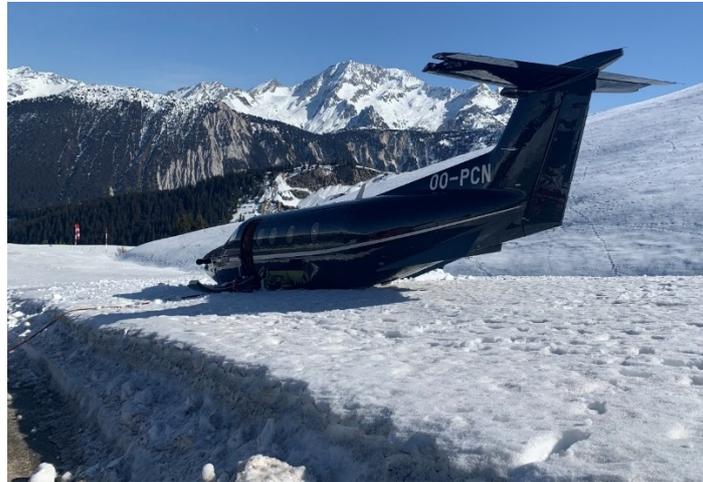
Figure 4: photograph of OO-PCN after the accident (Source: mountain airfield operator)

The wreckage was moved before the BEA investigators arrived at the site. Based on the information retrieved by the BEA, the aeroplane came to a stop around 200 m from the threshold of runway 22.

Examination of the site found that the wheels of the main landing gears and nose landing gear made contact with the bank 1 m before the runway threshold. The left wing was detached from the rest of the airframe at its root and the left landing gear was detached from the wing, as a result of the impact with the snow bank on the left side of the runway and the aeroplane's spin in the snow. The left wing and landing gear were found further down the runway. The five blades of the propeller failed when they hit the snow bank and were thrown several tens of metres away.

The examinations carried out on the aeroplane did not reveal any technical malfunction. The flight controls linkages were operational without any friction points found, the engine was delivering power at the time of the accident, and all the failures observed were of a sudden nature and a result of the accident.

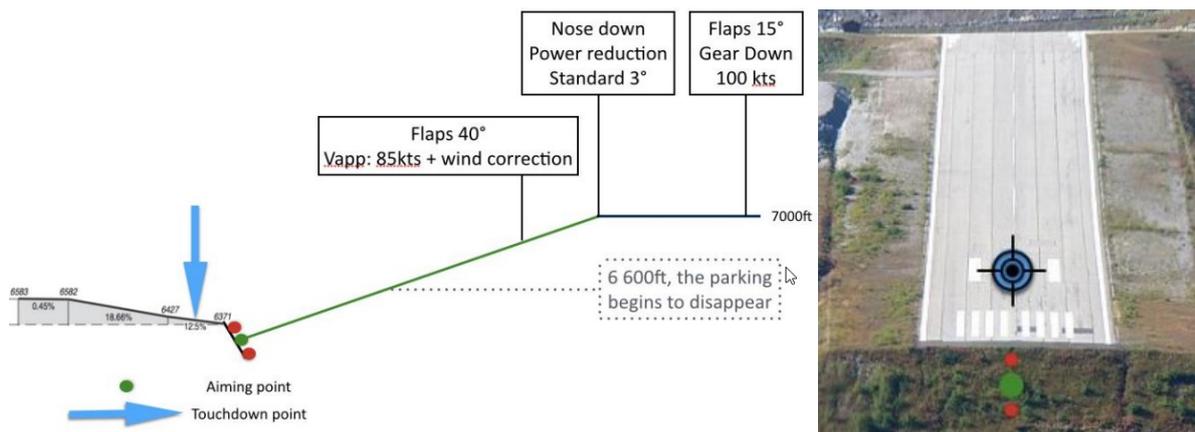
Figure 7: diagram and photo taken from EAPC OM and the instructor's theoretical briefing.

The stall speed of the PC-12 in final with no wind is 85 kt. The pilot's instructor explained that when this speed is stabilised and the aeroplane is on the slope, no input is required on the power control during the descent performed before crossing the runway threshold (about 100 m before touchdown) (see **Figure 7**). It is possible to reduce power after crossing the runway threshold. At no time on final must the aeroplane drop below the runway threshold altitude.

- updated the theoretical briefing included in the Operations Manual for Courchevel mountain airfield, in particular the approach circuit and details of the actions to be taken on approach, with a warning to never descend below the touchdown zone before crossing the runway threshold;
- updated the distribution of crew for flights to Courchevel, based on the pilots' ratings and experience: in particular, a pilot-in-command who has recently obtained the mountain flight rating for Courchevel and has completed the additional training on PC-12s at Courchevel, must be accompanied, for their first flights, by another pilot-in-command holding the mountain flight rating for Courchevel, and for subsequent flights during their first season, by a pilot (co-pilot or pilot-in-command) holding the PC-12 type rating and briefed on operations at Courchevel.
