Serious incident between
the Embraer ERJ-175 registered **PH-EXH**
and the Boeing 737-800 registered **7T-VKR**
on 5 September 2022
at Lyon-Saint-Exupéry (Rhône)

Landing on a runway occupied by an aeroplane taking off

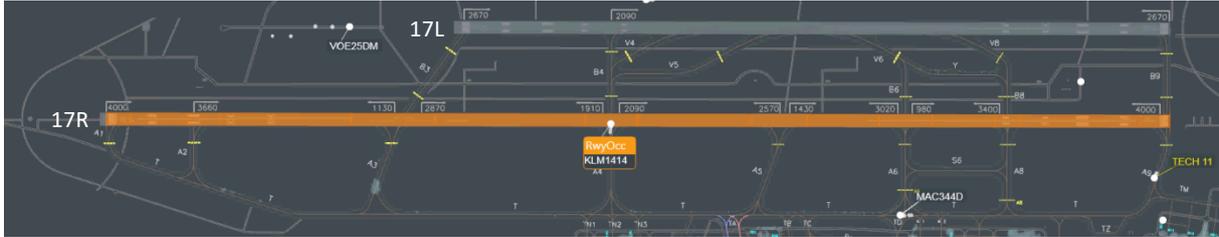
Figure 1: RwyOcc information associated with the Embraer as it crossed runway 17R, on the A-SMGCS screen (source: DSNA)

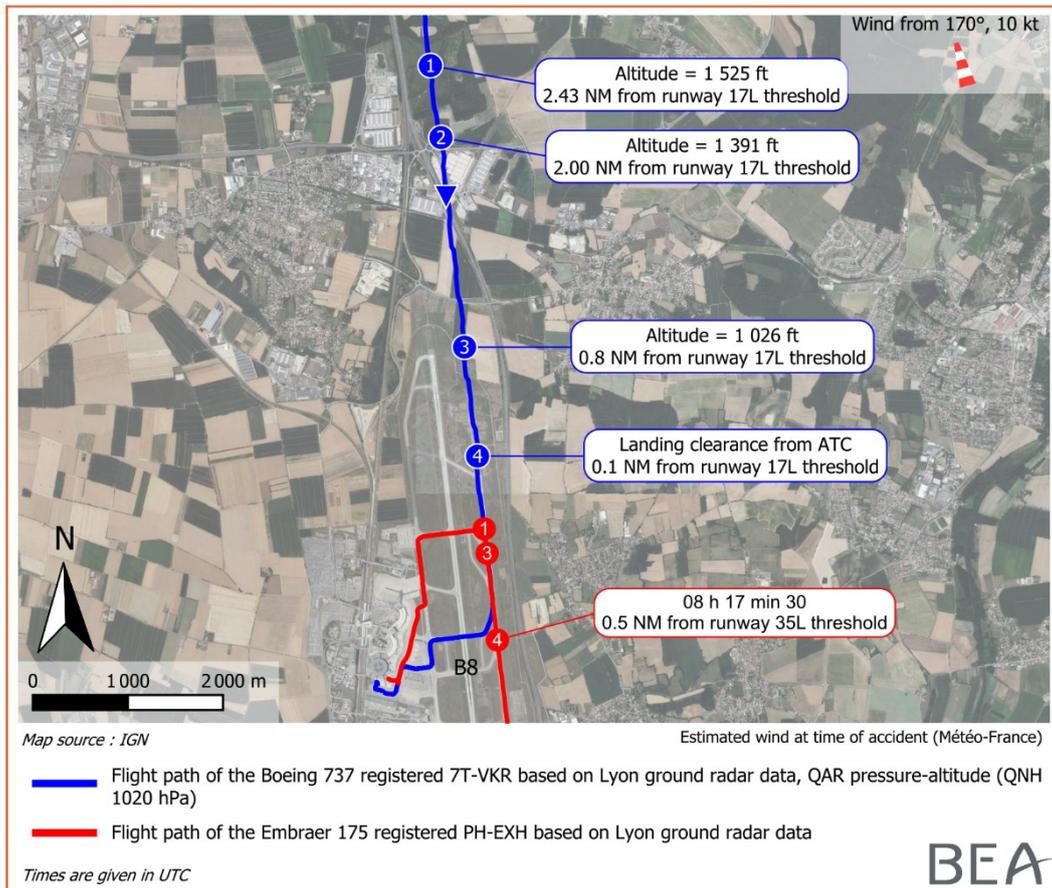
Figure 2: paths of the Boeing 737 registered 7T-VKR and of the Embraer 175 registered PH-EXH

At 08:16:31, the TWR controller cleared the Embraer crew to take off⁴ (see **Figure 2**, point ① coinciding with point ②). The Boeing was 2.4 NM from the threshold, at an altitude of 1,525 ft (see **Figure 2**, point ①). The Embraer crew immediately read this back⁵ and applied the brakes. The engine thrust started to increase at 08:16:51.

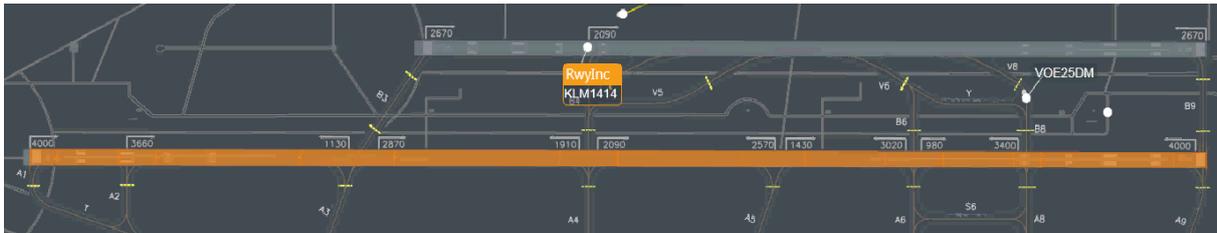
Meanwhile, at 08:16:42, the **RwyInc** information associated with the Embraer triggered on the A-SMGCS display (see **Figure 2**, point ②, as well as **Figure 3**). The **RwyInc** information was not yet visible at this time over the Boeing label on the A-SMGCS screen.

Figure 3: **RwyInc** information associated with the Embraer – The Boeing was not yet visible on the A-SMGCS screen (source: DSNA)

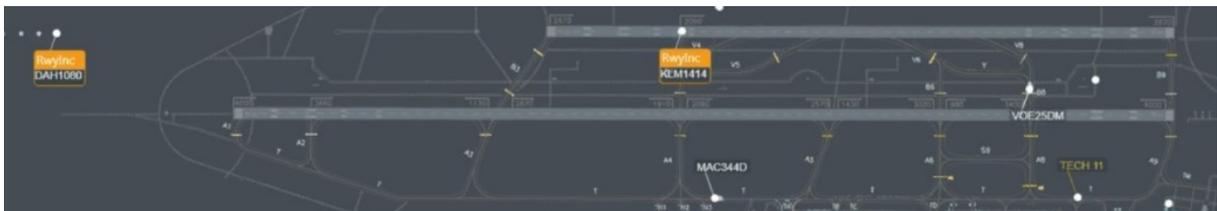
Note: on the playback video of the event on the A-SMGCS, the **RwyInc** information associated with the Boeing appeared at 08:16:57 (see **Figure 4**). However, the zoom scale used by the controller on the A-SMGCS screen was not recorded, so it was not possible to determine exactly when the **RwyInc** information was visible on the controller’s display.

Figure 4: **RwyInc** information associated with the Boeing and the Embraer (source: DSNA)⁶

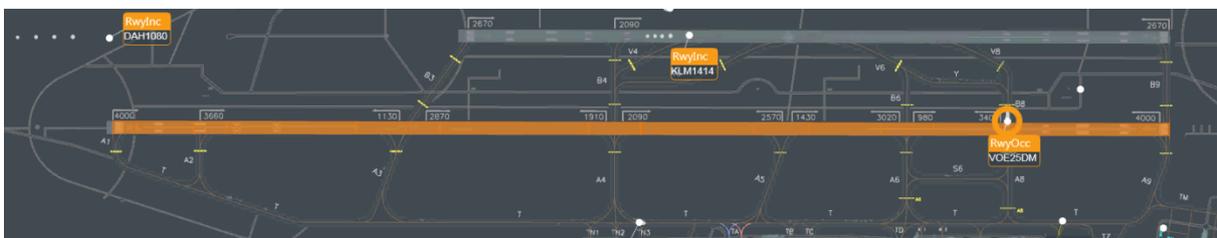
At 08:17:06, the **RwyOcc** information associated with the Airbus operated by Volotea appeared as the latter crossed runway 17R (see **Figure 5**).

Figure 5: **RwyOcc** information associated with the Airbus operated by Volotea (source: DSNA)

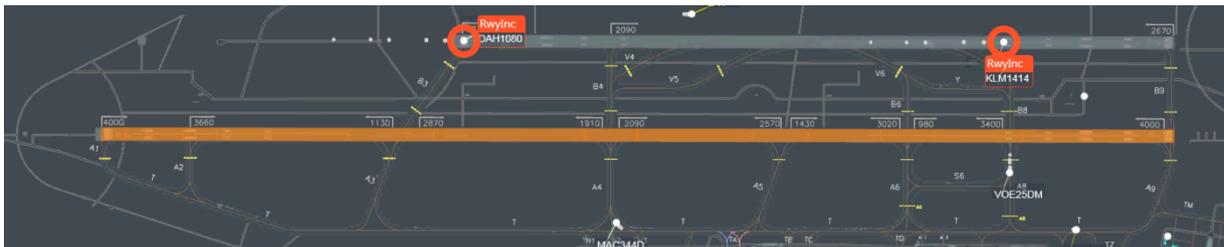
At 08:17:13, the **RwyInc** information concerning both the Embraer and the Boeing disappeared for 18 s (see **Figure 2**, points **3** and **3**). At 08:17:14, the Boeing was 0.7 NM from the threshold and the TWR controller informed the crew that the landing clearance would be given late. At 08:17:30, at the same time as the Embraer's wheels lifted off the ground, the controller cleared the Boeing crew to land on runway 17L (see **Figure 2**, point **4**). The Boeing was 0.11 NM from threshold 17L and at a height of 60 ft⁷, while the Embraer was 0.5 NM from the opposite threshold (see **Figure 2**, point **4**). At the same time, **RwyInc** alerts associated with both aeroplanes appeared on the A-SMGCS screen (see **Figure 6**). One second after these alerts appeared, the Boeing flew overhead threshold 17L.

Figure 6: **RwyInc** alerts associated with the Embraer which had just lifted off and the Boeing flying overhead threshold 17L (source: DSNA)

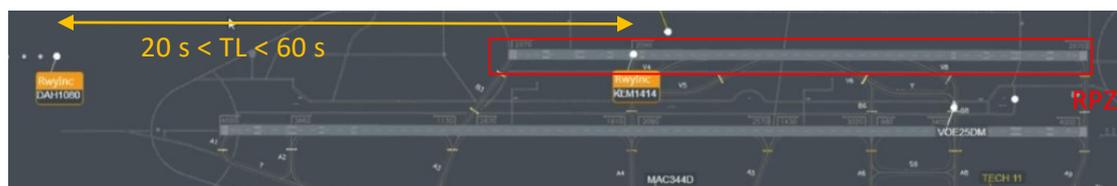
During the event, the initial **RwyInc** information displayed on both aircraft (see **Figure 11**) disappeared when the Embraer crew started the take-off run, because the TL between the two aeroplanes became greater than 60 s (see **Figure 12**). The Boeing's entry into the RPZ then immediately triggered an **RwyInc** alert on both aircraft (see **Figure 13**).

Figure 11: **RwyInc** information on the Boeing and the Embraer (source: DSNA, BEA annotations)¹⁹

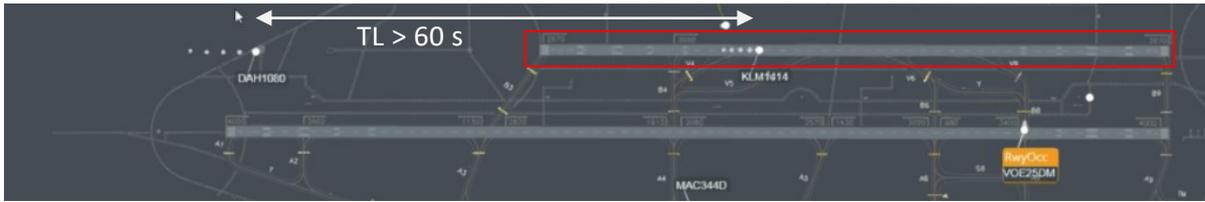
Figure 12: **RwyOcc** information on the Volotea when it crossed runway 17R (source: DSNA, BEA annotations)

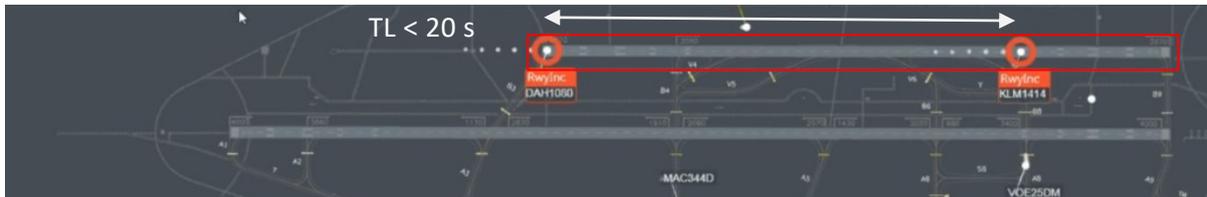
Figure 13: **RwyInc** alert on the Boeing and the Embraer when the Boeing entered the RPZ (source: DSNA, BEA annotations)
