Accident to the LANCAIR 360
registered **PH-KER**
on Wednesday 5 July 2023
close to Mulhouse-Habsheim aerodrome

**Loss of control in aerodrome circuit, collision with
vegetation and then ground**

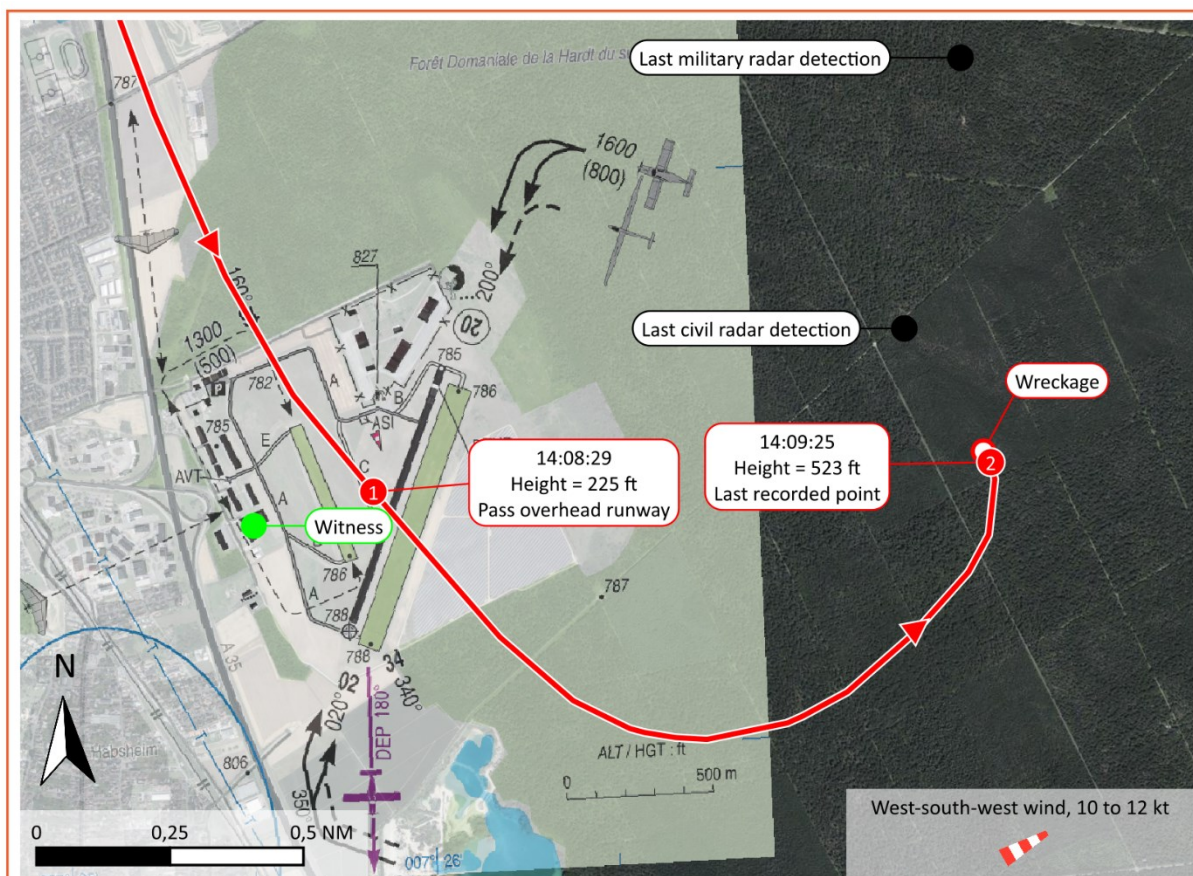
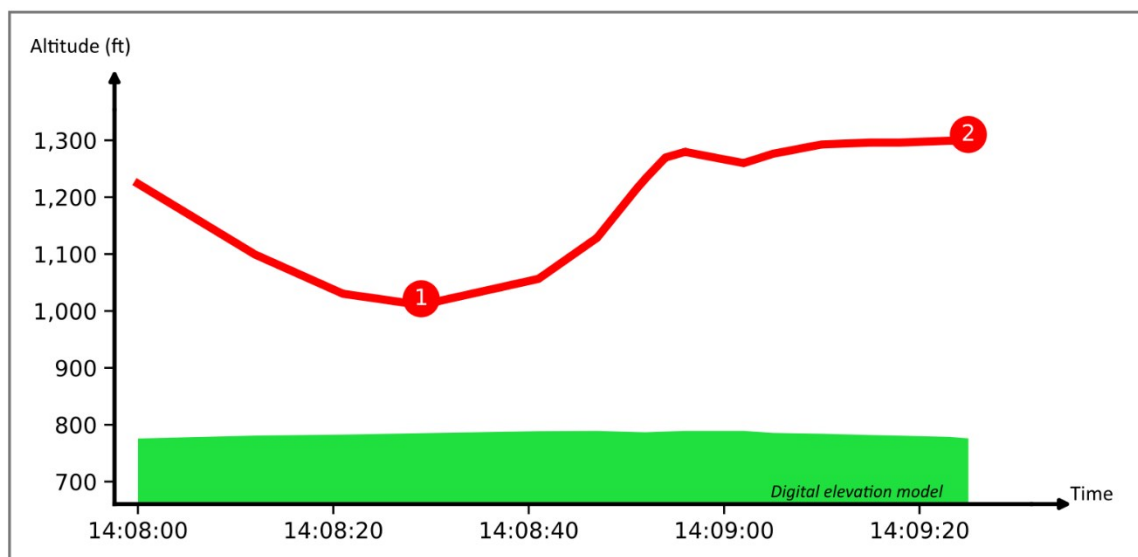
Figure 1: flight path of PH-KER

At 14:08, the pilot flew overhead runway 02/20³ at a height of 225 ft and a ground speed of 100 kt (see **Figure 1**, point ①) and then turned left in climb. The last point recorded by the on-board GNSS computer (point ②) at 14:09 indicated that the aeroplane was at a height of 520 ft with a ground speed of between 110 and 115 kt.

A witness on the ground saw the aeroplane turn left and perform what seemed to him to be a half-roll before pitching towards the ground. He then lost sight of it behind tree tops. The aeroplane collided with the ground without the witness being aware of it. Thinking that the aeroplane was carrying out acrobatic manoeuvres, he stopped watching it and returned to the hangar where he was working.

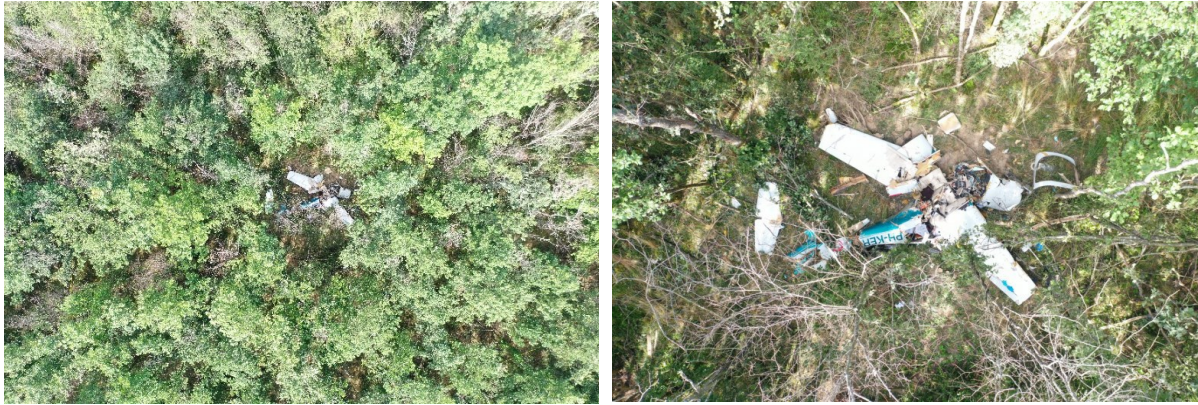
Figure 3: aerial views of wreckage (source: SRTA)

The small amount of damage to the trees around the wreckage indicates that the aeroplane collided with the vegetation on a largely vertical flight path. The examination of the wreckage found that the ruptures observed were the result of the impact with the vegetation and the ground. The aeroplane was whole and the flight controls continuous when it entered the canopy. The actuator of the flap electric motor was found in a configuration close to maximum extension. The control linkage from the actuator to the flap on the right-hand side was continuous, the control linkage on the left-hand side was found ruptured under overload (due to impact). These observations on the flap control linkage indicate that the flaps were extended in a configuration close to the landing configuration. The landing gear was extended.

The examination of the site, the wreckage and the engine-propeller assembly did not find evidence of any malfunction which could explain the accident.
