Accident to the DE HAVILLAND – DHC-6 – 300
registered **PJ-WII**
on 13 February 2019
at Saint-Barthélemy

Time	14:52 ¹
Operator	Windward Island Airways International
Type of flight	Passenger commercial air transport
Persons on board	Captain, co-pilot, four passengers
Consequences and damage	Ramp agent seriously injured

**Ramp agent injured by rotating propeller,
at apron position**

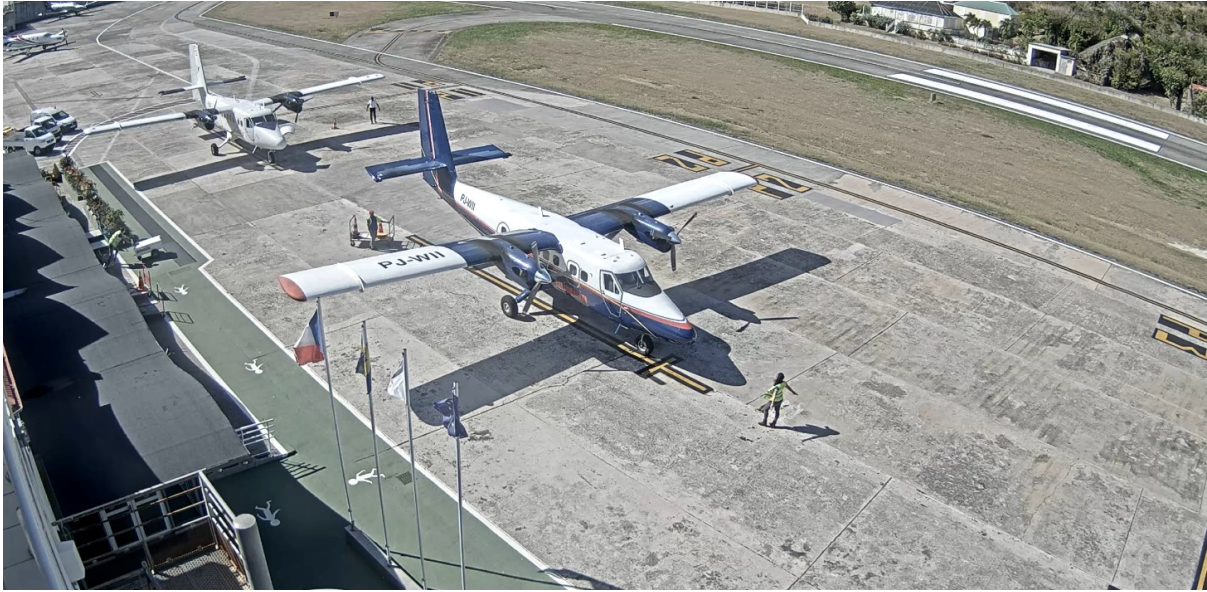
**Figure 1: marshaller guiding PJ-WII on its arrival at apron position
(source: surveillance video)**

The crew feathered the propeller blades of the two engines and the marshaller, standing on the left side of the aeroplane's nose, positioned the chocks around the nose gear wheel. She then walked around the front of the Twin Otter and turned to make a sign with her arms to someone she knew in the terminal building. She walked backwards down the right side of the airframe. The anti-collision light was still operating.

As she passed the right engine propeller which was still rotating, she was struck on the head by a blade which seriously injured her.

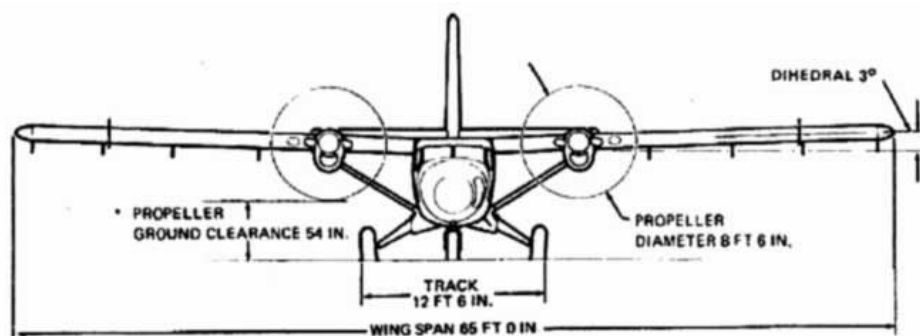
Figure 3: description of DHC-6 Twin Otter (source: Pilot Operating Handbook)

Note: 8 ft 6 in = 2.5908 m / 54 in = 1.37 m

The lowest point of the propeller disk is at 1.37 m from the ground.

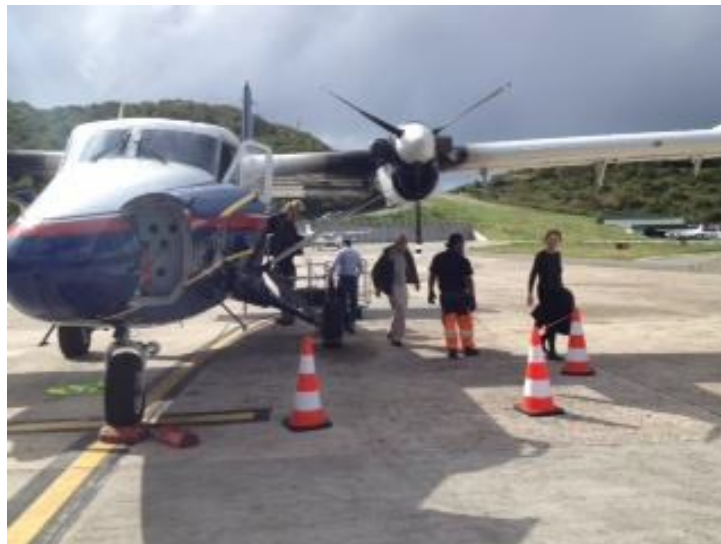
- Anti-collision lights on = engines operating or about to be started up.
- It is recommended to pay particular attention to the propellers as they cannot be easily seen when they are rotating and furthermore may be silent, especially after the shut-down of the engine. It is therefore recommended to wait for the propellers to come to a complete stop before moving around the aircraft and, even when stopped, to always maintain a distance with respect to the propellers.
- During the ground operations, it is advisable to mark out the aeroplane’s footprint on the ground using cones, tape, etc. at least at the wing tips, positioned at a distance of 1 m. Cones or tape can also be positioned under the tail and in front of the engines (see Figure 3).

Figure 3: position of cones around engines (source: safety booklet)
