## Serious incident

between the De Havilland DHC-6 registered **PJ-WIX** operated by Winair and the Pilatus PC12 registered **N590TW** operated by Tradewind Aviation on Wednesday 29 January 2025 on Saint-Barthélemy airport

## Landing on an engaged runway

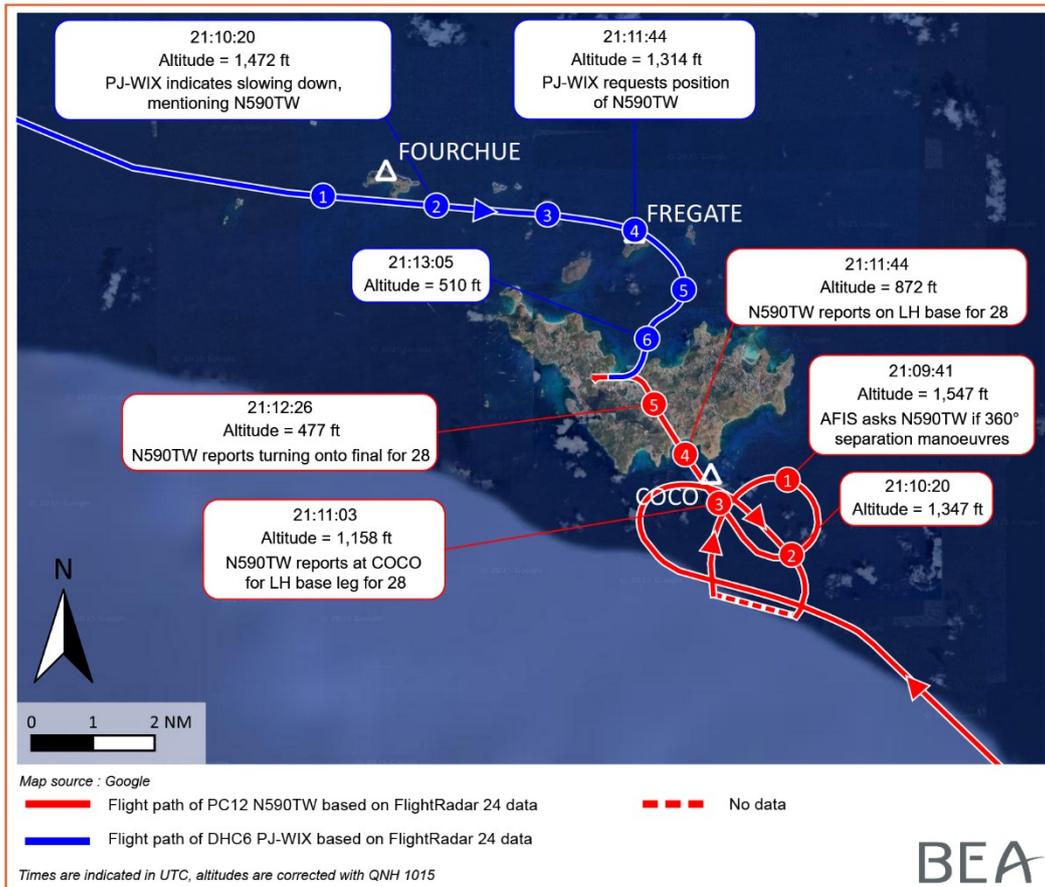
Figure 1: flight paths - overall view (source: BEA)

From 21:07, the crew of N590TW carried out 360° separation manoeuvres south of point COCO (see **Figure 1**, point **1**) due to traffic in front of them on approach to land on runway 28. At the same time, the crew of PJ-WIX were approaching FOURCHUE. The AFIS officer informed the two crews of their respective position in the approach sequence. The crew of PJ-WIX indicated that they were slowing down and mentioned N590TW (point **2**).

At 21:11:03 (point 3), the crew of N590TW reported that they were at point COCO for a LH approach to runway 28.

At 21:11:44, the crew of PJ-WIX asked for the position of N590TW. The crew of N590TW reported that they were on the LH base leg (point 4) and then at 21:12:26, that they were turning onto final for runway 28 (point 5).

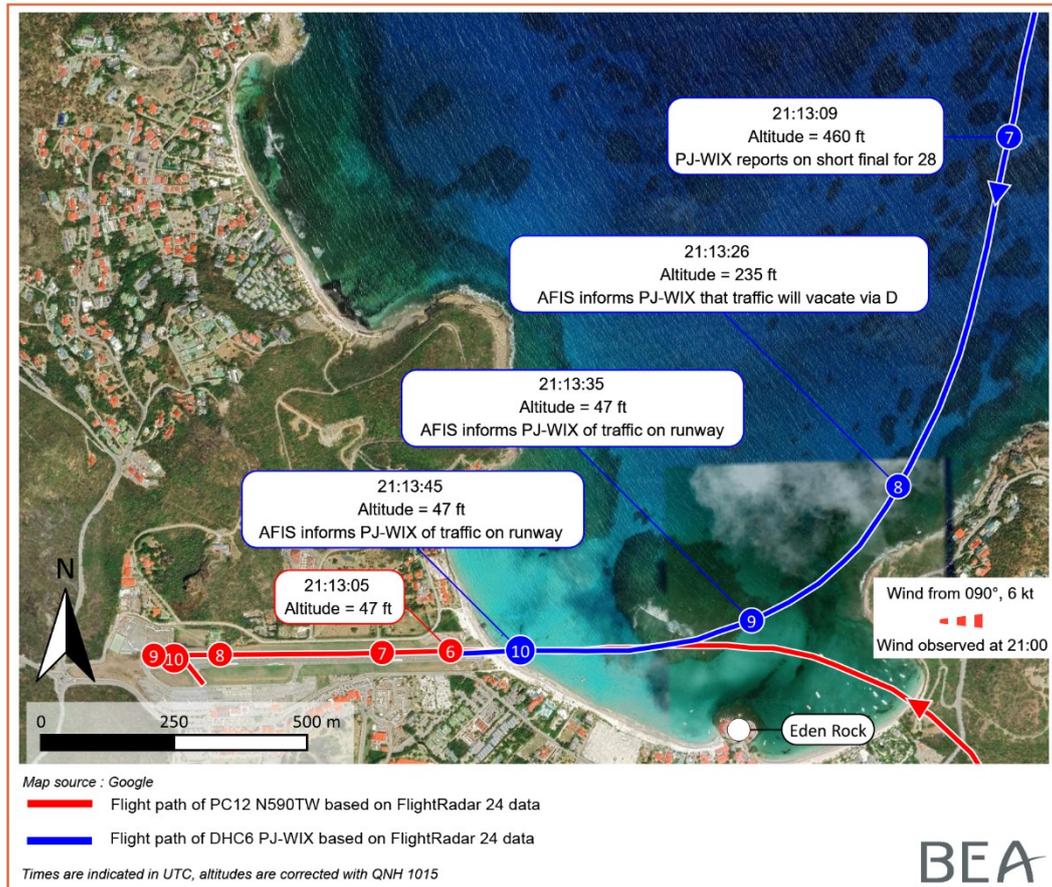
Figure 2: flight paths - detail view (source: BEA)

At 21:13:05, the crew of N590TW landed on runway 28 (see Figure 2, point 6). Four seconds later, the crew of PJ-WIX reported that they were on short final. At this point, they were at the end of the RH base leg for runway 28 (point 7).

At 21:13:26, the AFIS officer warned the crew of PJ-WIX who were then turning onto the final approach (point 8) of traffic<sup>4</sup>, "Caution traffic has to vacate by D<sup>5</sup>". The crew of PJ-WIX did not acknowledge the message. At the end of the landing run, without transmitting a message on the frequency, the crew of N590TW veered onto the paved strip situated on the RH side of the runway (see paragraph 2.2.1), carried out a LH U-turn and then started backtracking the runway.

At 21:13:35, the AFIS officer again warned the crew of PJ-WIX of the presence of the preceding aeroplane on the runway. PJ-WIX then arrived abeam EDEN ROCK (point 9) which constitutes the point beyond which the crew cannot carry out a missed approach; the crew briefly pushed the push-to-talk by way of a readback. The AFIS officer repeated the information ten seconds later when PJ-WIX was on short final at 47 ft (Point 10). The crew of PJ-WIX landed as the crew of N590TW backtracked the runway before vacating it via taxiway "B".

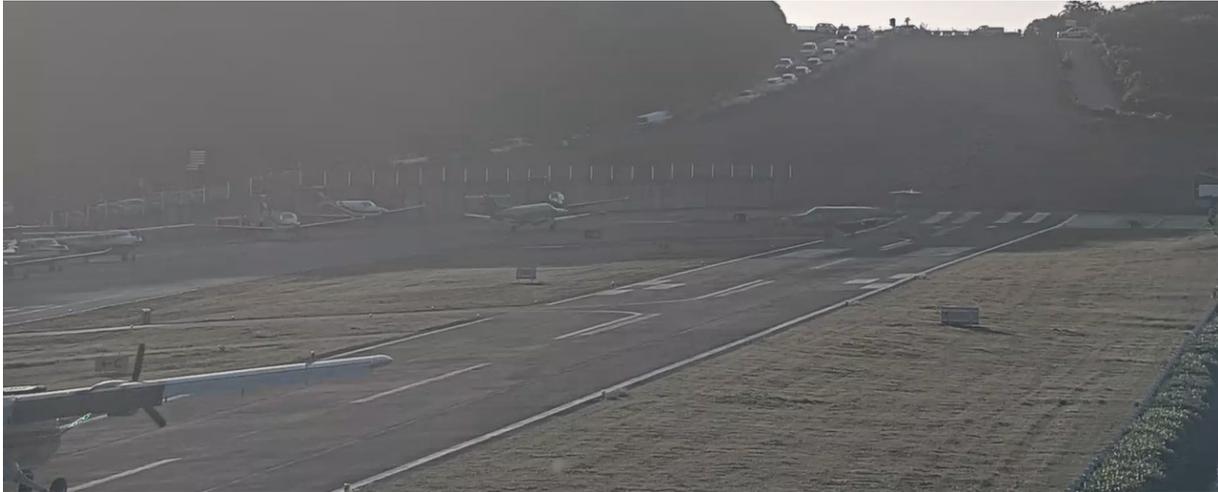
Figure 3: image from security camera recording  
(source: aerodrome operator)

In the image from the security camera recording (see Figure 3), PJ-WIX can be seen (at the bottom LH side) carrying out its landing run. At this point, it was around 360 m from the intersection with taxiway "B" which the crew of N590TW were taking to vacate the runway.
