**Accident** to the BOEING - 737 - 800 - 8JP  
registered **SE-RPE**  
on 25 July 2021  
en route to Nice

## **Turbulence en route, severe injury to a cabin crew member, emergency landing at destination**

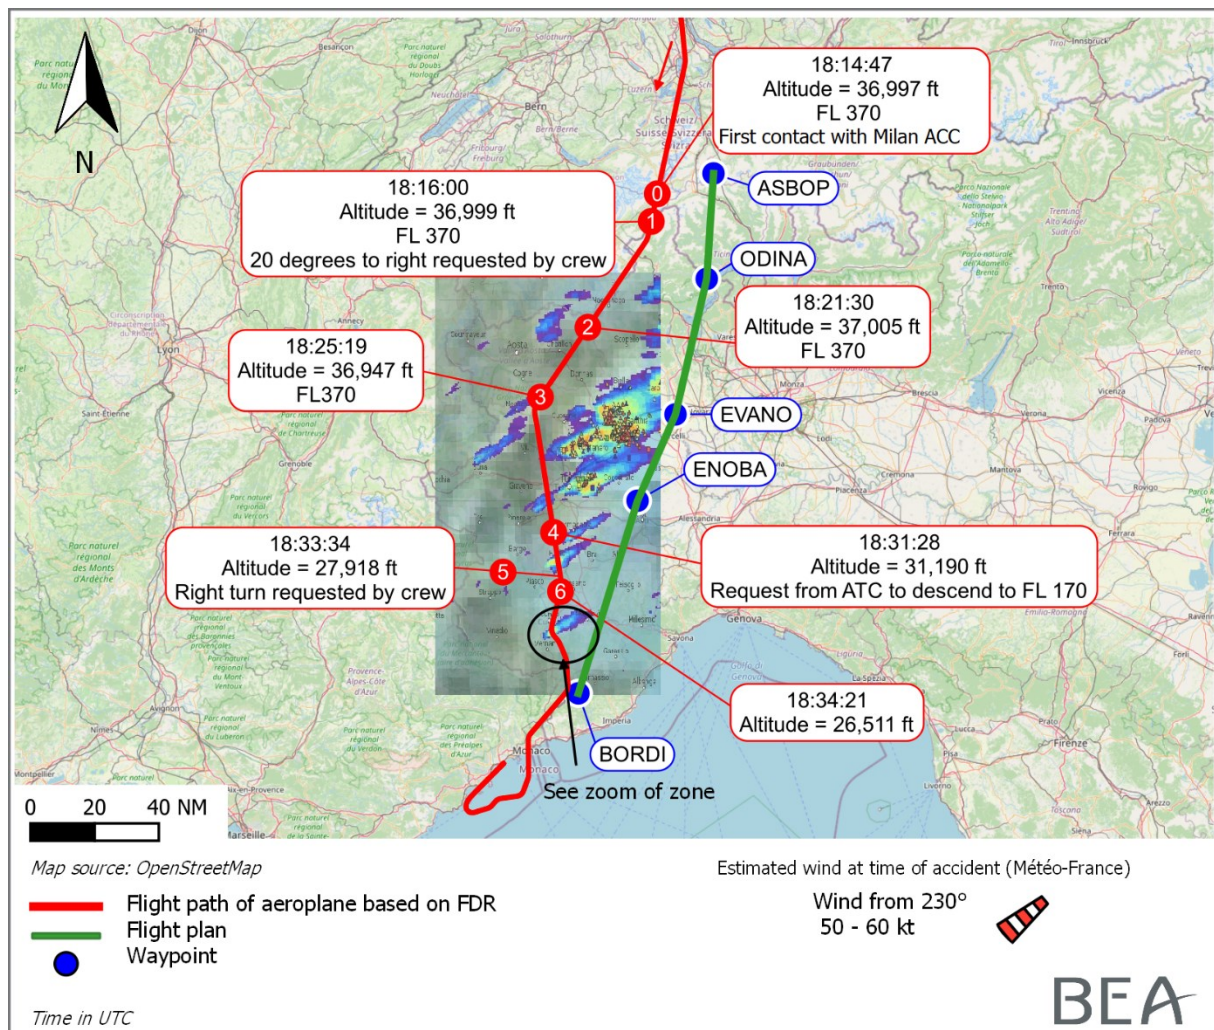
**Figure 1: path of the aircraft superimposed over the Météo-France radar image at 18:40<sup>8</sup>**

At 18:14:47, the crew contacted the Milan Area Control Centre (Milan ACC) and reported that they were on heading 195° in order to avoid storm cells (see Figure 1, point **0**). The aircraft was then at Flight Level 370 (FL 370).

At 18:16, the crew requested approval to carry out an avoidance manoeuvre by deviating 20° to the right (see Figure 1, point ①). The controller authorised the manoeuvre. Around five minutes later, the flight was transferred to another Milan ACC control sector. At this moment, the crew were discussing the large storm cells to their left.

Upon first contact with this sector at 18:26:09, the crew received approval to descend to FL 310 then to FL 270 and lastly to FL 170 with the controller requesting that they reach this level before BORDI (see Figure 1, point ④).

At 18:33:34, the crew requested “20° to the right to avoid” from the Milan ACC (see Figure 1, point ⑤). The controller approved the manoeuvre and asked the crew to stop their descent at FL 210.

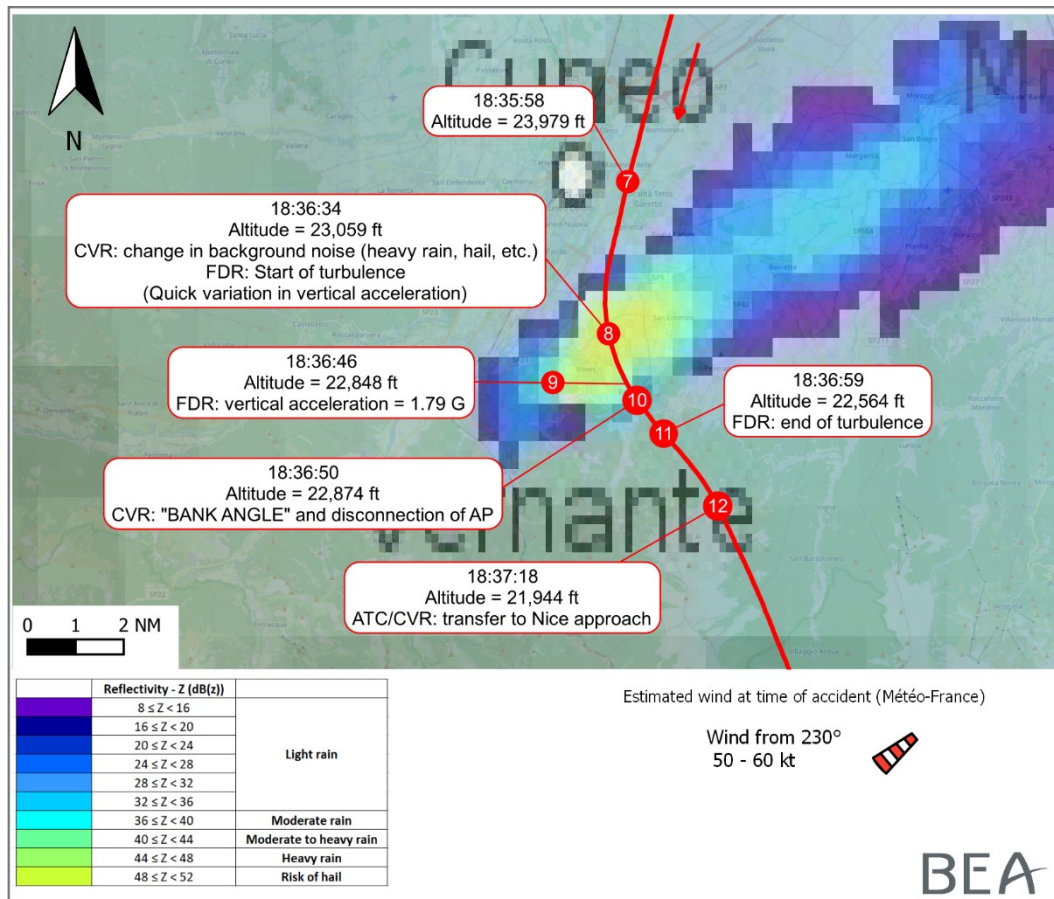
Figure 2: zoom in on the path at the time of the accident

At 18:34:21, the controller asked the crew over what distance they wanted to maintain this heading<sup>4</sup> (see Figure 2, point ⑥)<sup>5</sup>. The crew said that they needed to maintain it for a further 10 NM.

At 18:35:58, the crew notified the controller that they were able to head towards BORDI waypoint (see Figure 2, point ⑦). The controller authorised the manoeuvre and asked the crew to descend to FL 170 in order to be at this level on reaching BORDI waypoint. The crew read this back.

At the same time, the PF announced, "*Engine anti-ice on*". One second later, there was a change in background noise (see Figure 2, point 8), as if there was heavy precipitation pelting down on the cockpit windshields.

At 18:36:46 (see Figure 2, point 9) the recorded vertical acceleration<sup>7</sup> reached + 1.79 g, decreased to 0.38 g in the following second, and then rose to + 1.52 g in the next two seconds.

At 18:36:50, the roll angle reached a maximum of 35.5°. The "BANK ANGLE" synthetic voice message was activated. The PF disconnected the autopilot (see Figure 2, point 10). The vertical acceleration decreased to 0.27 g, then increased again to 1.67 g in the following two seconds. During this two-second phase, the speed decreased from 272 kt to 250 kt.

At 18:36:59, the turbulence stopped (see Figure 2, point 11).

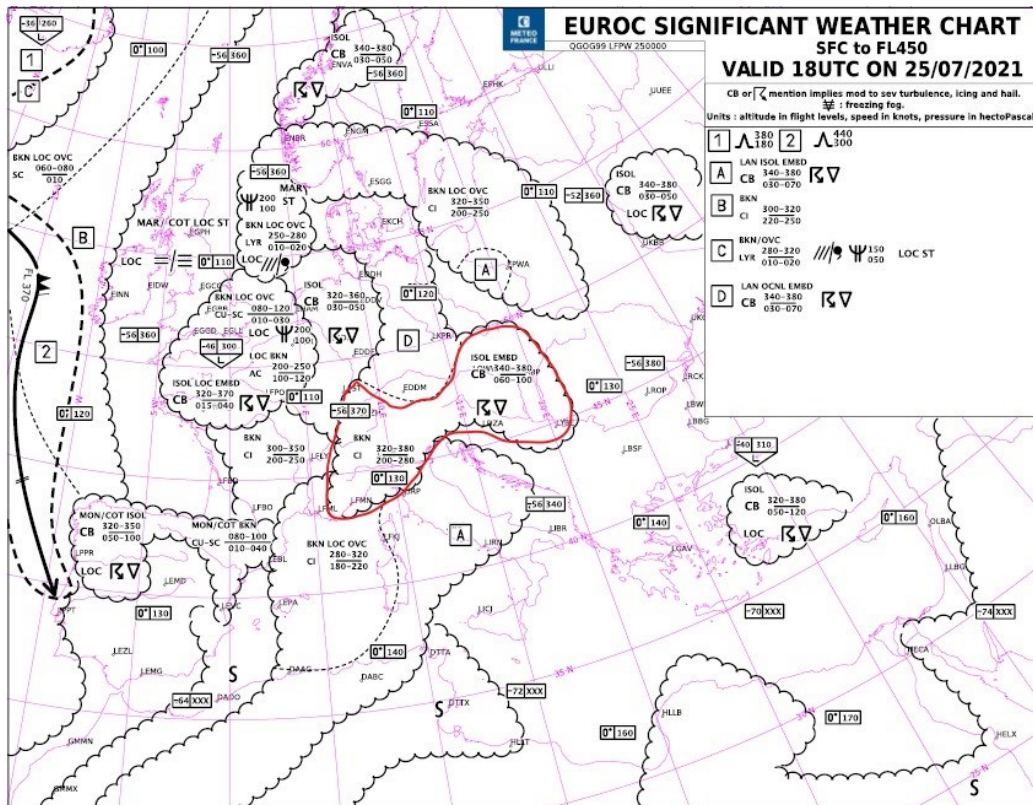
Figure 3: SIGWX chart valid at 18:00 (source: Météo-France)

The area circled in red on the SIGWX chart incorporates the accident site, and indicates:

- isolated CB, base FL 060 - FL 100, top FL 340 - FL 380;
- broken cirrus clouds, base FL 200 - FL 280, top FL 320 - FL 380;
- a 0° isotherm at FL 130.

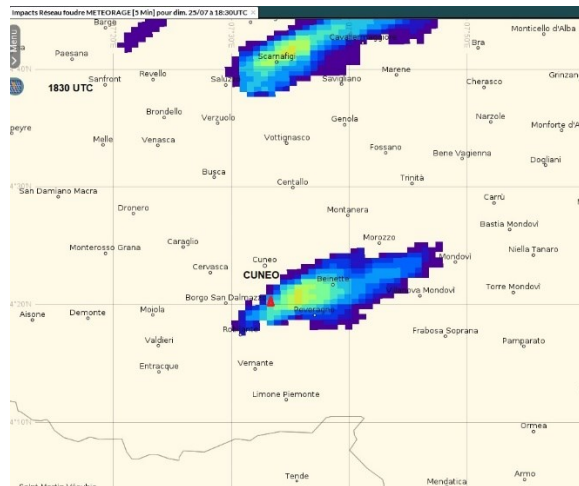
**Figure 4: situation at 18:30 (Source: Météo-France)**

An isolated convective cloud formed between 18:15 and 18:20 less than 10 km to the south of Cuneo (Italy), in the vicinity of the position indicated as the occurrence site. This almost-stationary convective cloud extended rapidly between 18:20 and 18:40, generating heavy showers with no thunderstorm activity, which made it difficult to decide whether it was a TCU with a long vertical extension or a CB; it dispersed as quickly as it had formed between 18:50 and 19:00.

The red triangle shows the position of the accident (each square measures 40 km x 40 km)

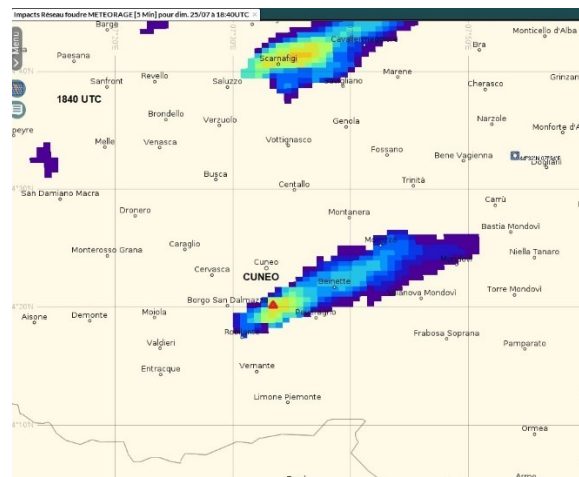
**Figure 5: situation at 18:40 (Source: Météo-France)**

The red triangle shows the position of the accident (each square measures 40 km x 40 km)

The area of strong convection slightly moved to the west, in the opposite direction to the southwesterly wind, and was located just below the accident site. The showers were moderate to heavy. No lightning strike was detected but this situation usually causes windshear and severe turbulence.
