## Final Report

**EgyptAir A320 Aircraft crash in the Mediterranean, registered SU-GCC,  
flight number MSR804, from Charles De-Gaulle Airport, Paris to Cairo  
International Airport, on 19/05/2016**

EGAI2016-01

October 2024

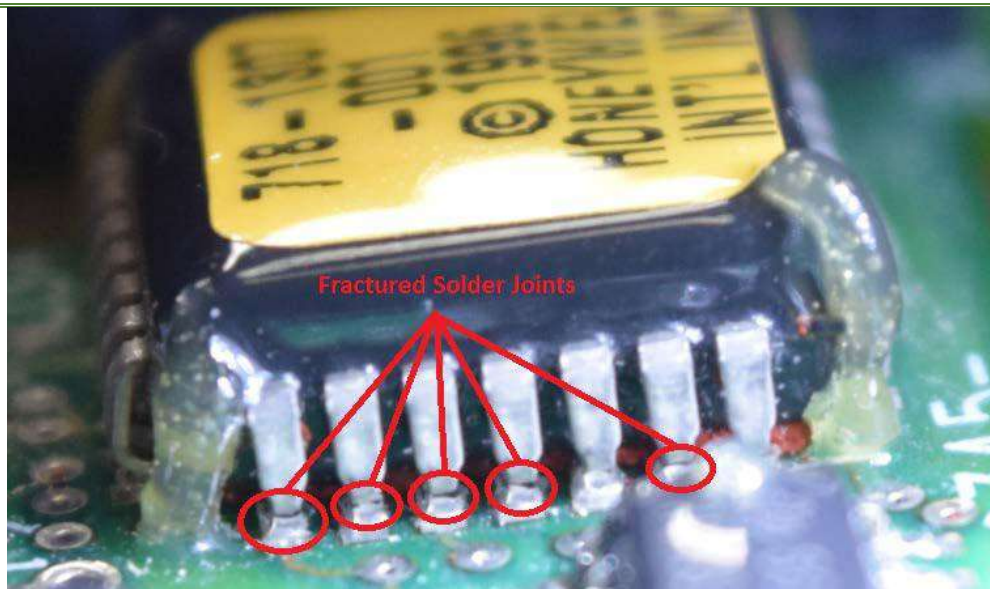
Figure 1.11/3: Solder Joint Fractures

Honeywell was advised of this small difference and assisted the Technical Group assessing the issues and reviewing the memory board schematic to identify a possible cause of the failed downloads. Pin 24 of the connector is a direct connection to pin 2 of the PAL chip. (The PAL is the chip on the memory board that manages the memory interface addressing from the SSFDR chassis). A microscopic examination of the PAL leads and solder joints was performed. The examination of the soldering points showed that more than 50% of the pins were fractured at or near the solder joints. Figure 1.11/3 shows the fractures on the pin 18–25 edge of the PAL.

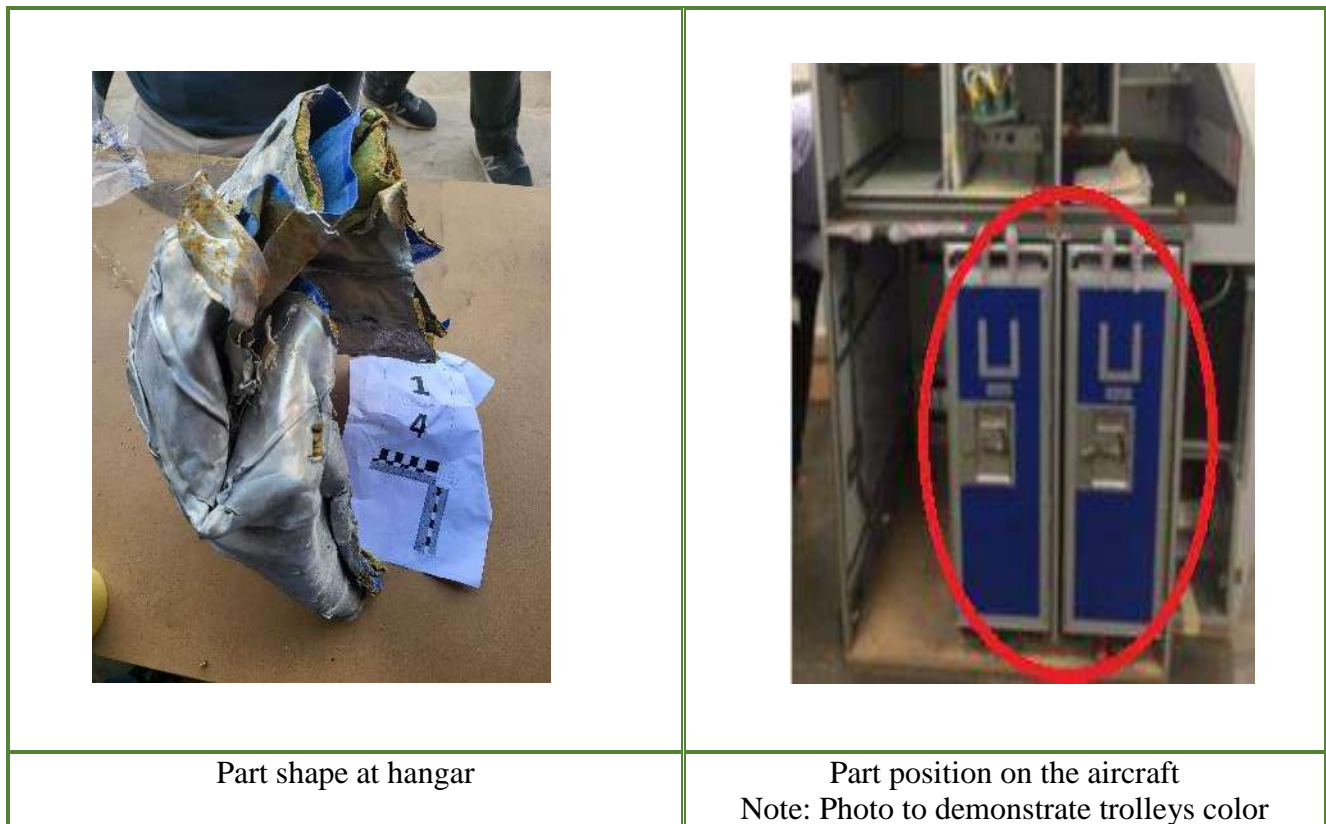
Figure 2.11/1: Food trolleys

- Two sides of two trolleys were twisted inside-out together with a part of galley composite wall stuck within. The trolley tray tracks were so worn out probably due to gas wash.

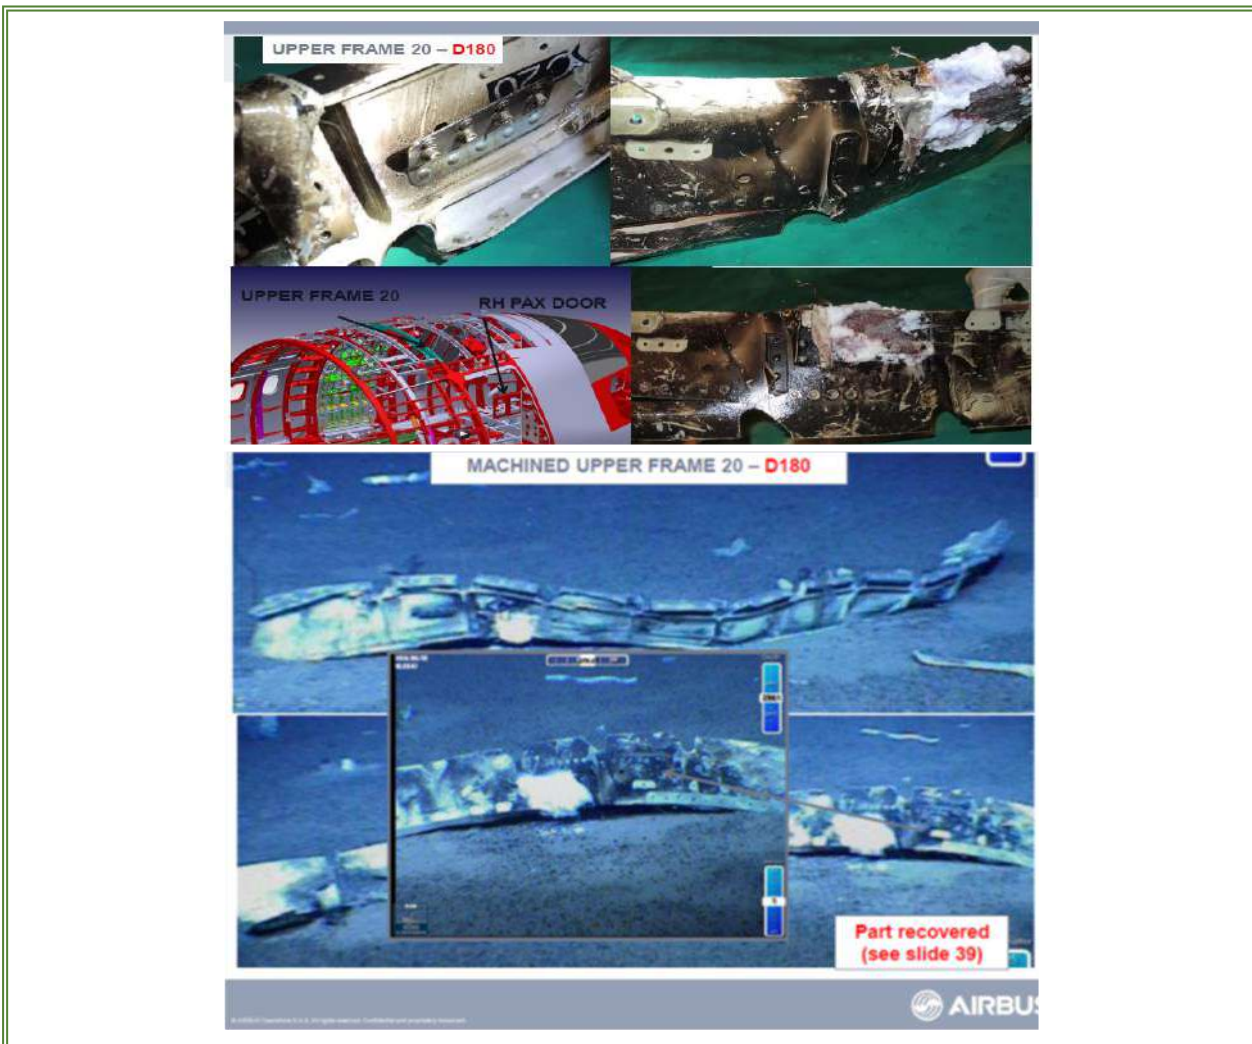
Figure 2.11/2 : Upper central segment of frame 20 Food trolleys

- The original crescent shape has deflected backward out of its original vertical plane.
- A bend was found in the center and edge.
- A change in the original metal color was identified on both edges.

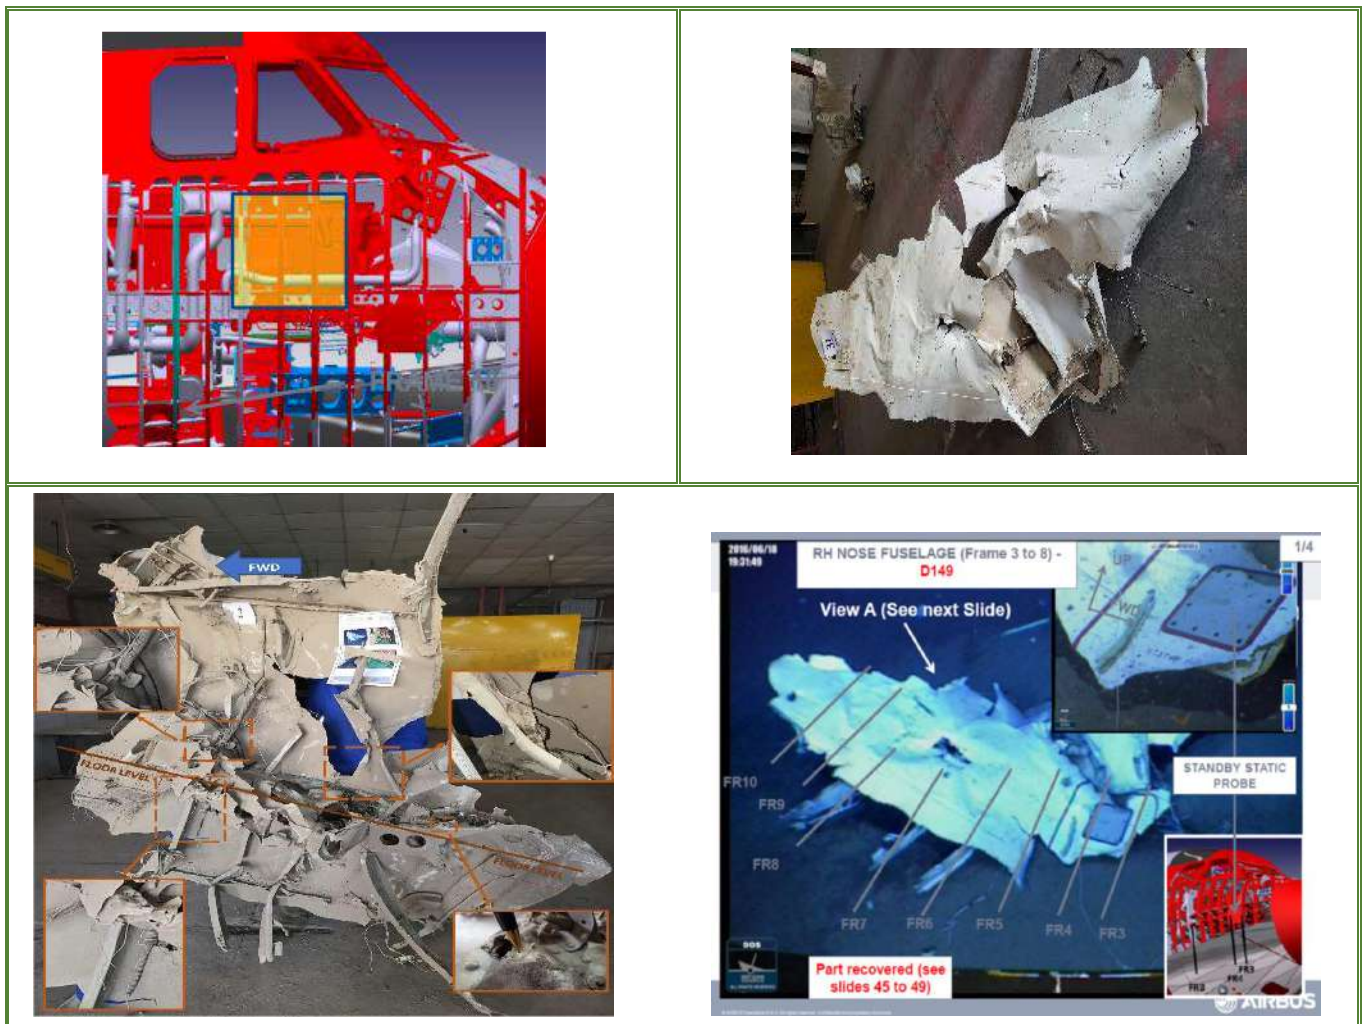
Figure 2.11/3 : Forward fuselage part with stand by static port

- Stringers /frames deformed outward in a backward direction.
- Electric cables with their insulation seemed to be normal (no apparent heat effect).
- A puncture was identified in the middle of the part.
- All edges were torn off, and dark spots were noted in the internal lower part
- Skin rolled outward and stringers bent outward.

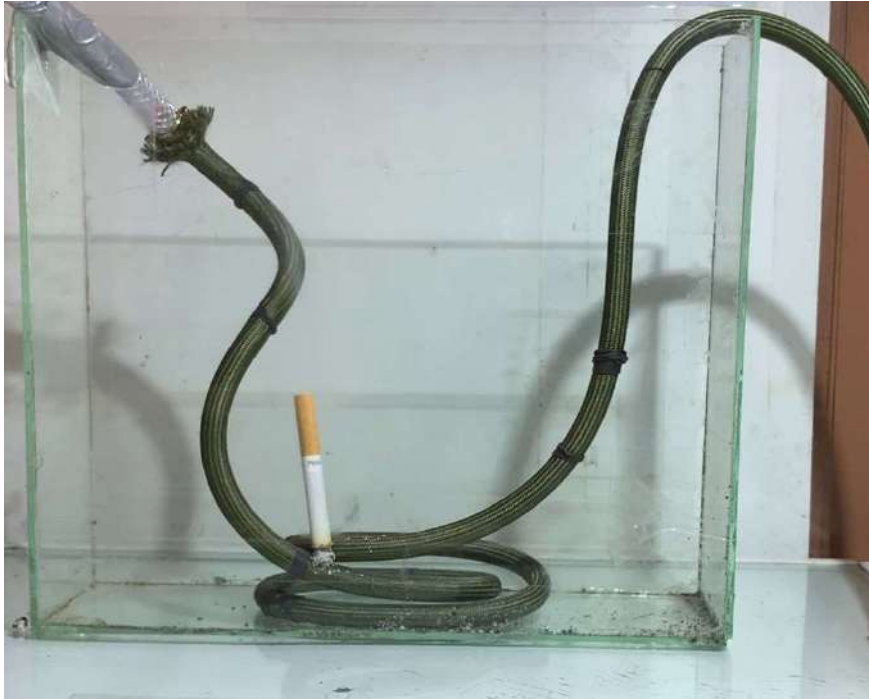
**Figure 29: open-air test (source: BEA)**

Thus, in the test conditions, a glowing cigarette placed in an open-air enclosure in contact with a pressurised oxygen hose did not damage the system or start a fire. The absence of damage is consistent with the certification, which requires equipment manufacturers to use fire-resistant materials to limit the outbreak and spread of fires.

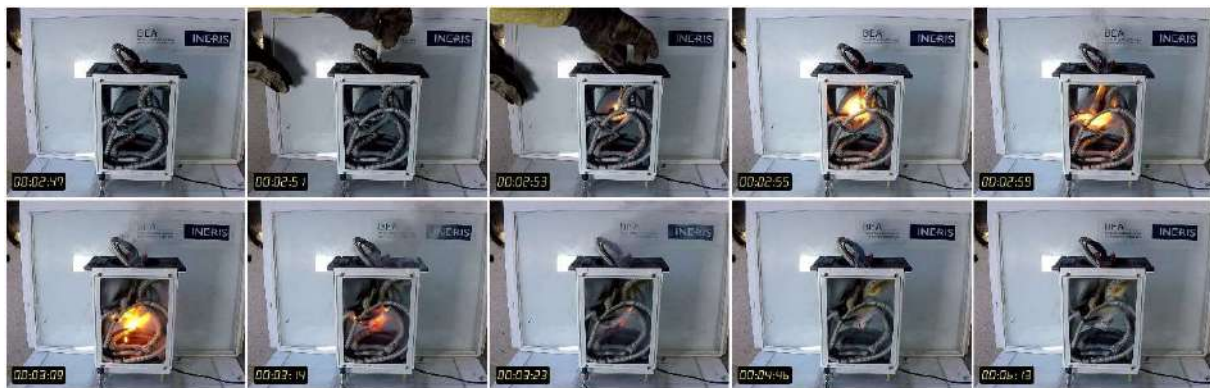
Figure 31: cigarette\_01 test - video sequence (source: BEA)

During the first test (Cigarette\_01), the cigarette landed on the mask's harness and perforated it. The fire did not spread to other parts of the mask and extinguished.

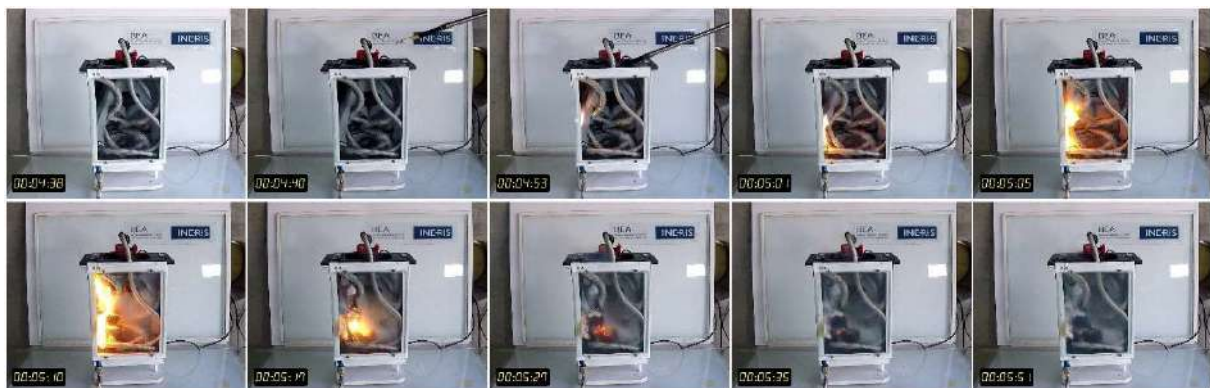
Figure 32: cigarette\_02 test - video sequence (source: BEA)

During the second test (cigarette\_02), the cigarette landed on the silicone envelope of the oxygen mask nose cup and began to consume this part of the mask. When the oxygen contained in the box was consumed, the intensity of the fire decreased and the fire went out.

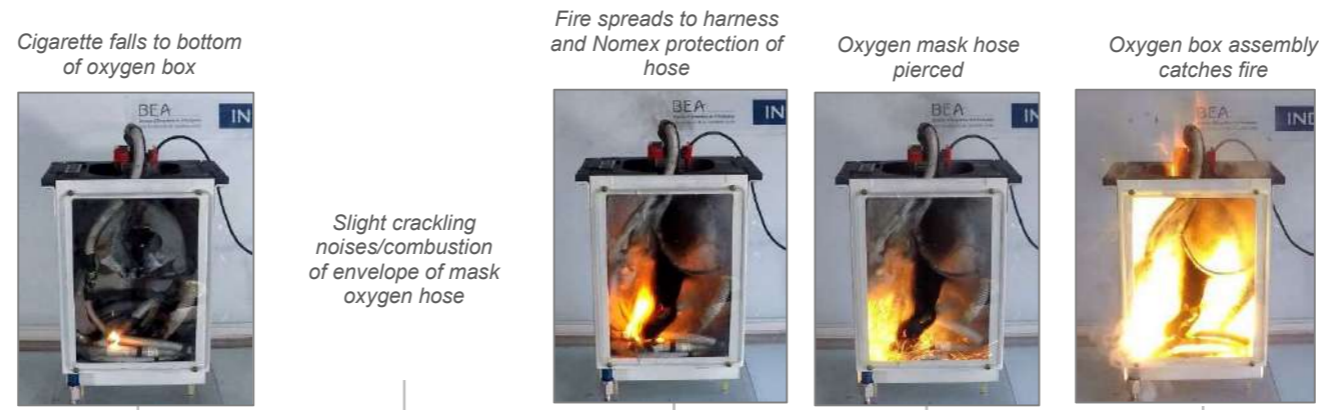
Slight crackling noises/combustion of envelope of mask oxygen hose
