Ministry of Transport and Civil Aviation of Federal Republic of Somalia

Aircraft Accident Investigation Branch

Final Report

Accident to the AIRBUS - A321
registered **SX-BHS**
operated by Daallo Airlines
on 2nd February 2016
On initial climb from AD Mogadishu
(Somalia)

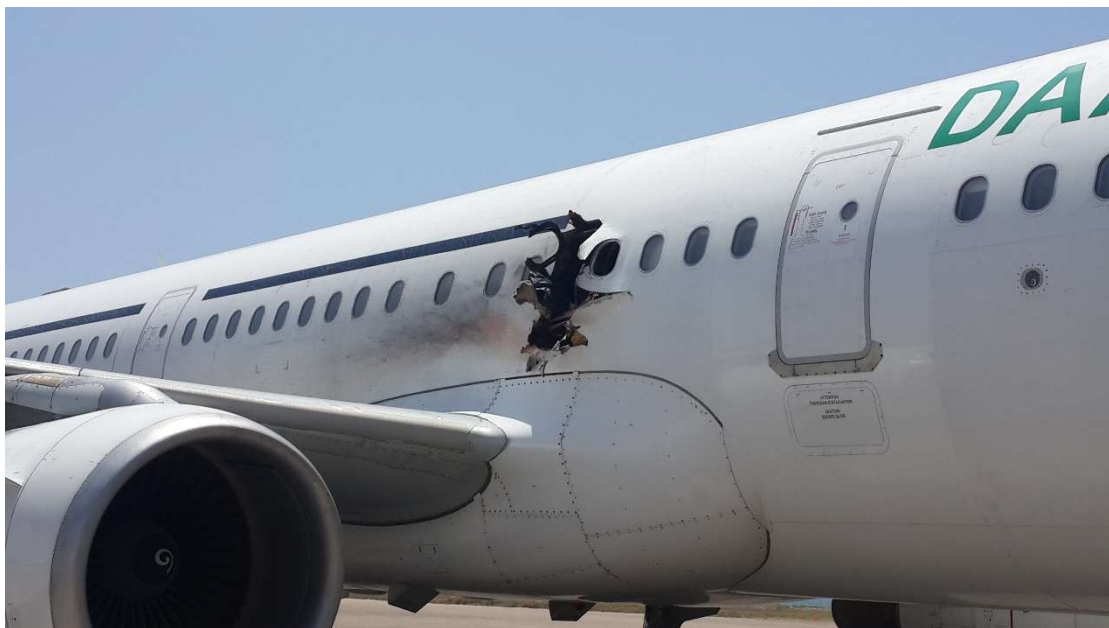
Fuselage was perforated on its right hand side on approximately 1 square meter at the level of row 16 around frame (FR) 35.8, between the wing and the emergency door 2.

Aircraft picture taken after landing

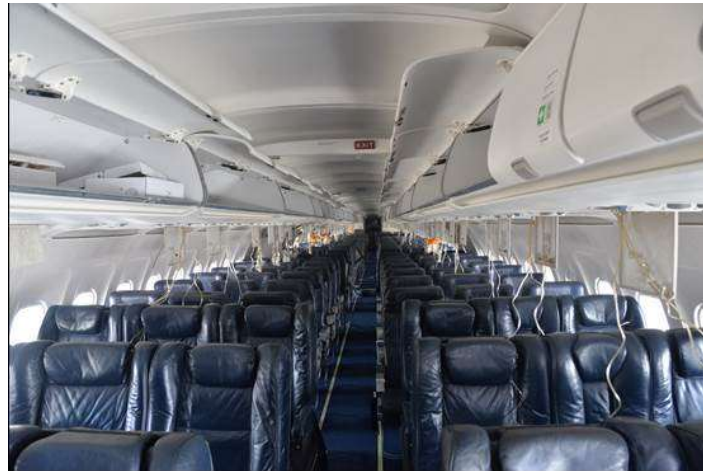
During cabin inspection, a number of oxygen masks were observed to be deployed.

Cabin interior forward looking aft

From the observations made and the pilot report, the masks have probably dropped following the dynamic overpressure (blast) inside the cabin.

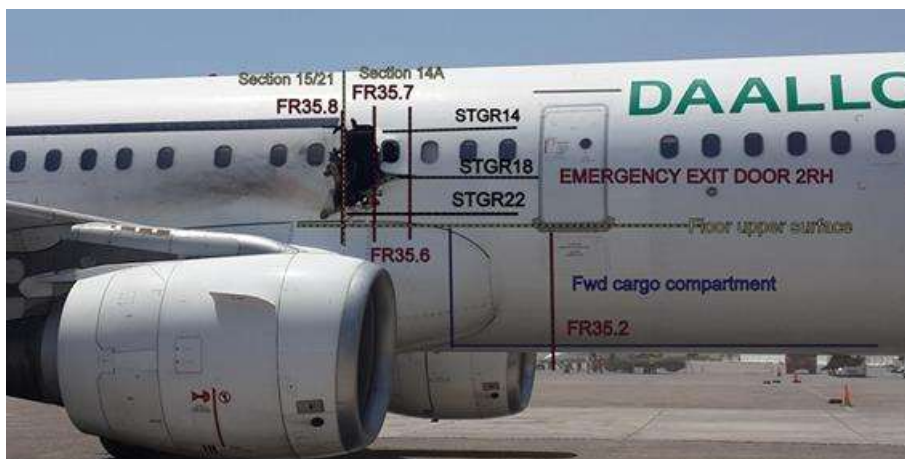
Main fuselage damage area was observed on the right hand (RH) side of the fuselage between frames FR 35.8 and FR 35.6, and stringers (STGR) STGR 14 and STGR 22.

The fuselage showed a separation of the skin from stringers and frames associated with outwards deformation.

General view of the fuselage perforated area

The fuselage structure showed evidence of skin failure mode in dynamic shear consistent with a dynamic internal overpressure located between frames 35.7 to 35.8, stringers 18 to 20RH, above the passenger floor.

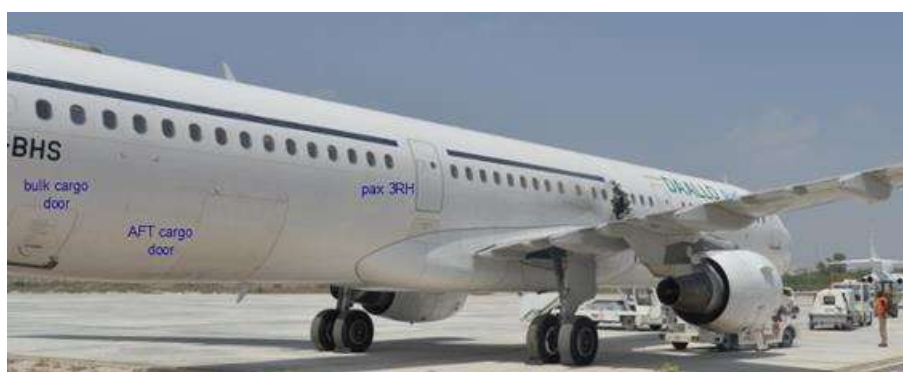
All passenger doors, forward and aft cargo doors and bulk cargo doors were in expected position (closed).

Right hand fuselage doors views

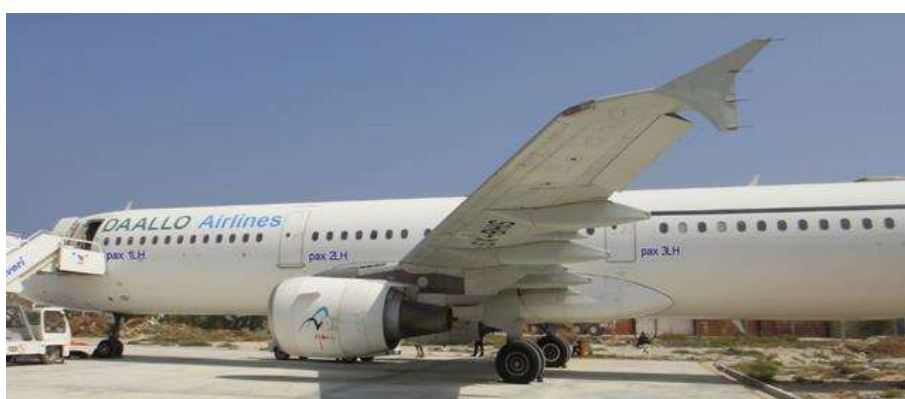
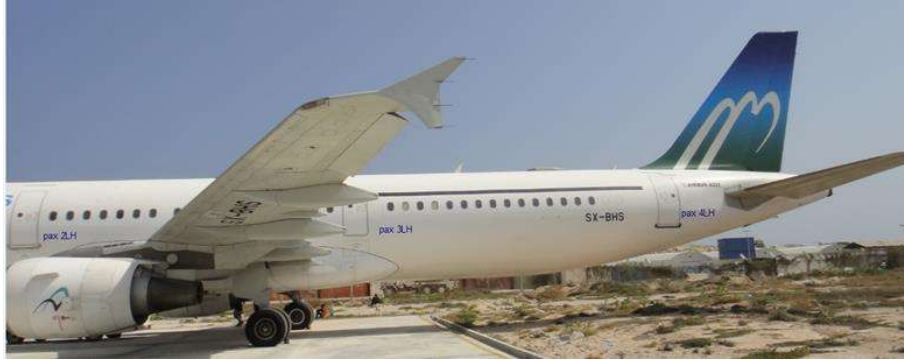
Left hand side of the aircraft did not present any visible damage:

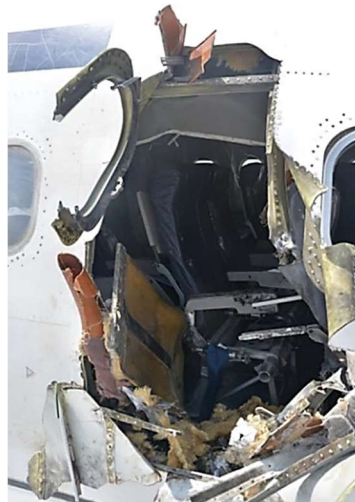
There was an overall outward deformation of the skin and the stiffening structure. Part of the fuselage skin was pull-out from fastening lines of stringers, frames and windows.

Figure 1 - Skin missing

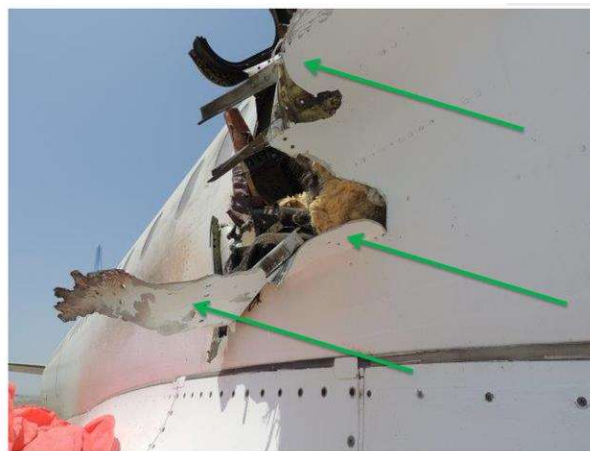
The skin was damaged in multi fragments without any sign of shear:

Figure 2 - Skin damaged in multi fragments

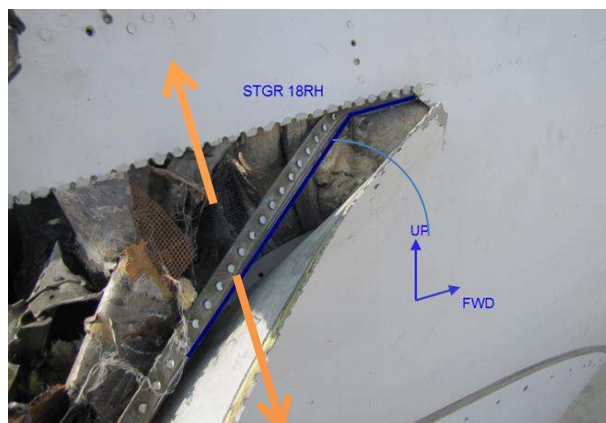
Ruptures along the rivet lines of skin attachment to stringers and frames are observed to be tension ruptures.

Figure 3 - Tension rupture at STGR 18 RH riveting line

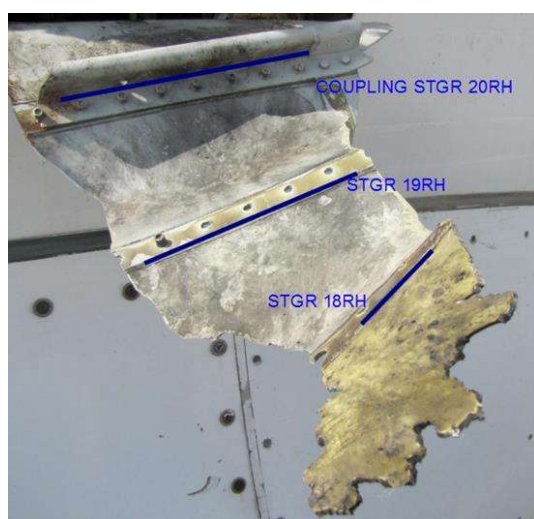
The damaged skin, in its inner face, showed overheated and melted areas at fragmental impact locations (indicated by blue arrows).

Figure 4 - Skin showing overheated and melted areas

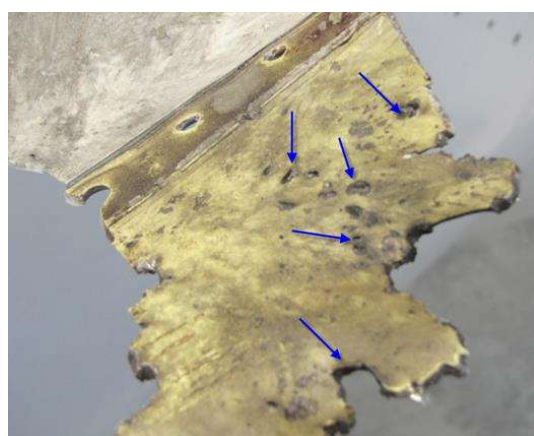
Figure 5 - Skin with burnt marks and impacts

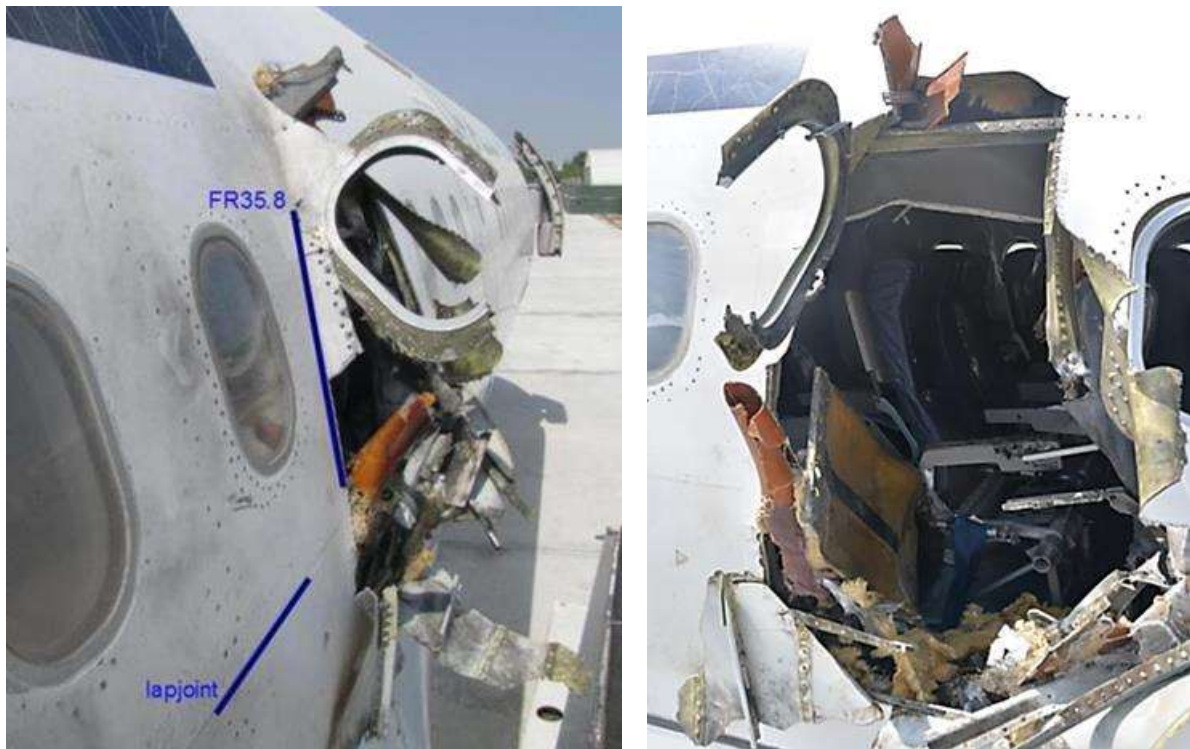
Underneath the cabin window forward of FR 35.8 and above the “lapjoint”⁴, the skin is pulled out from the fastening line with fasteners still in place on the window.

Figure 6 - Window frame area

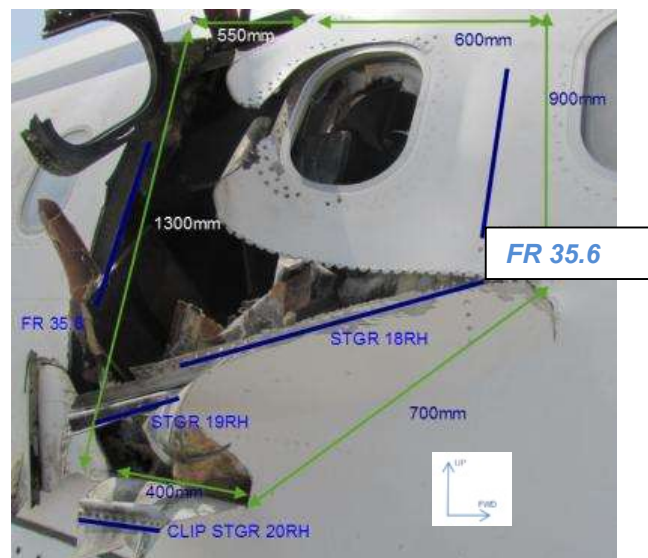
A piece of fuselage skin is missing between FR 35.7 to FR 35.8 and STRG 13 to STRG 21, around the cabin windows. Relevant part number is PN D532-35255 with thickness from 1.2mm to 3.2mm.

Figure 7 - Skin damaged dimension

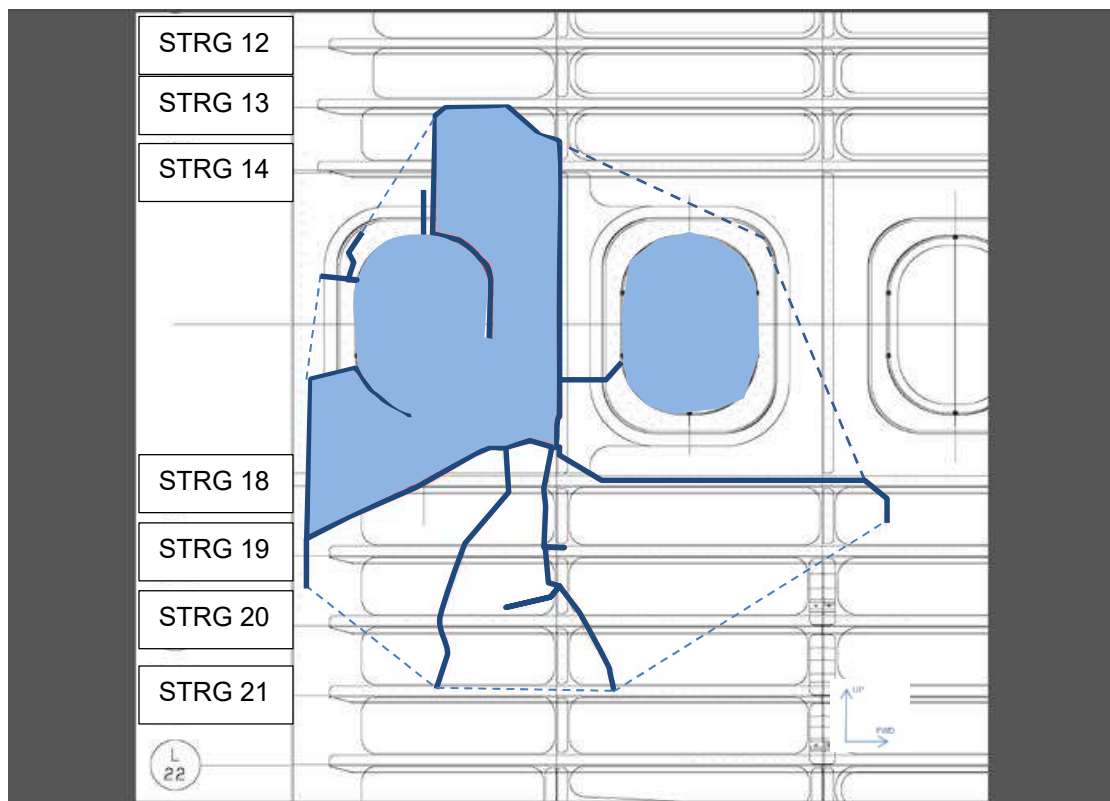
Figure 8 - Skin rupture & bending sketch - missing parts (light blue)

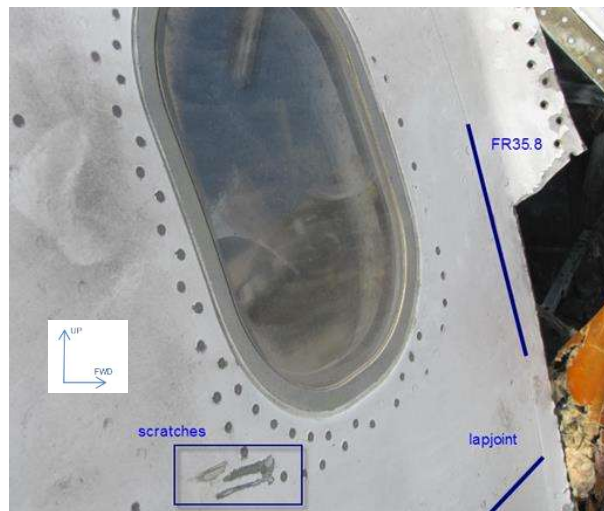
Rearwards FR 35.8 lapjoint, there is no evidence of major skin damage, only few minor scratches.

Figure 9 - Scratches after FR 35.8

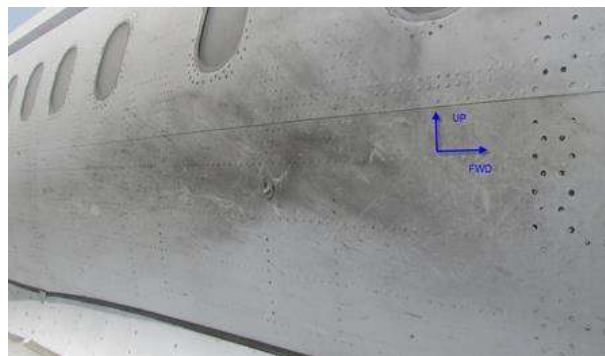
Black soot traces were observed on fuselage between FR 35.8 and around FR 42.

Figure 10 - Black Soot traces

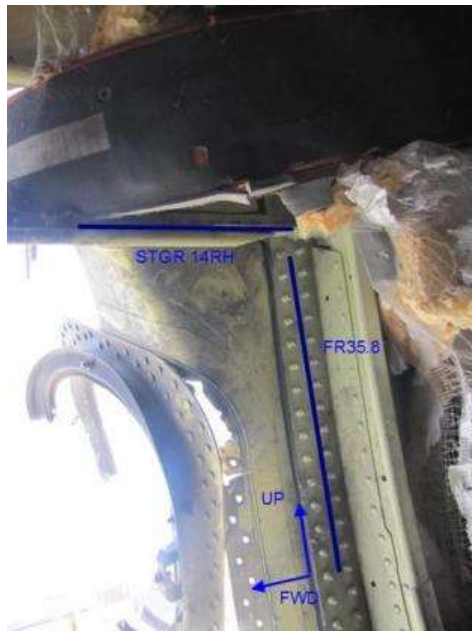
Figure 13- Frame FR 35.8 view from inside

Rows of fasteners were still attached the fuselage skin to the FR 35.8. There was no sign of fatigue damage initiated at this junction.

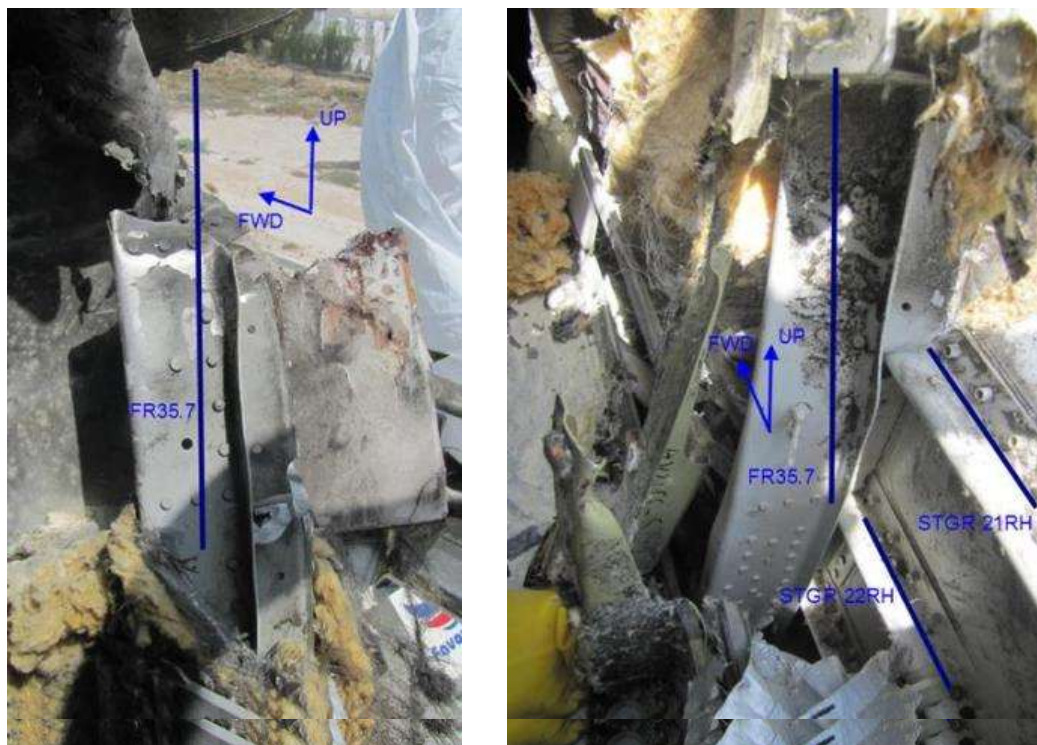
Frame 35.7 is cut with a rupture in tension without sign of shear.

Figure 14 - Frame FR 35.7

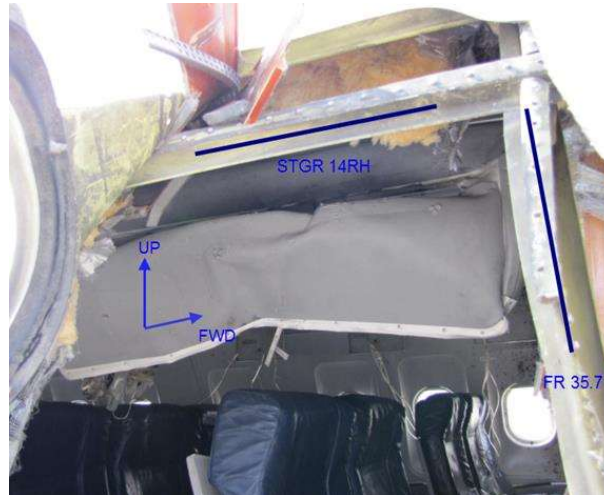
Stringer 14RH was still attached to the FR 35.7 and FR 35.8. The skin was pulled out at fasteners riveted lines.

Figure 15 - Stringer 14RH view

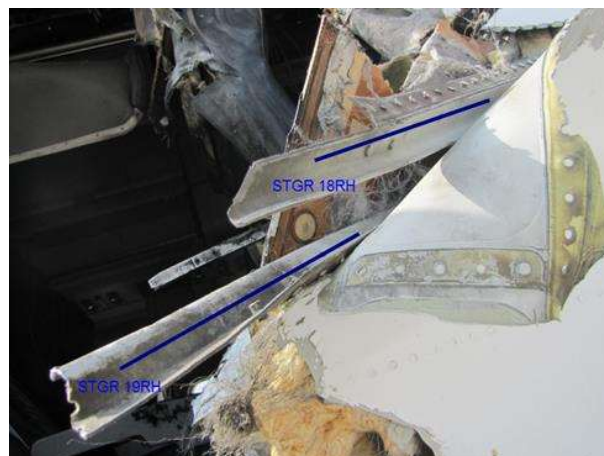
Three consecutive stringers STRG 18, 19, 20 (RH) were broken and bent outwards.

Figure 16 - Stringers 18 & 19RH view

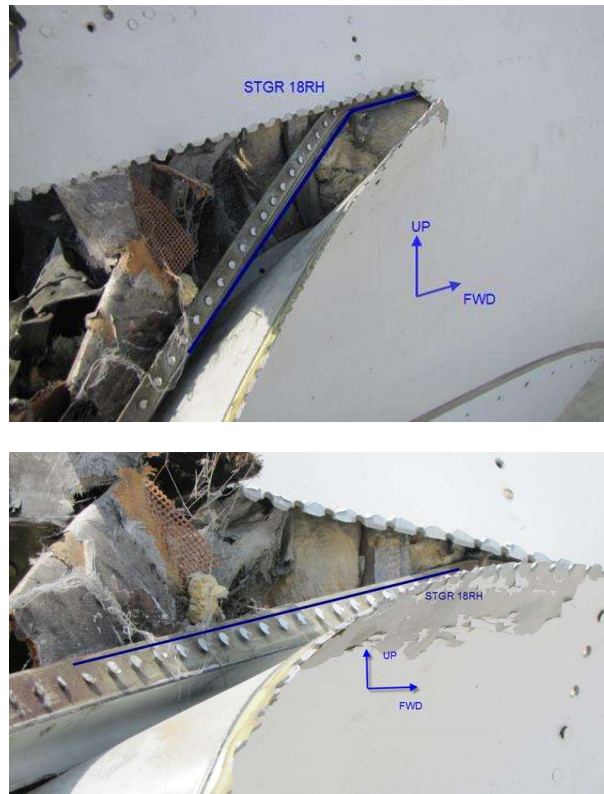
Fasteners were still in place at stringer level consistent with tension rupture of the skin along the rivet line without visible sign of shear.

Figure 17 - Stringer 18RH view with skin tension rupture

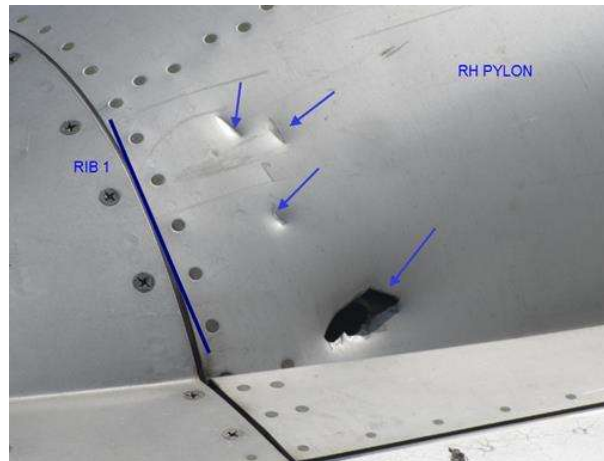
A hole was observed on the RH pylon cantilever panel surrounded by several dents.

Figure 18 - Dents and hole on the RH pylon cantilever panel

These findings were consistent with secondary impact damage by fuselage debris.

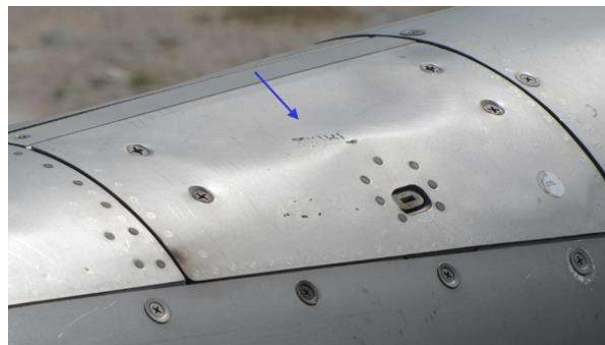
Dent on the overpressure panel was also observed.

Figure 19 - Dent on the overpressure panel

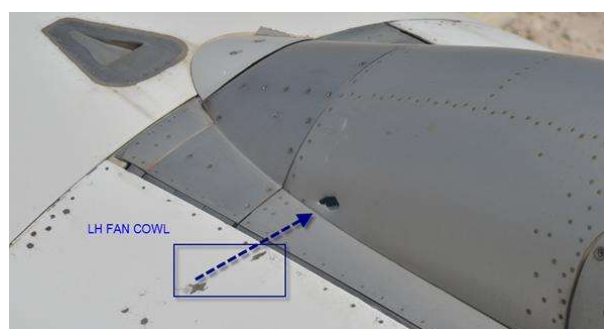
Close to the cantilever panel, scratches on the upper side of the LH fan cowl were observed.

Figure 20 - Scratches on the LH fan cowl engine 2
