Accident to the BOEING - 737 - 400
registered **TF-BBM**
on 20 November 2022
at Paris-Charles de Gaulle (Val-d'Oise)

Time	21:32 ¹
Operator	Bluebird Nordic (Island)
Type of flight	Freight commercial air transport
Persons on board	Captain and co-pilot
Consequences and damage	Aeroplane substantially damaged
This is a courtesy translation by the BEA of the Final Report on the Safety Investigation. As accurate as the translation may be, the original text in French is the work of reference.

Uncontrolled movement of aeroplane during push-back, strike with infrastructures

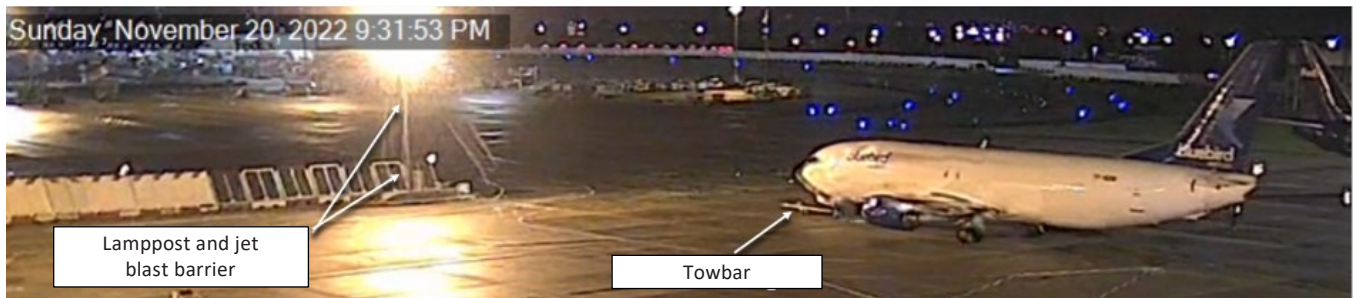
After unhooking the bar from the tug, the operator with the headset observed that the aeroplane was moving forward with the bar still connected to the nose gear. It was no longer possible for him to reconnect the bar to the tug and he asked the crew several times to apply the parking brake. The crew replied that the parking brake was on and that they could not brake. The tug and the ground operator managed to move out of the way as the aeroplane accelerated (the maximum recorded speed was 12 kt). As the towbar and steering lockout pin were still in place on the nose gear, the crew were unable to steer the aeroplane which struck a lamppost and a jet blast barrier before coming to a halt.

Figure 1: excerpt from video surveillance recording just before collision
(source: FEDEX)

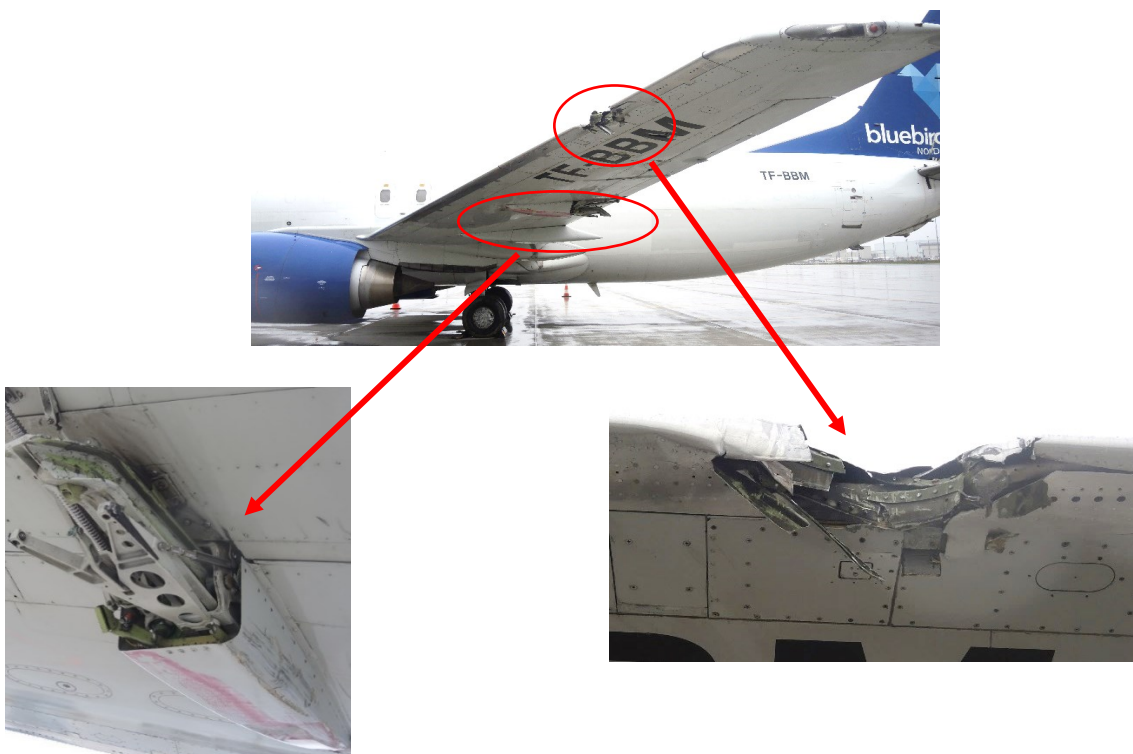
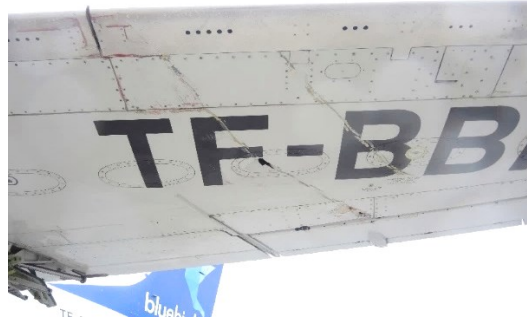
The damage was confined to the left wing.

Figure 2: damage to aeroplane (source: BEA)

After colliding with the lamppost and the jet blast barrier, the aircraft came to a halt. The crew observed a large fuel leak from the left wing tank, requested assistance from the firefighting services and then shut down all the electrical systems to prevent a fire.

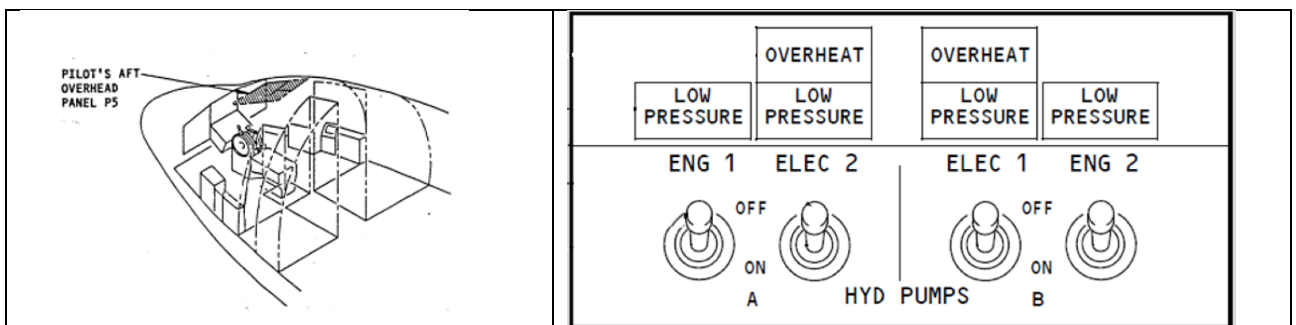
Figure 3: hydraulic system A and B control panel P5 (source: Boeing)

- SYS A ENG 1 in OFF position
 - As engine 1 had been started up, the HYD SYS A ENG 1 parameter indicated a low pressure (LOW PRESSURE light lit) and the examination of engine driven pump ENG 1 showed that it was functional, hydraulic system A was not pressurised by engine driven pump ENG 1.

- SYS B ELEC 1 in OFF position
 - The operation of the parking brake depended on the activation of electric motor pump 1, which pressurises system B.
 - The HYD SYS B ELEC parameter indicated a low pressure (LOW PRESSURE light lit) which showed that the electric motor pump was not electrically powered (the examinations did not find any fault on this pump). An intermittent fault on this pump cannot, however, be excluded.

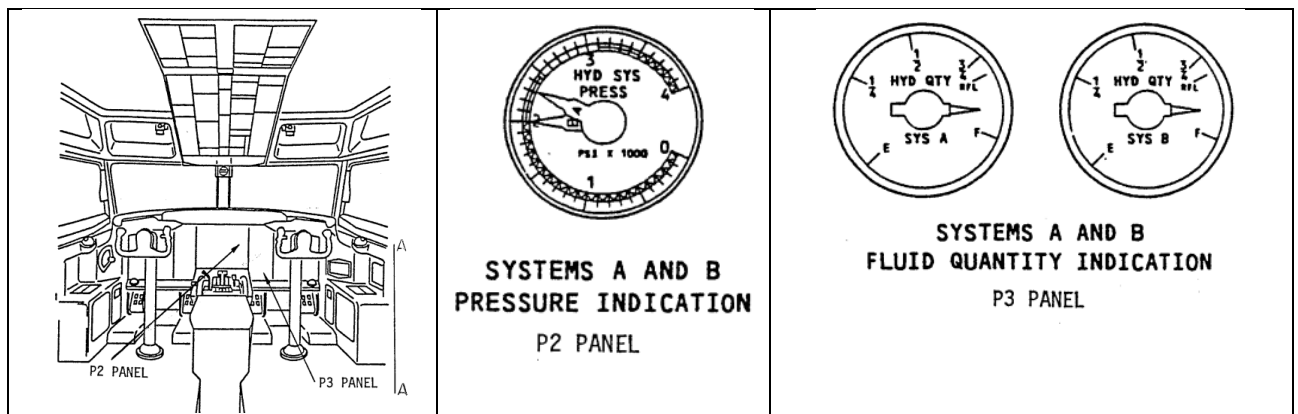
Figure 4: hydraulic system A and B pressure and fluid quantity indicators (source: Boeing)

Four binary parameters (HYD SYS ENG - 1 / 2 and HYD SYS A/B ELEC) indicated that the LOW PRESSURE indicator lights on the upper panel of the hydraulic system (see **Figure 5**) were all on. This shows that the output pressures of the engine driven and electric motor pumps of systems A and B were below the 1200-1600 psi values.

The crew stated that they applied the before push-back start-up procedure. This procedure required the system A switches to be set to "OFF" and the system B switches to be set to "ON". They added that since engine 2 had not been started up, many of the lights were red and that they had not paid attention to the status of the low pressure lights of the system A and B pumps (see **Figure 3**, panel 5). They also specified that they did not check the pressure indicator for systems A and B (see **Figure 4**, panel 2) or the accumulator pressure indicator (see **Figure 5**).

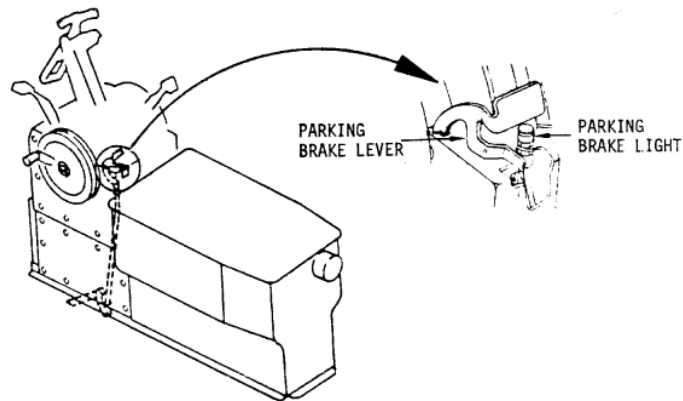
Figure 6: parking brake lever (source: Boeing)

This light is associated with the position of the lever and does not confirm the pressurisation of the parking brake system.

At the end of the push-back and before disconnecting the towbar, the crew operated the parking brake lever and considered that the latter was operational on observing that the associated red light illuminated. Due to the design of the system, this light only indicates that the parking brake lever is correctly positioned for applying the brake, it does not guarantee that the braking system is pressurised. The crew explained that they did not check that the pressure of hydraulic system B was at a minimum value of 2,800 psi and did not pay attention to the indicator lights indicating low pressure in the various systems and in the accumulator.

- the crew's erroneous understanding of the meaning of the red light next to the parking brake lever;
- the crew not checking the pressure indicators of the hydraulic systems and the low-pressure indicator lights of the pumps;
- the operator's choice to simplify the manufacturer's procedure by the systematic absence of pressurisation of system A, even when the steering lockout pin was in place, and by not asking the crews to check that system B was actually pressurised.
