Serious incident between
the AIRBUS A320 registered **TS-INP** operated by Nouvelair
and
the AIRBUS A320 registered **OE-IJZ** operated by easyJet Europe
on Sunday 21 September 2025
at Nice

This is a courtesy translation by the BEA of the Preliminary Report on the Safety Investigation. As accurate as the translation may be, the original text in French is the work of reference.

Approach at night on a runway engaged by an aeroplane lined up ready for take-off, near-collision, rejected landing

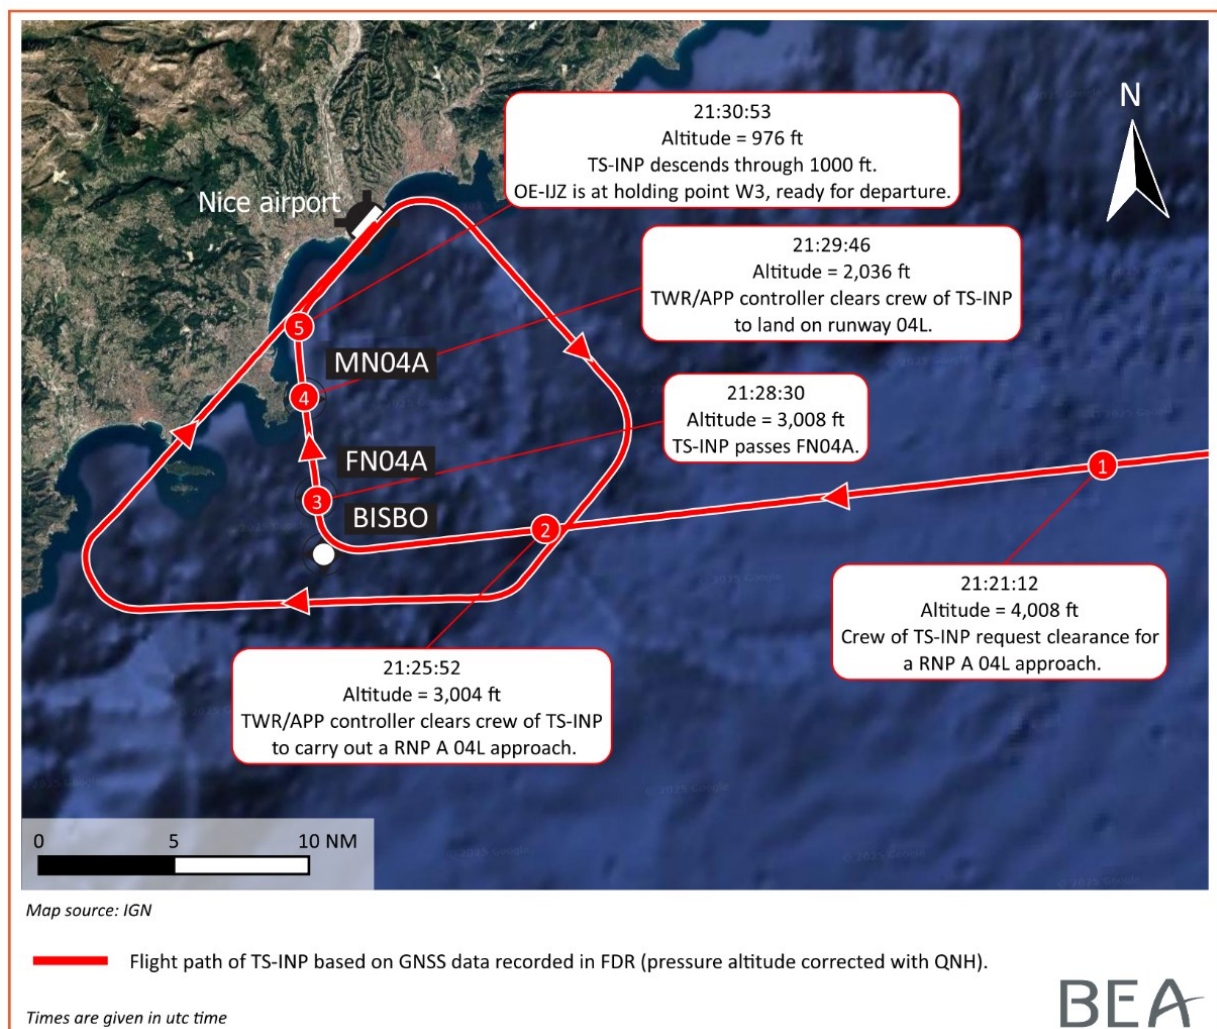
Figure 1: TS-INP's flight path

At 21:21, the TWR/APP controller asked the crew of TS-INP to confirm their wish to carry out a RNP A 04L approach. The crew confirmed that they wanted a RNP A 04L (see Figure 1, point ①). The TWR/APP controller cleared them to descend to 3,000 ft to BISBO. The crew observed that the Promenade des Anglais was visible. They carried out the approach check-list.

At 21:25, the TWR/APP controller cleared the crew of TS-INP to start the RNP A approach to runway 04L after BISBO. The crew read this back correctly (point ②).

At 21:28, TS-INP passed FN04A in descent towards MN04A (point ③). The autopilot was in FINAL APP mode.

At 21:30, the TWR/APP controller cleared the crew of TS-INP to land on runway 04L (point ④) and the crew read this back correctly. The aeroplane passed MN04A (MAPt of RNP A 04L) at 2,000 ft in descent. They followed a heading of 357°. The PF disengaged the autopilot.

At 21:30:53, flight through 1,000 ft was indicated by the radio-altimeter height automatic call-out (point 5). The indicated airspeed of the aeroplane was 138 kt⁵ and its rate of descent 1,100 ft/min. The aeroplane was on a heading of 015° in a right-hand turn at 3.4 NM from threshold 04R.

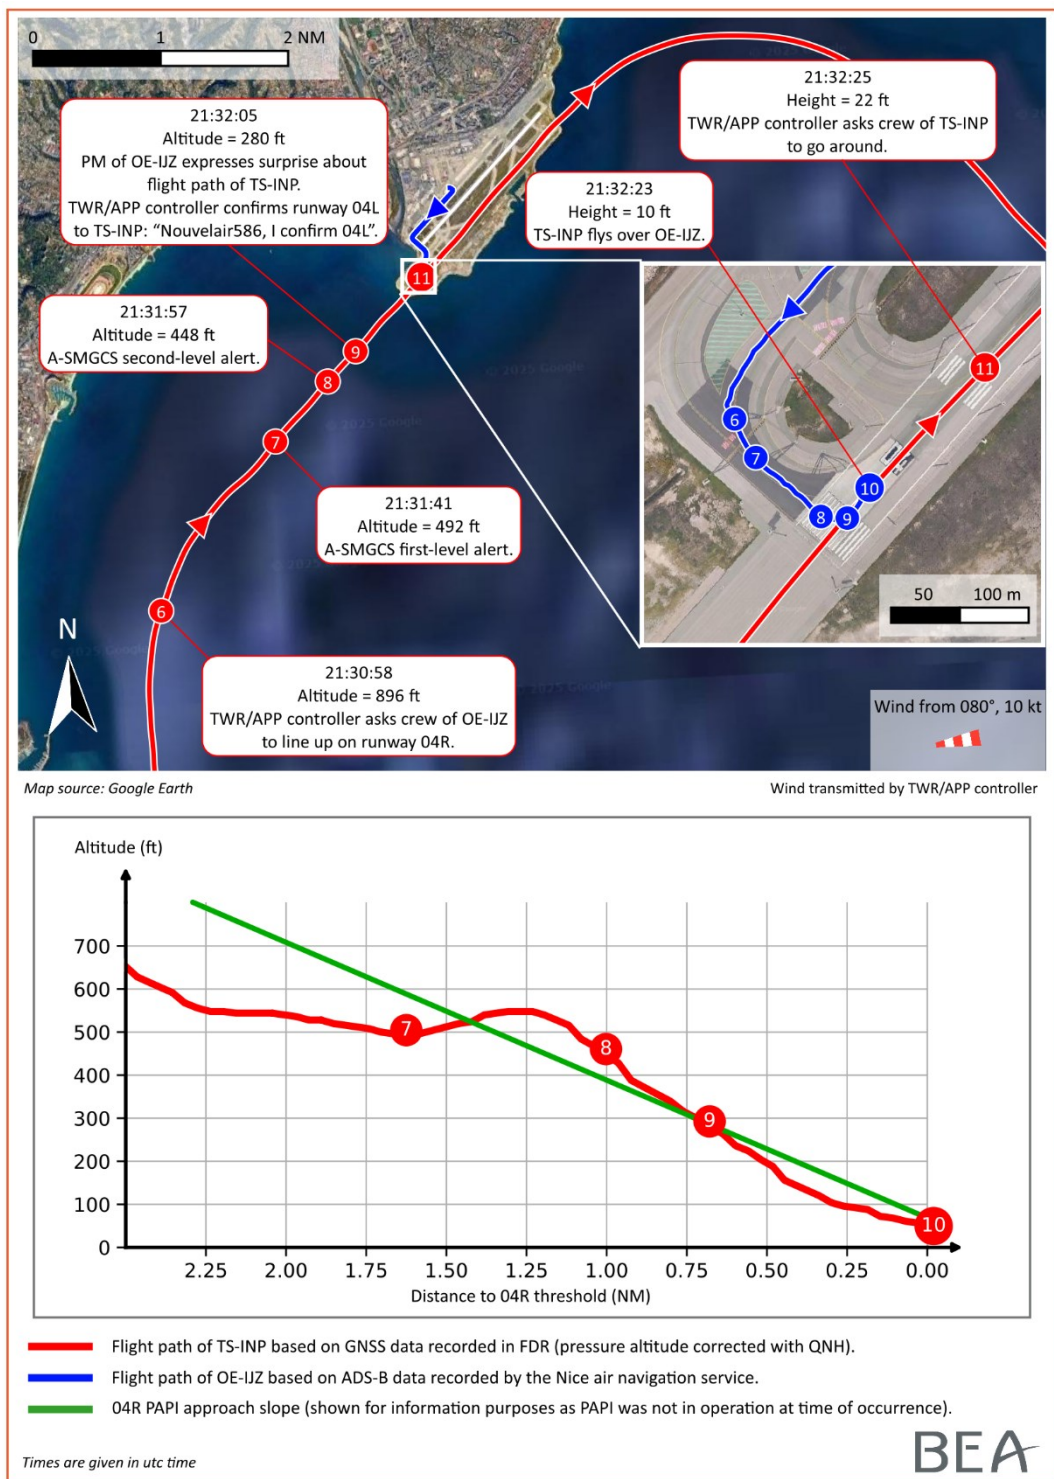
Figure 2: final approach of TS-INP and ground path of OE-IJZ

At 21:30:58, the TWR/APP controller asked the crew of OE-IJZ to line up on runway 04R and to hold (see Figure 2, point 6). The crew of OE-IJZ read this back correctly.

At 21:31:41, the first alert level (amber alert) of a runway incursion generated by the A-SMGCS system was activated⁶ in the control tower (points 7 and 7) when OE-IJZ entered runway 04R. TS-INP was at 492 ft in descent at around 1.6 NM from the threshold of runway 04R.

At 21:31:57, the second alert level (red visual and aural warning) was activated (see points 8 and 8). TS-INP was at 448 ft in descent at around 1 NM from the threshold of runway 04R.

At 21:32:05, OE-IJZ was on the threshold stripes of runway 04R in a left-hand turn to line up on the runway centreline (point 9). The PM of OE-IJZ saw TS-INP on final. He expressed his surprise at the perceived flight path. However, the crew did not identify any conflict. TS-INP was 0.7 NM from the threshold of runway 04R, descending through 278 ft with an indicated airspeed of 141 kt and a rate of descent of approximately 1,200 ft/min (point 9).

At 21:32:23, TS-INP flew over OE-IJZ, which was stopped and aligned with the centreline of runway 04R (points 10 and 10). The TS-INP radio altitude value dropped from 39 ft to 10 ft in one second before rising to 24 ft in the following second⁷.

At 21:32:25, the TWR/APP controller asked the crew of TS-INP to perform a go-around (point 11). The 20 ft and "retard" automatic call outs were activated at this time in the aeroplane. The crew of TS-INP crew carried out a missed approach.

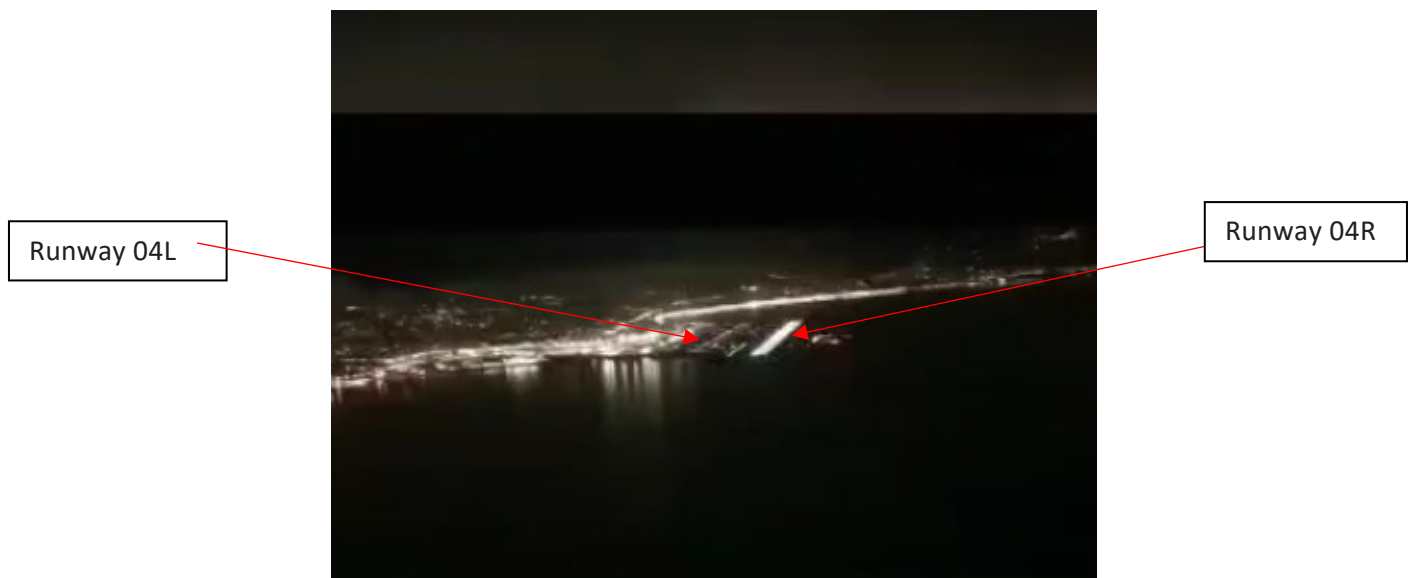
Figure 10: image taken from a video of an approach at night, date not known, brightness level of 04L and 04R lighting not confirmed

At night, the runway 04R lights are much brighter than the 04L runway lights.
