**Accident** to the JONKER JS1B  
registered **ZS-GDE**  
on 15 July 2022  
at Château-Arnoux - Saint-Auban (Alpes-de-Haute-Provence)

<b>Time</b>	Around 14:15 <sup>1</sup>
<b>Operator</b>	Centre National de Vol à Voile (CNVV)
<b>Type of flight</b>	Local
<b>Persons on board</b>	Pilot
<b>Consequences and damage</b>	Glider substantially damaged
This is a courtesy translation by the BEA of the Final Report on the Safety Investigation. As accurate as the translation may be, the original text in French is the work of reference.

## Collision with trees on short final

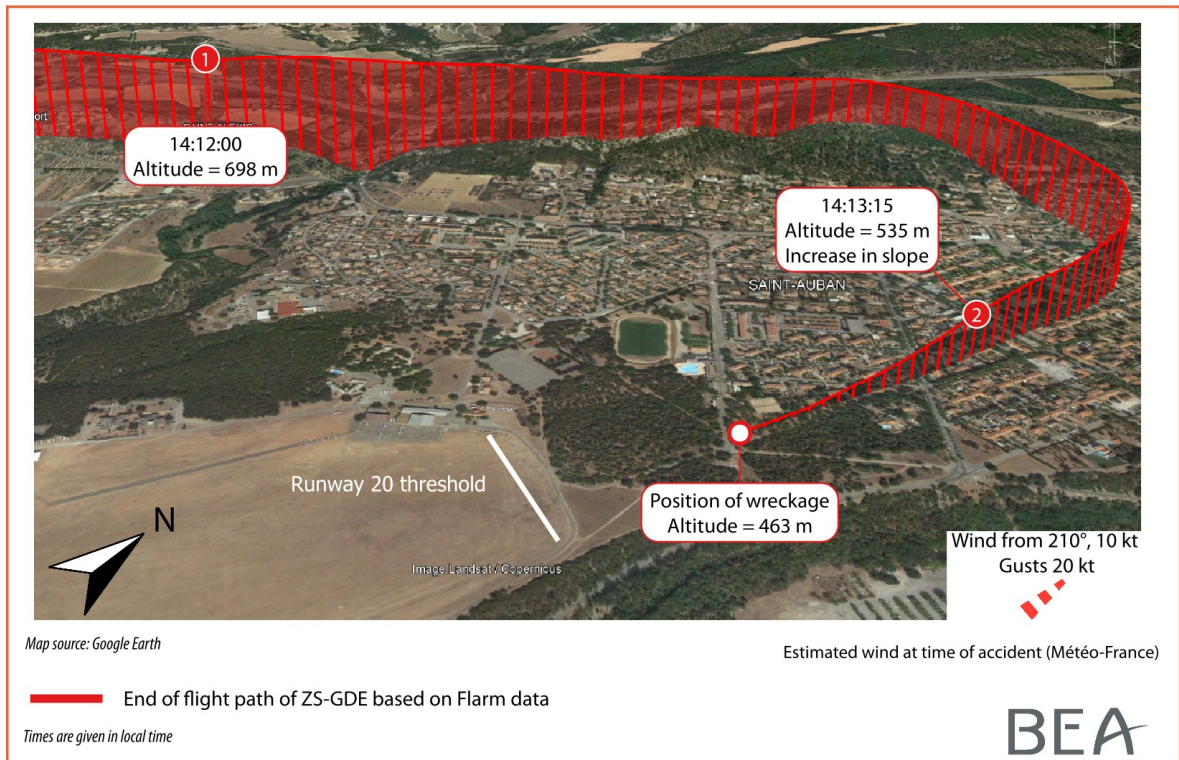
Figure 1: path based on FLARM

The comparison of these paths with that of ZS-GDE did not reveal any anomalies either in terms of altitude in the downwind leg or in terms of following the final approach path to an altitude of 500 m. From this point onwards, the slope of ZS-GDE was steeper than that of the other finals.

Analysis of the final path of ZS-GDE showed that the glider initially followed an average glide path of around 13 % (i.e. an apparent lift-to-drag ratio of 7.7) with an average ground speed of around 95 km/h, compatible with a short landing. This data is consistent with a normal approach speed (around 100 km/h) and the use of air brakes. The glide path then increased to reach an average slope of almost 24 % (apparent lift-to-drag ratio of 4<sup>3</sup>) with an average ground speed of 92 km/h. At the end of the path, the glide path decreased and stabilised at a slope of around 10 %. A few seconds later, the ground speed fell sharply, probably corresponding to the glider's impact with the top of the first trees.

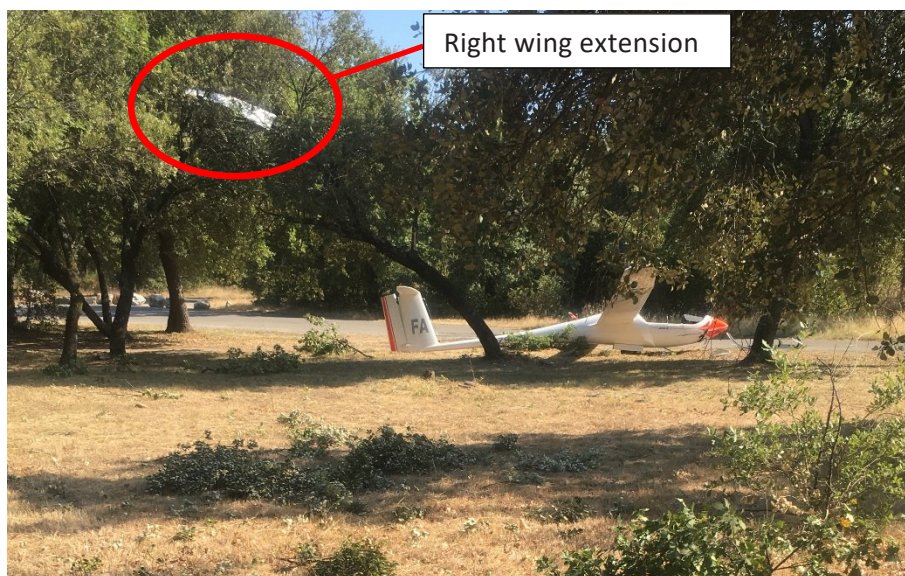
The glider wreckage was located on the side of a road about 350 m from the threshold of runway 20 at Château-Arnoux - Saint-Auban aerodrome.

Figure 2: accident site (Source: BEA)

Several tree branches severed by the glider were found on the ground over a distance of around 30 metres, along a path oriented 180°. The right wing struck the branch of a tree, tearing off the wing extension and causing the glider to spin and dive and then collide with the ground on its nose.

With the exception of the right wing extension, which was torn off when the glider hit a tree, the wreckage was complete and not dispersed. No structure technical failure prior to the collision with the ground was identified. The examination of the flight controls did not reveal any anomaly. All the failures observed were caused by the impact with the ground.

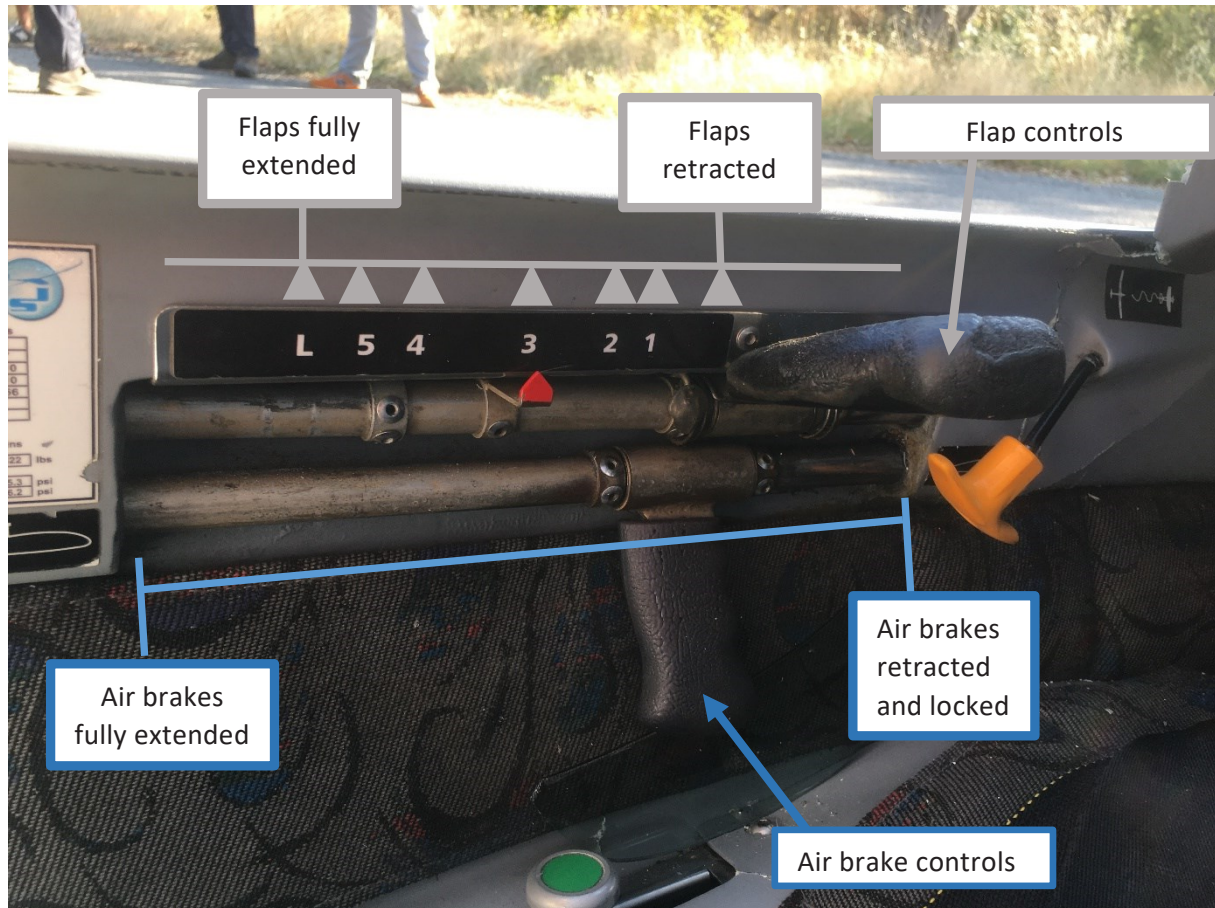
The trim was found in neutral position, the flap position indicator was found between positions 3 and 4, and the landing gear was extended. The air brake control was unlocked in the forward position (air brakes retracted).

The air brake control (vertical handle, blue) has only one locking notch corresponding to the forward position. To lock the air brakes in the retracted position or to unlock them, a force of 15 to 20 kg (forward or aft respectively) must be applied to move past this notch. During approach, the pilot constantly adjusts the position of the air brakes to maintain the path (forward to retract, aftward to extend).

Figure 4: location of flap and air brake controls (Source: BEA)
