Accident to the CENTRAIR – 101 Pégase registered F-CHLU

on 19 April 2010

at Pont-sur-Yonne (Bourgogne-Franche-Comté)

Collision with the ground during the approach

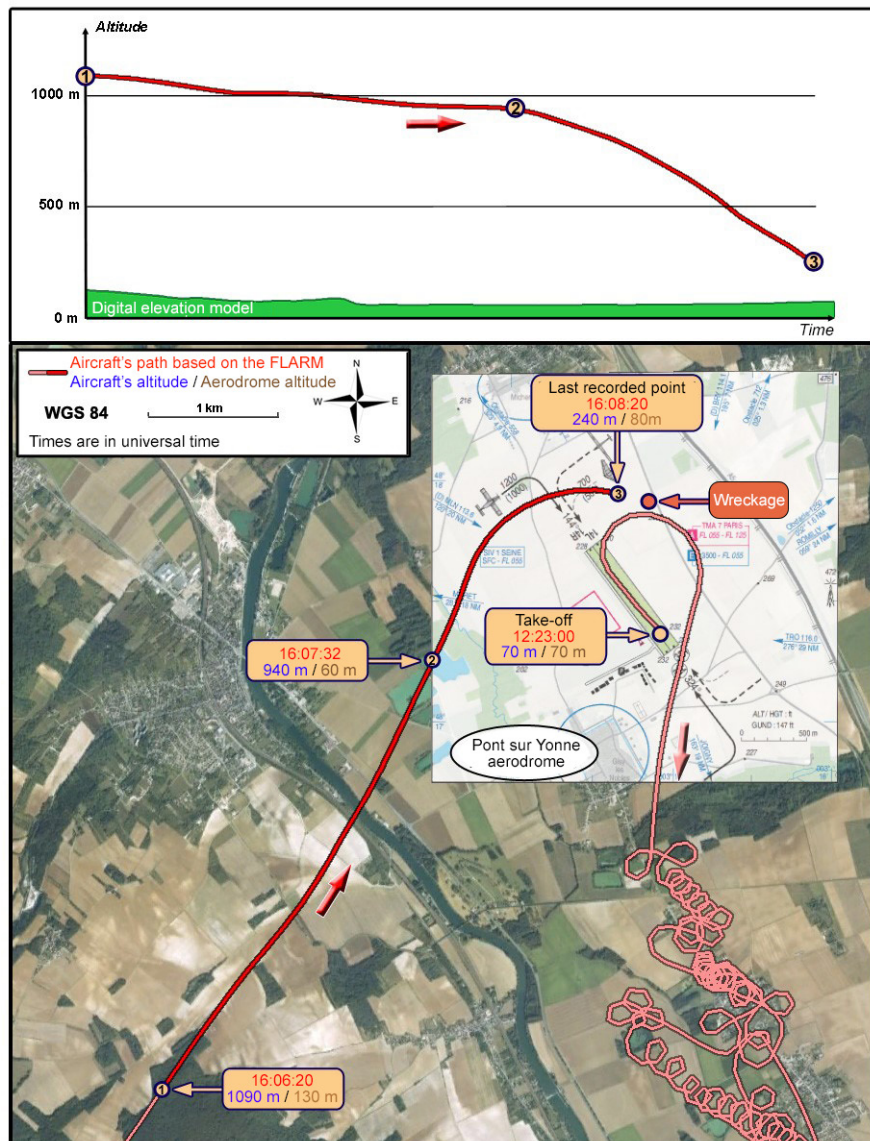
Glider's path

The analysis of the recorded data showed that the vertical speed increased abruptly one minute before the end of the flight from -500 ft/min to -4 000 ft/min at the last recorded point. During this time, the glider described a smooth turn with a radius of about 1000 m.
