# Report

Accident on **9 August 2007**  
off **the coast of Moorea (French Polynesia)**  
to the **DHC6-300**  
registered **F-OIQI**  
operated by **Air Moorea**

**BEA**

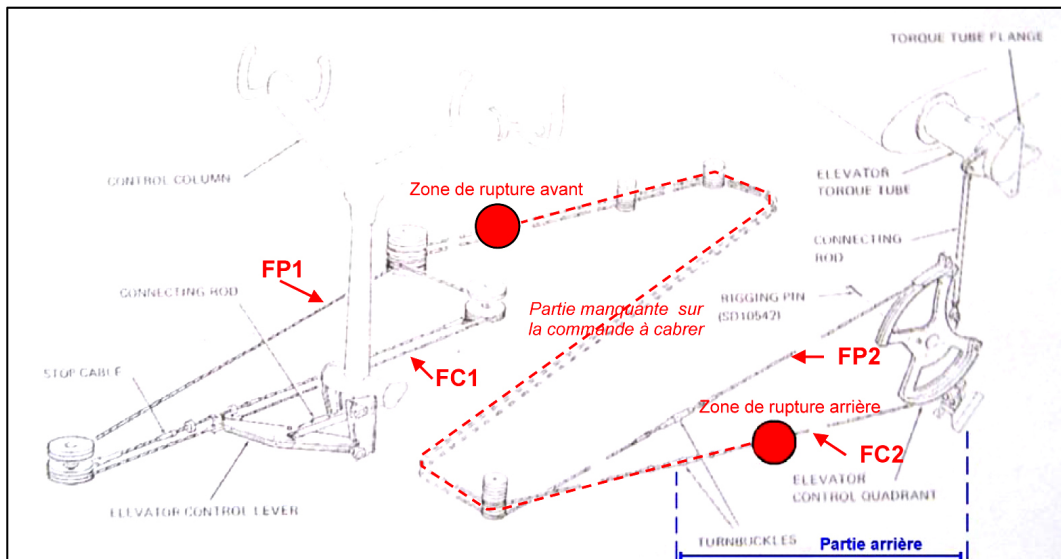
The two elevator control cables and the two rudder control cables broke off in a zone situated in the forward part of the aeroplane. The pitch-up control cable showed a second failure in the aft part of the aeroplane, with a different appearance to the other failures, and an 8.8-metre long piece of this cable was missing. All of the pitch-down elevator cable was recovered.

- FP1 : Fragment of pitch-up cable attached to control column, length 1.55 metres
- FP2 : Fragment of pitch-up cable attached to elevator, length 11.25 metres
- FC1 : Fragment of pitch-down cable attached to control column, length 0.75 metres
- FC2 : Fragment of pitch-down cable attached to elevator, length 2.60 metres
- Total length of pitch-up cable = 12.80 metres
- Total length of pitch-down cable = 12.15 metres

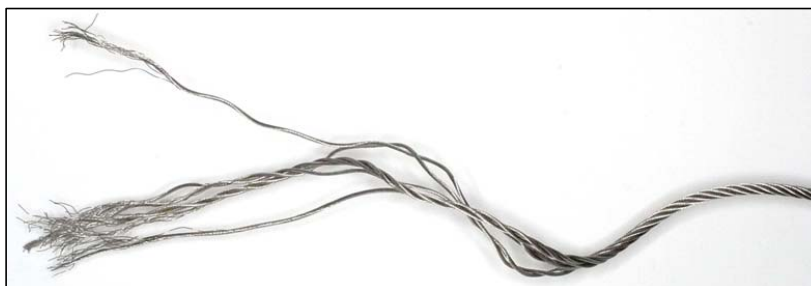
Typical failure of a cable broken off in the forward zone (scale 1:2)

All the failures that occurred in the forward zone were identical, the strands had separated (untwisting) over several centimetres. They were typical of overload failures. No deposit, traces of corrosion or signs of wear were observed in line with the failed areas.

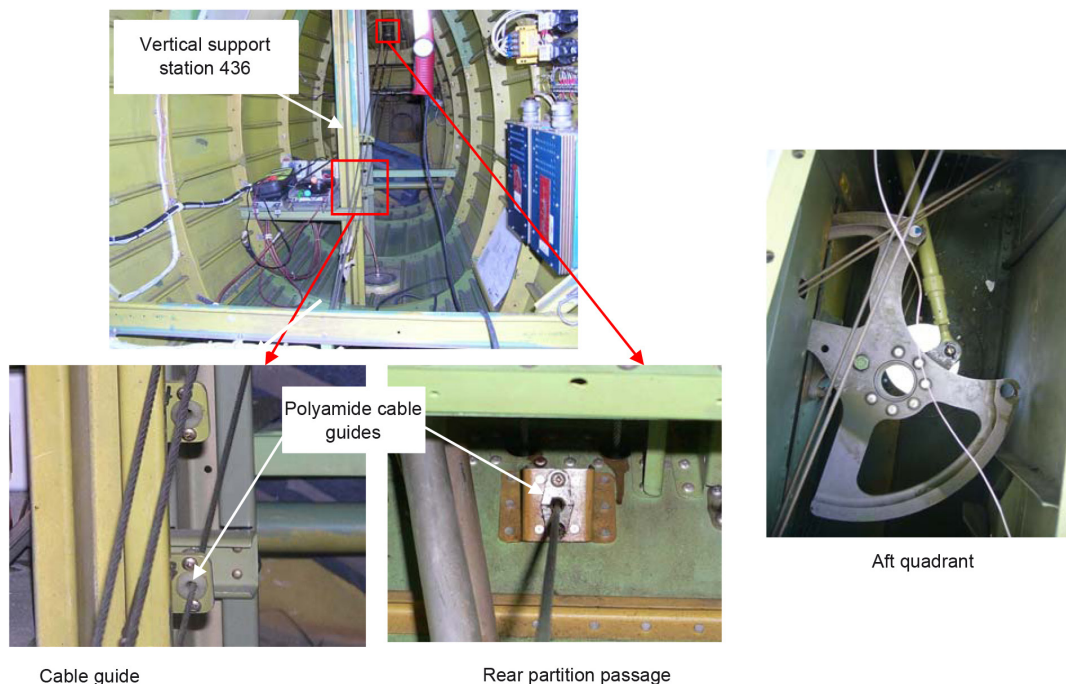
The two cables showed several signs of wear in the zones of contact with elements of the aeroplane: the rear quadrant, the rear partition passage and the cable guides attached to a vertical strut at the level of station 436. The formation of flat spots was observed on the section of the cables in contact with these elements and the presence of failed wires.

Wear at the metallic quadrant level presented a mat rough aspect relative to the metal on metal chafing. It was characterised by signs of chafing perpendicular to the cables' axis.

The areas of wear at the partition passage level and the cable guides had a shiny "polished" aspect. Their surface showed thin signs of chafing parallel to the cable axis. This wear was representative of chafing with the polyamide bushes located in the ferrules.

The rear failure of the pitch-up control cable was in line with the cable guide.

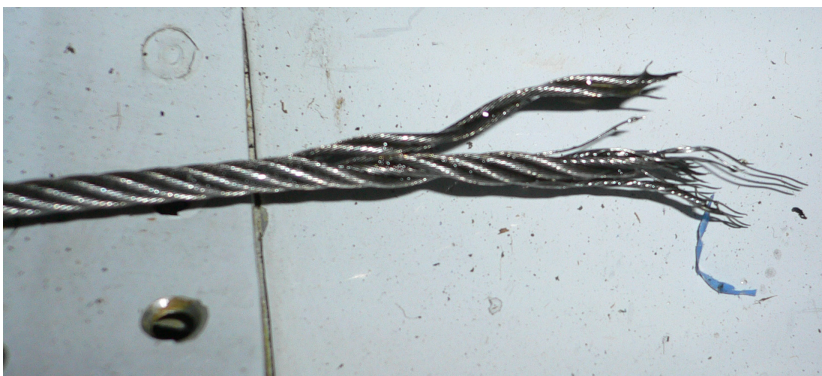
Aft failure of the pitch-up control cable (scale 1:1)

The strands stayed grouped on the whole in the aft failure area.

The specialists who conducted the examinations concluded that this cable had likely failed before hitting the water.

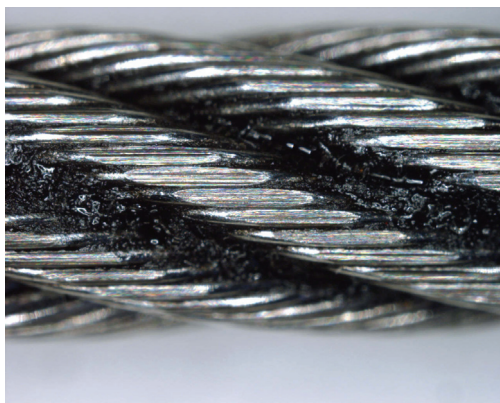
Binocular view of the wear area  
on a stainless steel cable  
after 150,000 cycles

A range of wear appeared on the stainless steel cable whereas no wear was detectable on the carbon steel cable. These tests confirmed what had been noticed in operation (see 1.18.1). They did not, however, allow a possible cable wear law to be established, if only because calculating the rate of wear by counting wires implied cutting the cable. Because of this, and even if it seemed likely, it was not possible to say if the rhythm of wear accelerated at the same time.

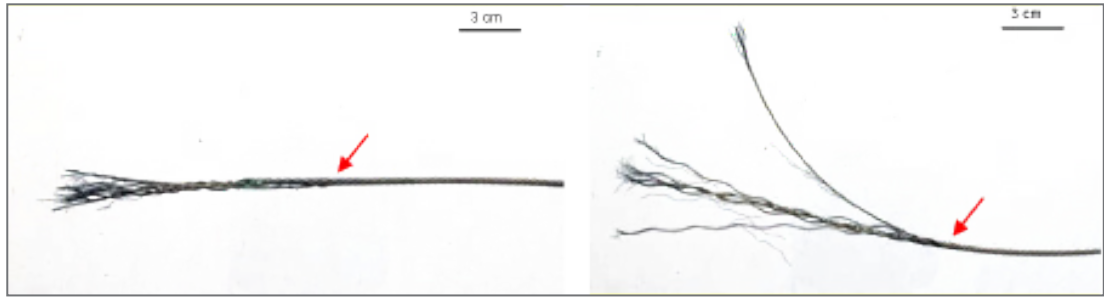
Appearance of the failed cable ends after fatigue test

Failure occurred after 58,000 cycles, on the worn spot, with a strong untwisting as far as the fixation zone marked below by red arrows.

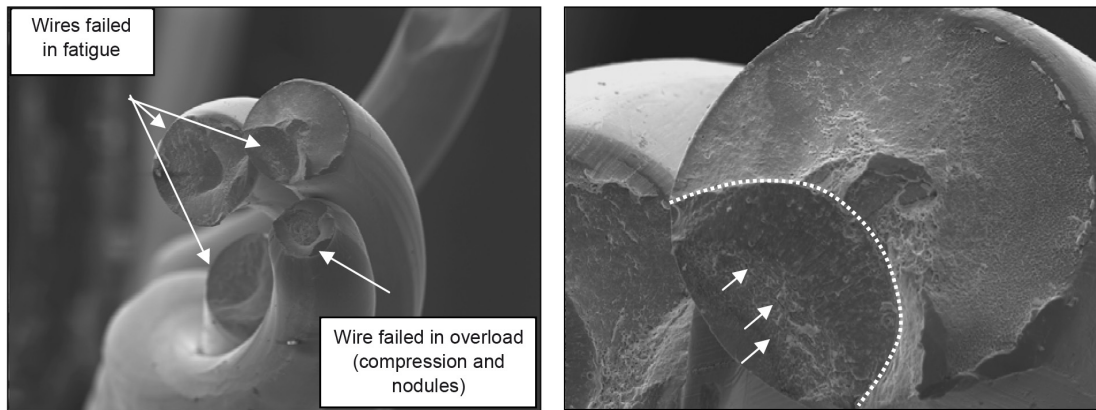
Fatigue failures of wires

Several of the outer and central strand wires showed signs of fatigue (see photo below), unlike the F-OIQI's pitch-up cable wires.

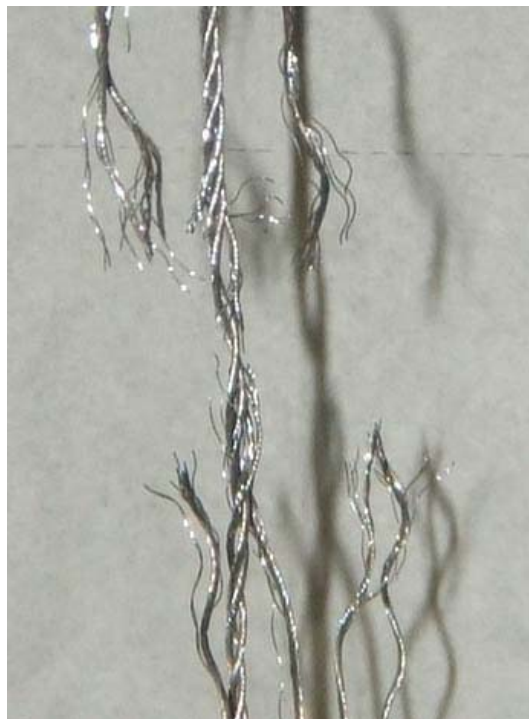
Detail of pitch-down-cable after test : two outer strands not broken

Note: For safety reasons, the test stopped when the drop in the load detected by the machine was above 80%. In both cases, two outer strands remained unbroken after the test.

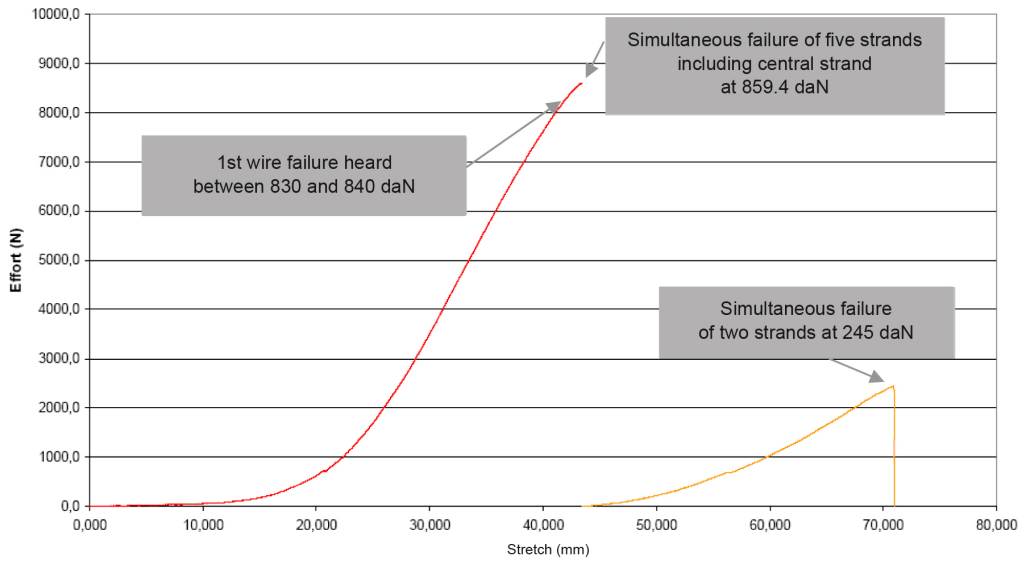
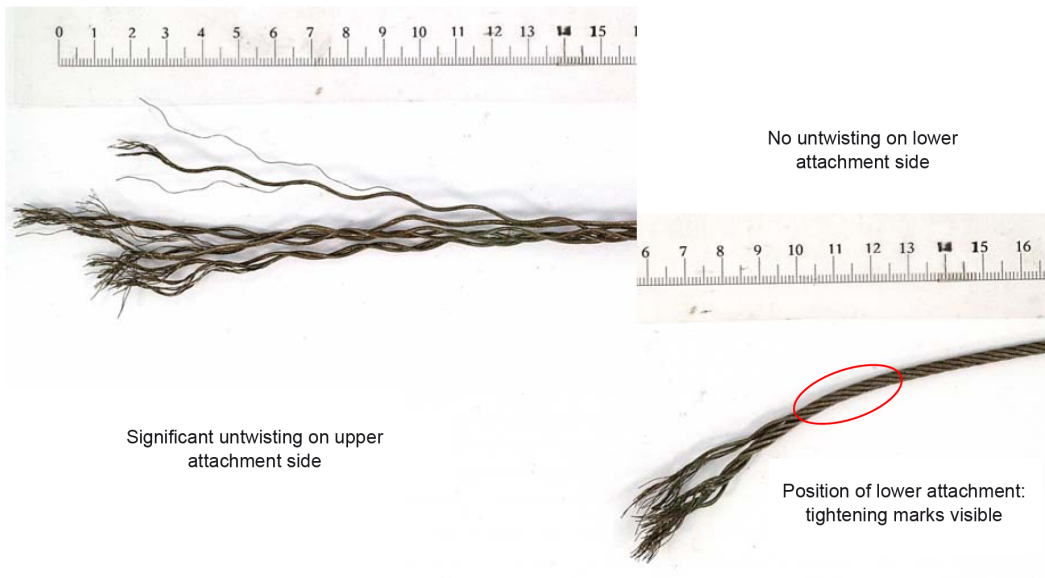
On a new cable, the failure occurred close to the lower attachment system.

Note: The proximity of the attachment system prevented the untwisting of the cable on the lower failed end. Signs of pinching were observed on this cable at the attachment point.

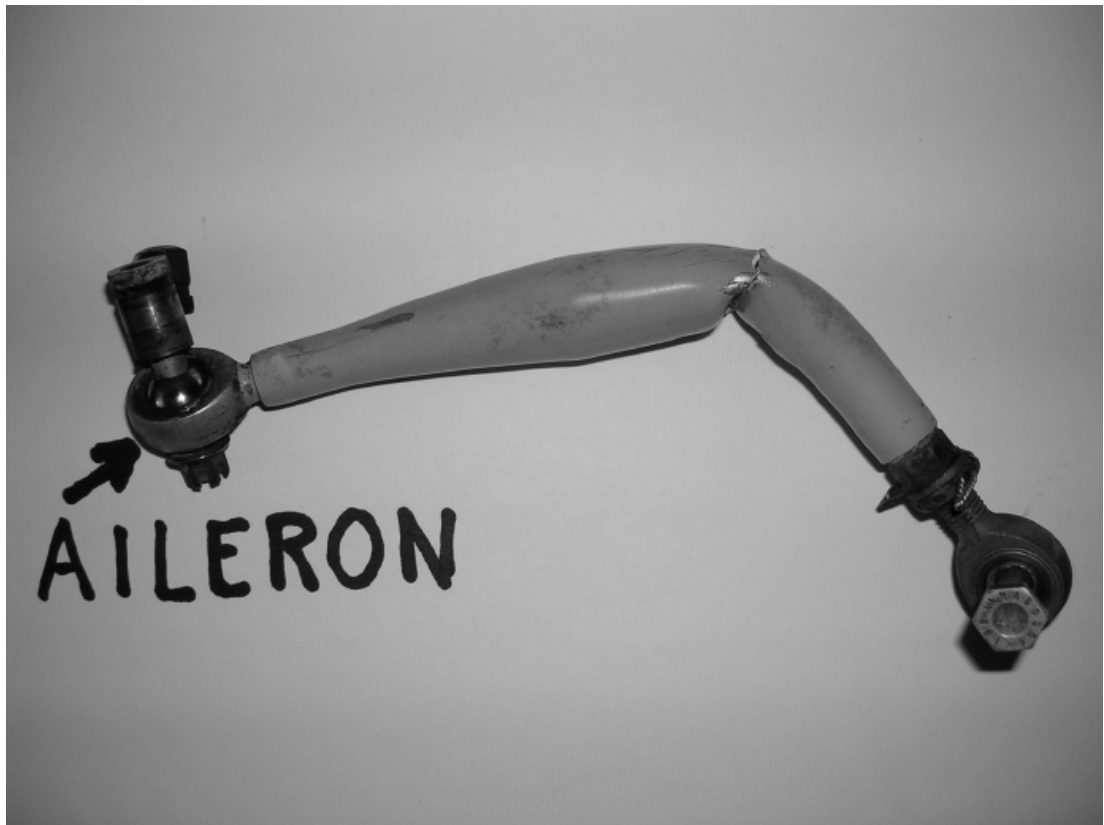
### 3. Examinations of the Aileron Pushrod

No marks that could indicate an external mechanical load (impact) on the control surface was found.

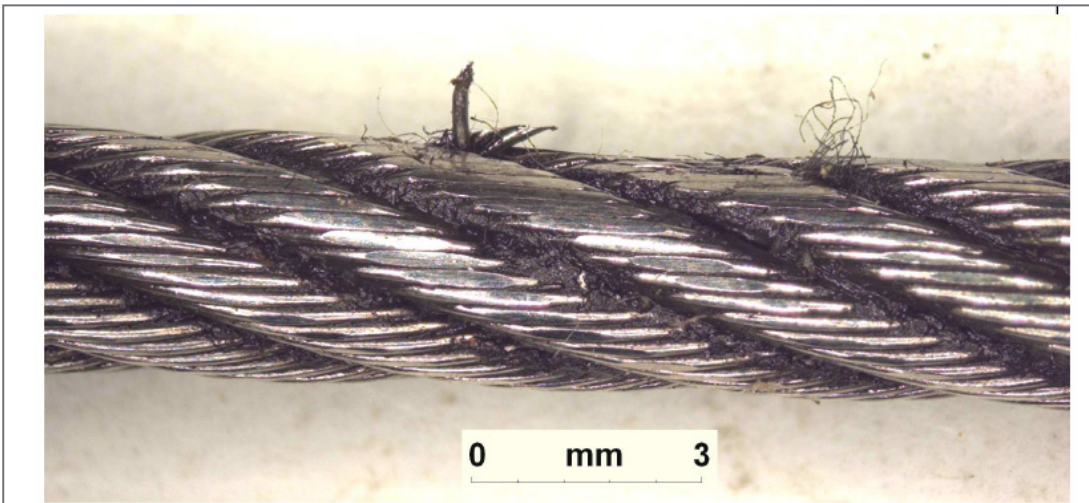
Cliché 5 : Zone d'usure E' sur le câble supérieur

The wear noted on the lower and upper cables was located exactly the same distance from the stops and had the same appearance.

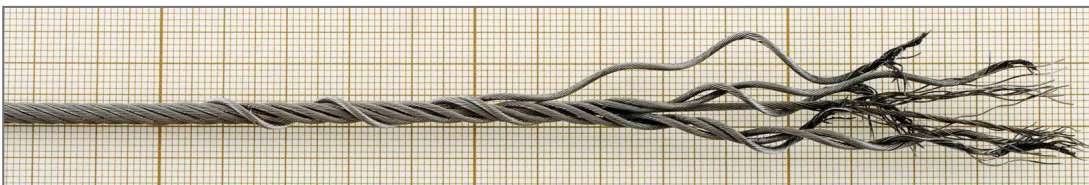
On the cross-section below (strands identified arbitrarily from A to F), the broken wires in line with wear are identified in red, that is to say 113 wires from a total of 133. This wear was characterised by the formation of flat spots, with traces of chafing parallel to the cable axis.
