Study

on Detection of Audio Anomalies on CVR Recordings

Bureau d'Enquêtes et d'Analyses
pour la sécurité de l'aviation civile

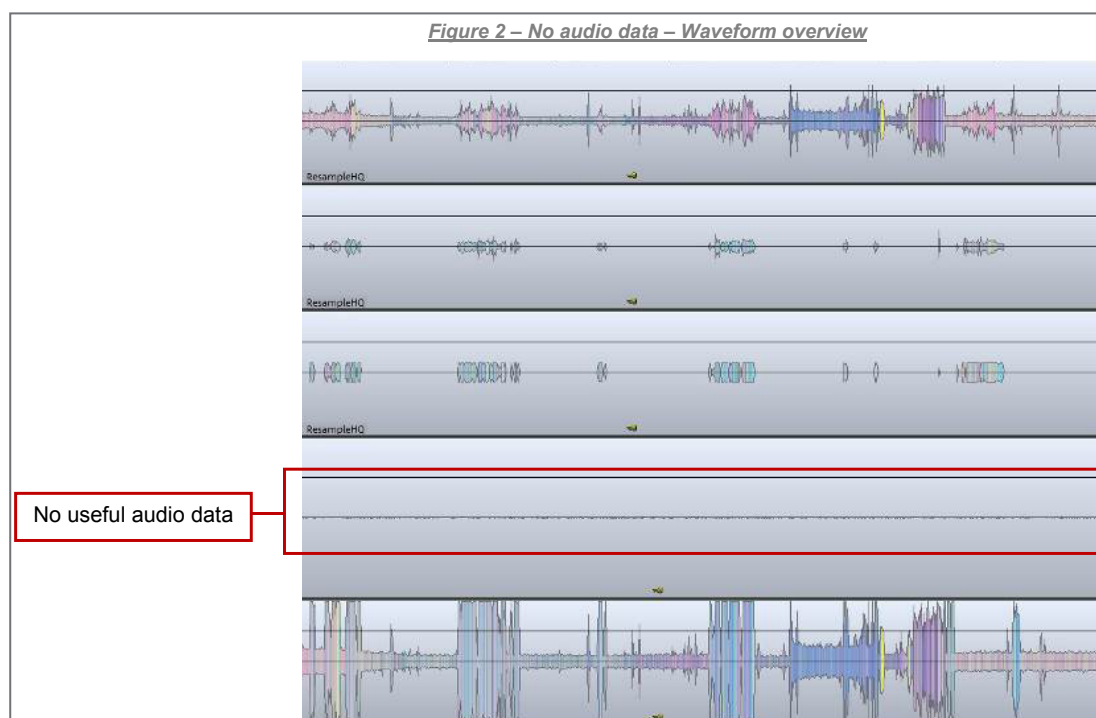
Figure 2 - no audio data - waveform overview

This defect is characterized by a lack of useful audio data on one or more tracks on the CVR. It is immediately identifiable when listening and by observing the waveform (see Figure 2): only noise associated with aircraft power supply is audible.

This anomaly is the most negative for any work to be carried out on the cockpit voice recorder because it makes a valuable source of information for understanding the event unavailable to the safety investigation.

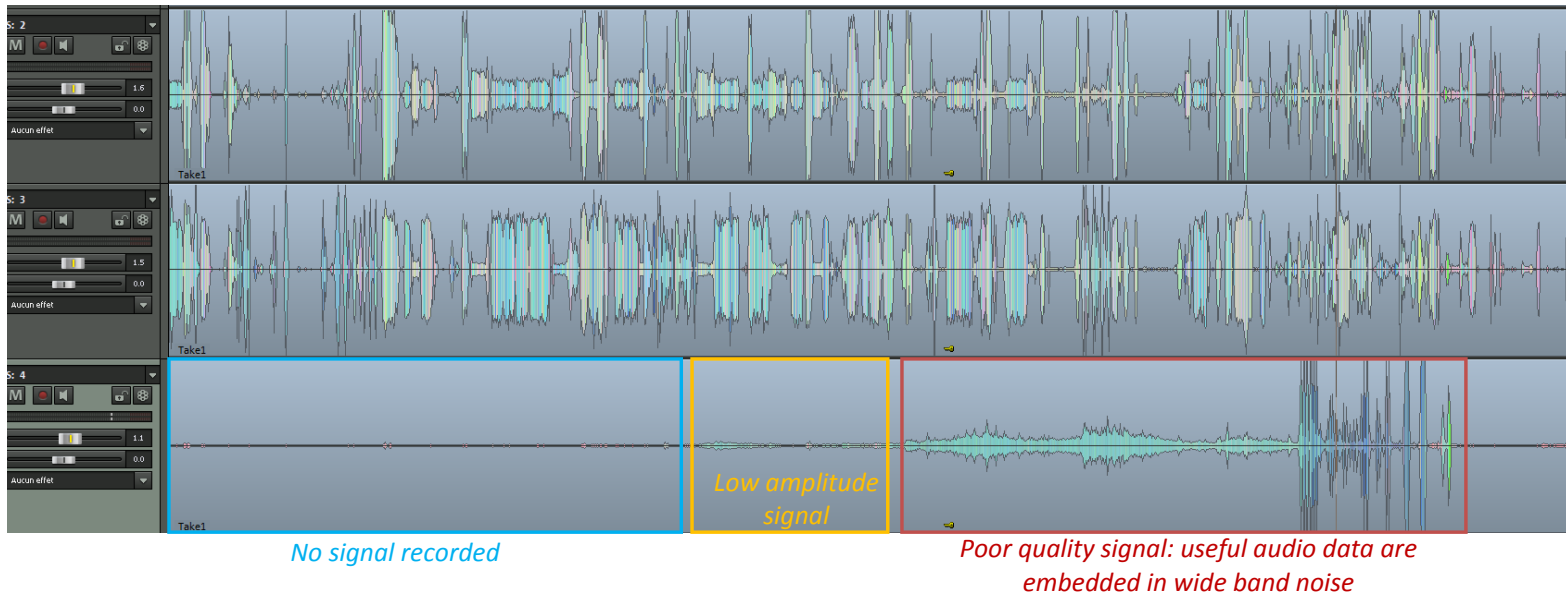
Figure 3 - poor recording quality CAM track - waveform overview

This anomaly can be caused by an intermittent malfunction of the CAM amplification box (Control Unit) or by poor electrical wiring throughout the CAM installation. The overall recording of the CAM signal may be of a very poor quality.

On listening, this defect leads to random variations in signal level: on some portions of the CAM track, the signal may have a very low level, or even non-existent – thus no audio signal (see figure 3).

This defect results in a loss of useful audio data on the CAM track (warnings, crew exchanges).

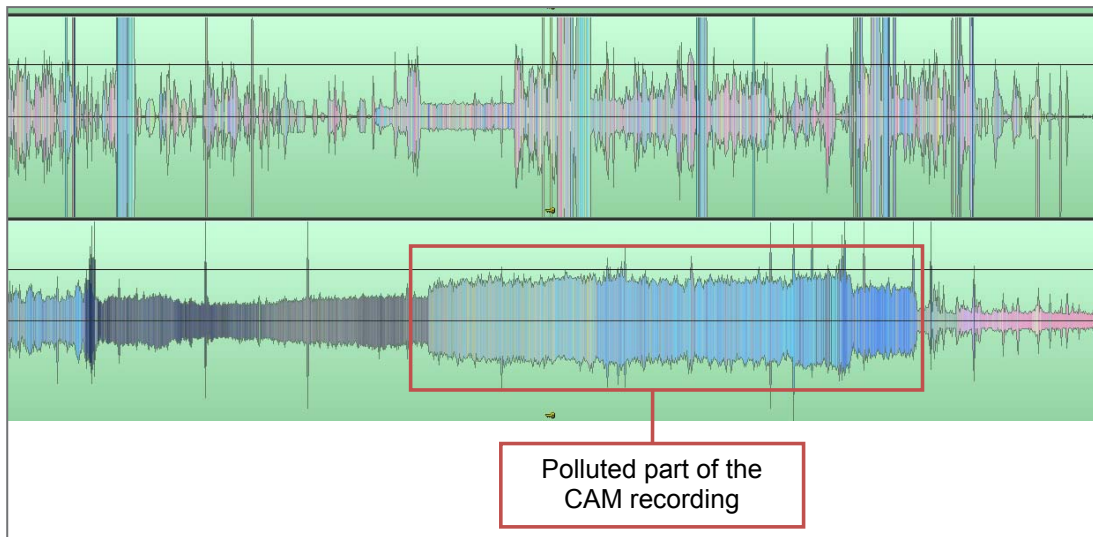
Figure 4 - CAM recording pollution - waveform overview

This pollution is characterized by the presence of a continuous parasite “*sound*” on the CAM track. The cases studied at the BEA showed that this sound was coming from the aircraft power supply. Listening is then very uncomfortable. This phenomenon appeared only on the cockpit area microphone track.

- ❑ Remark 2:
 - Audio signal listening and waveform observation make detection of this anomaly possible but are not sufficient to prove its presence (see Figure 4). The use of spectrum analysis is essential.

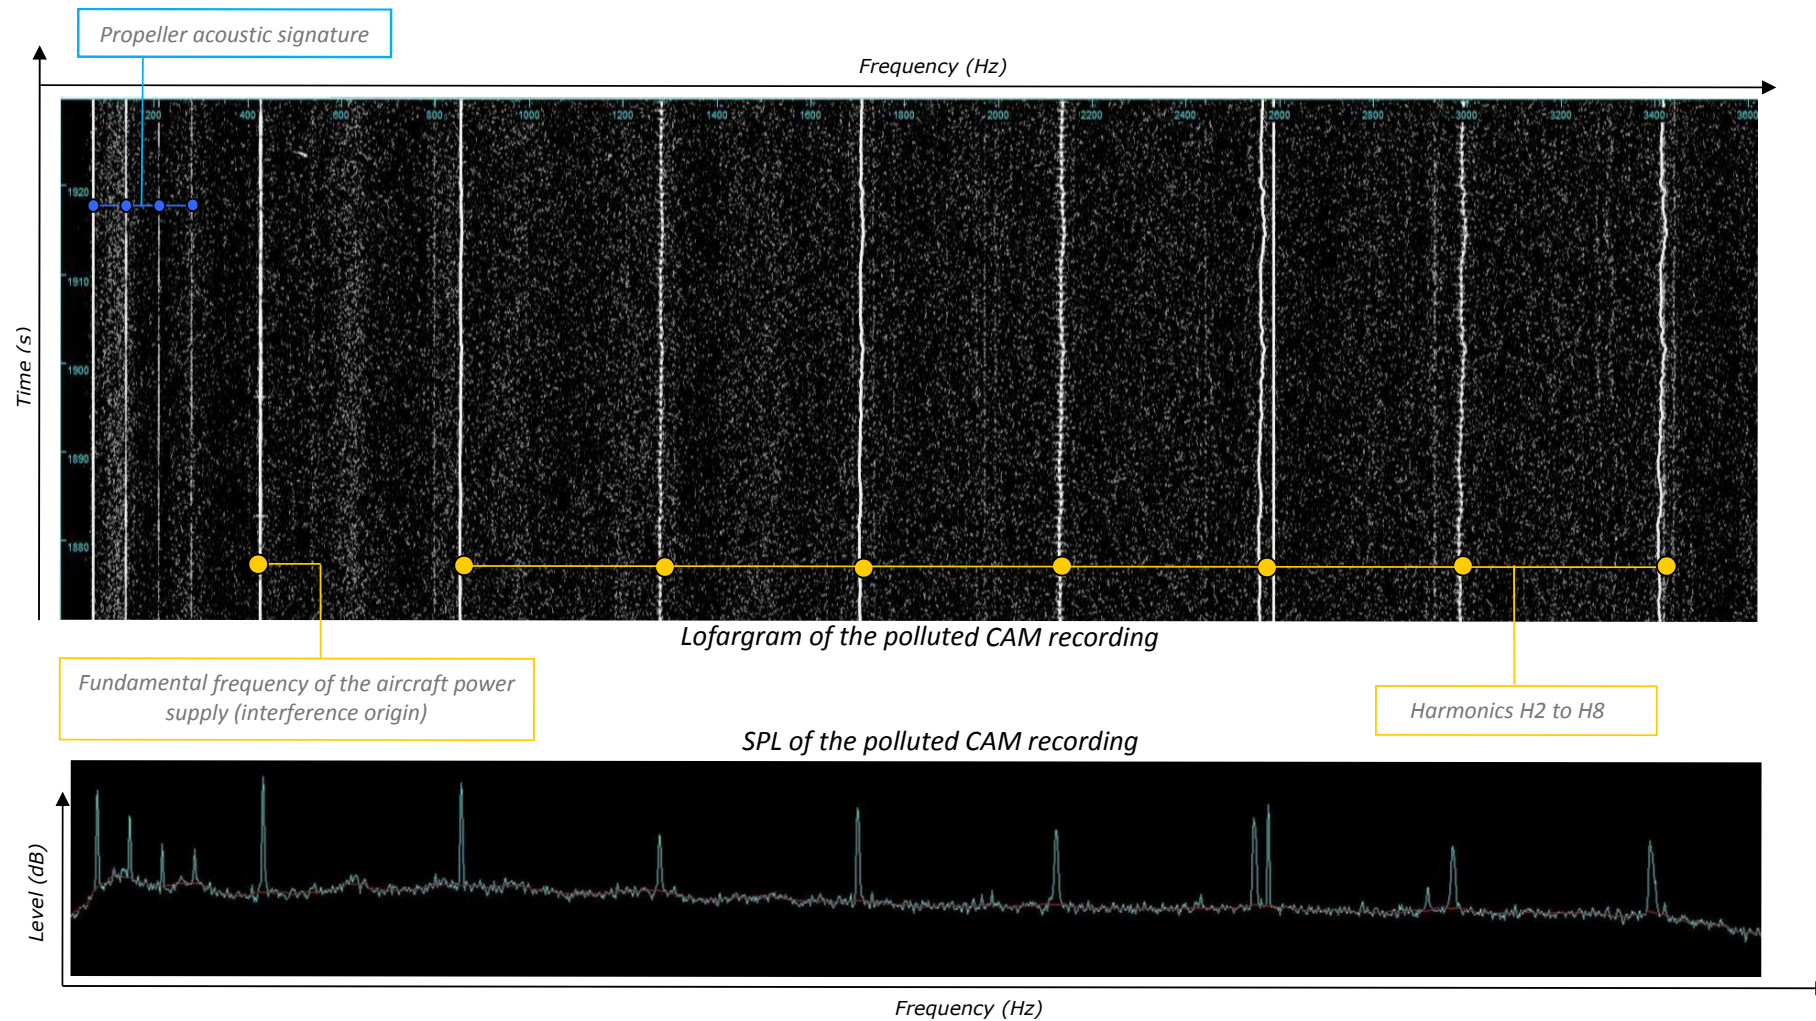
Figure 5 - CAM recording pollution - spectrum view (Lofar et SPL)

The presence of this anomaly on the recording can be confirmed by spectrum analysis (see Figure 5). This method reveals the presence of a harmonic family with a fundamental frequency moving around 400 Hz (between 340 and 490 Hz – aircraft power supply has a variable frequency for the cases studied). It appears that the greater the harmonic richness, the more severe the pollution will be and render any listening work difficult.

- ❑ Remark 1:
 - On some CVRs, the frequency causing the pollution is stable. It is then tolerated because it provides a useful time frame for the investigation (see ED 56A, §A.1.3.2, NOTE 1 or ED 112, § I-A.3.2.).

This interference causes listening discomfort which decreases the performance of the person responsible for carrying out the transcription work. In addition, when this pollution is severe, audio data present on the CAM track are hardly usable, especially conversations between crew members. However, it should be emphasized that regarding listening comfort, ED112 does not mention any restrictions or limitations on the level of the recorded signal as long as it does not exceed the recording capability of the whole CVR installation.

- ❑ Remark 3:
 - It is possible to use signal processing tools to filter this frequency and its harmonics. However, this technique may be difficult to implement because the fundamental frequency of the noise varies during flight. In addition, such filtering should be done with care and precision because if the pollution covers elements of the acoustic signature of the aircraft, removing it entirely (fundamental and each of its harmonics) can cause the loss of information essential to the investigation.

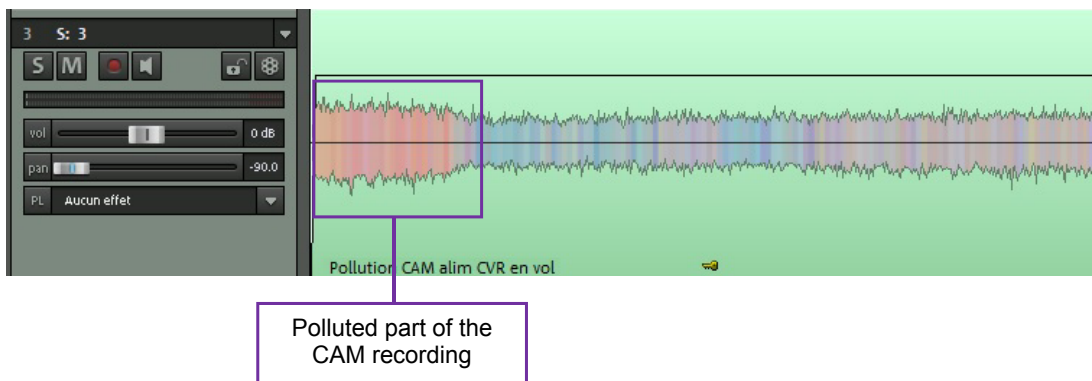
Figure 6 - CAM recording pollution - waveform overview

This type of pollution can be described as a high level wideband noise (continuous whistle) whose centre frequency fluctuates slightly according to the flight phase. The width of this band is approximately 300Hz. This phenomenon appears when the CVR starts and disappears when the usual power supply of the device is cut off (transition to RIPS⁽⁶⁾). This interference is generated by the electric power supplied by the CVR to the preamplification module (Control Unit).

- ❑ Remark 1:
 - Like the previous defect, audio signal listening and waveform observation make possible the detection of this anomaly but are not sufficient to prove its presence (see Figure 6). The use of spectrum analysis is essential.
- ❑ Remark 2:
 - Depending on the value of the centre frequency, it may be possible to remove this noise by using a notch filter. However, such filtering should be done with care because if the pollution covers over some elements of the aircraft's acoustic signature, removing it can cause a loss of information essential to the investigation.

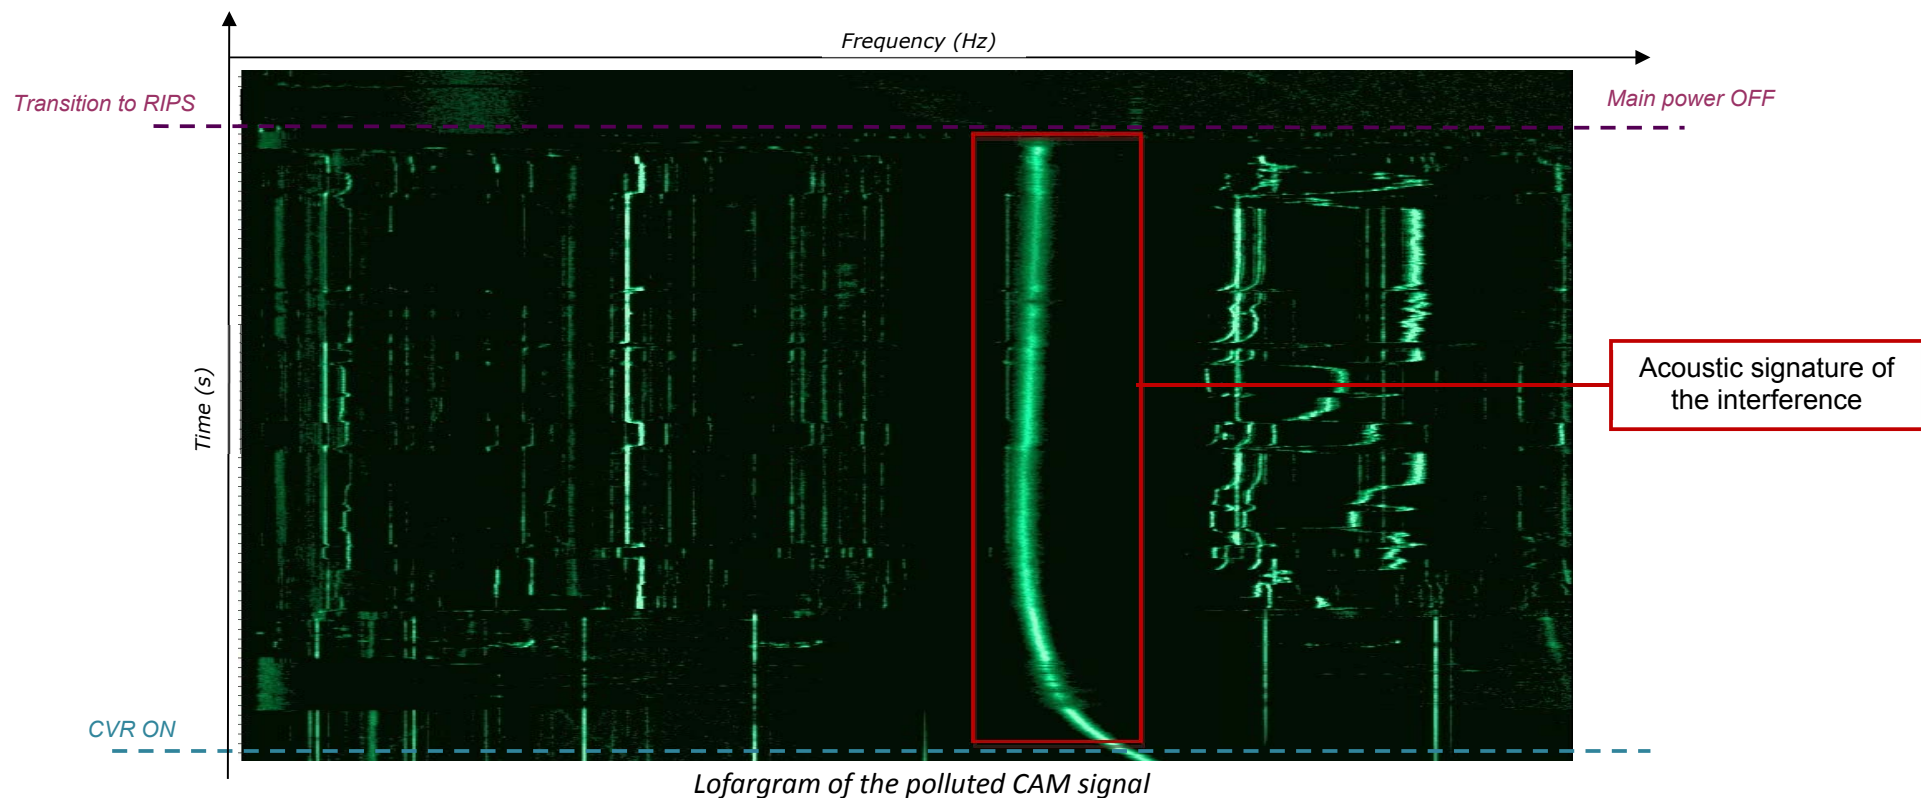
Figure 7 - CAM recording pollution - Spectrum view (Lofar)

This anomaly is easily detectable because it makes listening work quite uncomfortable. The presence of this type of pollution can be confirmed by a spectrum analysis (see Figure 7).

Lofargram of the polluted CAM signal

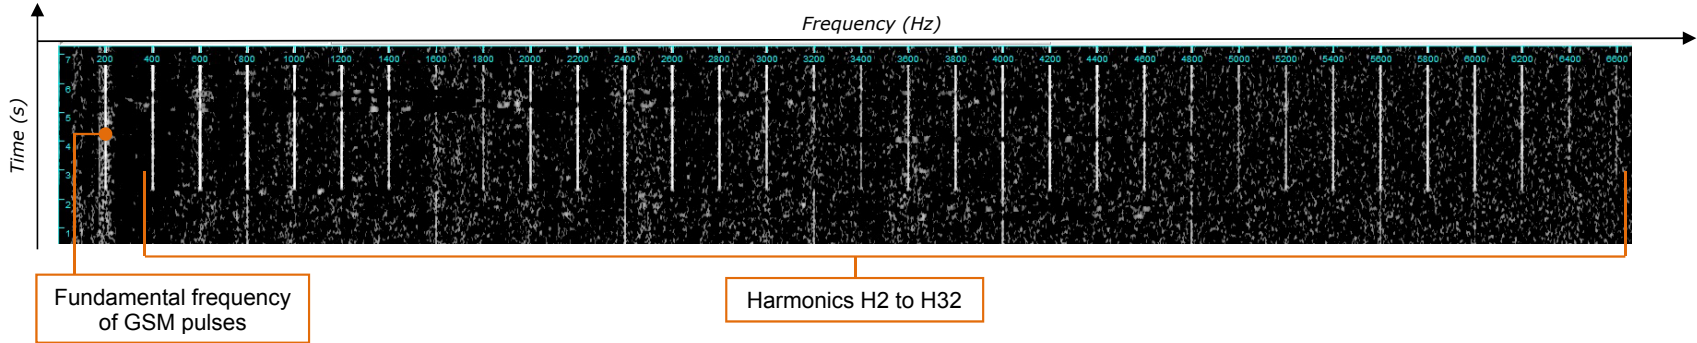
Figure 8 - CAM recording pollution by GSM pulses - spectrum view (Lofar)

This anomaly is characterized by the presence of interference on the CAM track. Depending on the level of the transmission, such interference may cause poor perception or even total masking of cockpit conversations. This defect can be detected by listening to the audio recording. A spectrum analysis will confirm its presence (see Figure 8).

Remark: the interference generated by GSM⁽⁷⁾ pulses depends on the frequency used (eg, 450 MHz, 900 MHz, 1800 MHz, 2.4 GHz). This pulse is transmitted every 4.6 ms. This periodic transmission produces, on the CVR acquisition installation, an audible signal whose fundamental frequency is 217Hz and some harmonics.

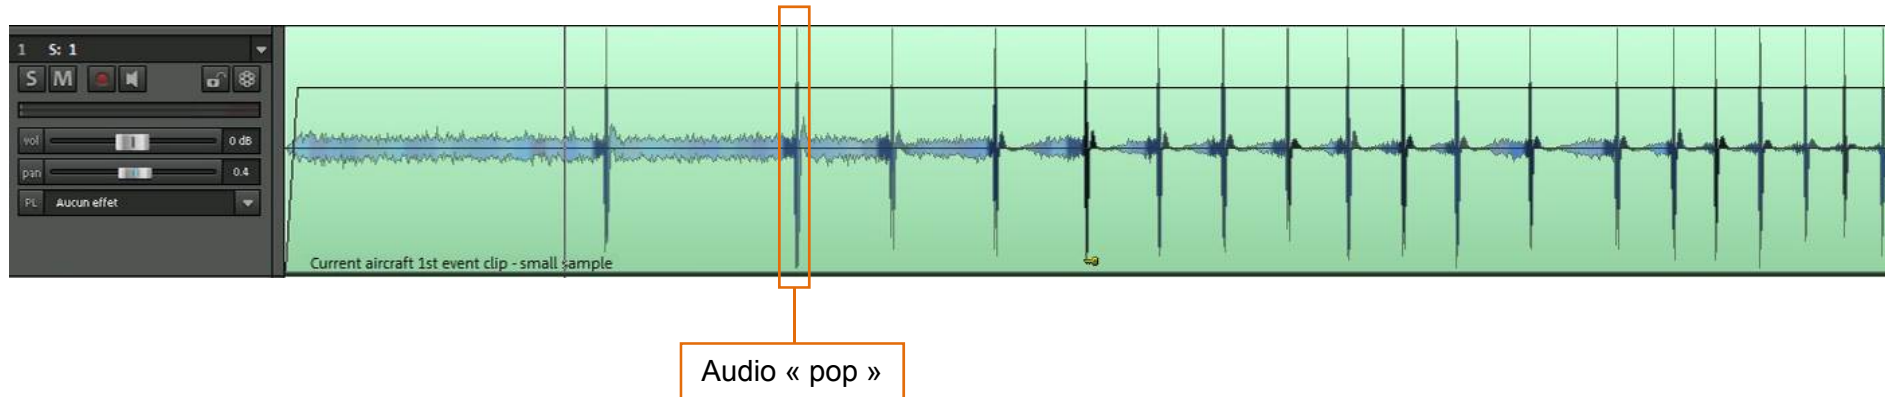
Figure 10 - audio popping on CAM recording - waveform overview

This problem appears when listening as a succession of “pops” on the CAM track. It is due to the sensitivity of the directional microphone or the Control Unit to electrostatic discharges (radiation). This event is predominant and easily identifiable on the waveform (Figure 10): It is similar to a succession of peaks, reaching the electric saturation point of the microphone.

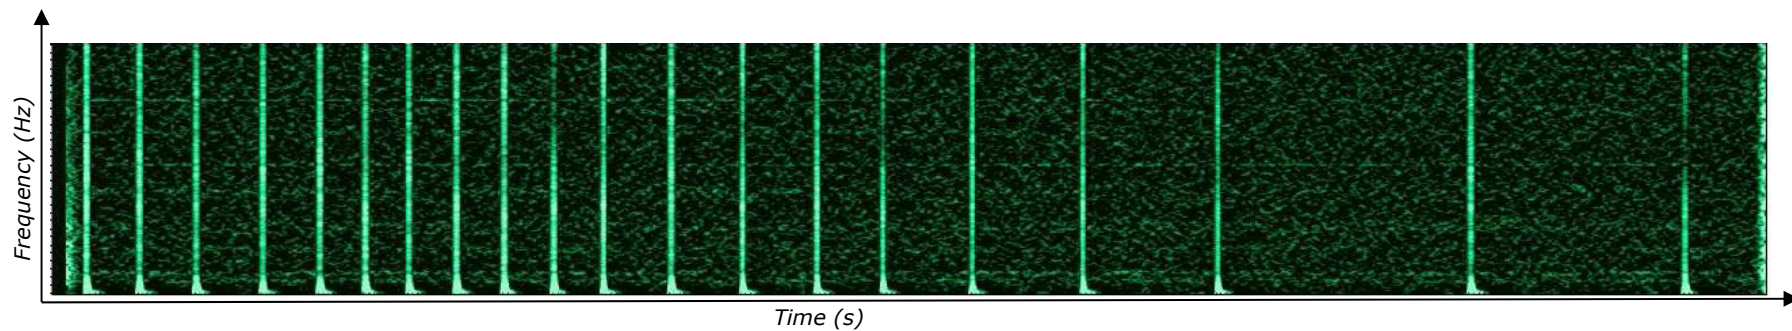
Figure 11 - audio popping on CAM recording - spectrum view (Sonar)

The defect becomes apparent with a spectrum analysis (see Figure 11): it may look like a series of «peaks» with variable levels of energy. The frequency of occurrence of these peaks is irregular: they may appear quasi-periodically or completely erratically.

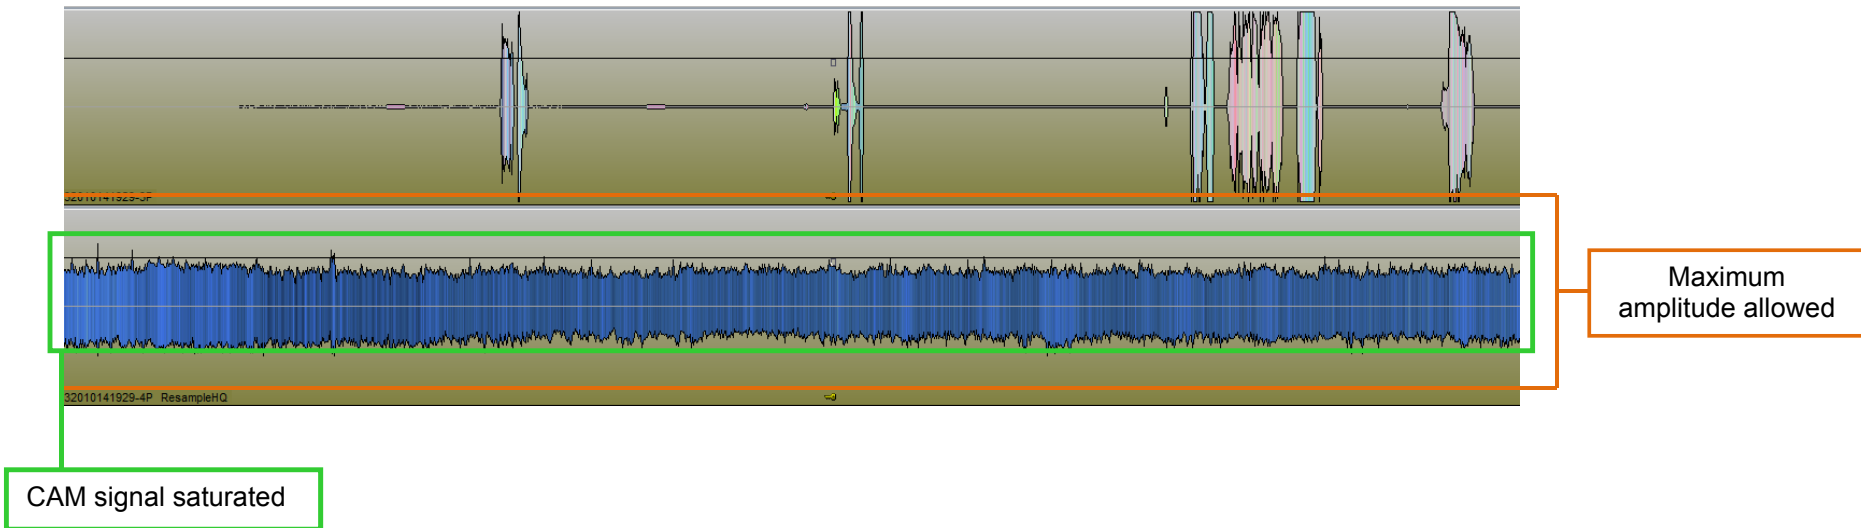
Figure 12 - CAM recording saturation - waveform overview

This saturation is due to an excessive sensitivity of the CAM to low frequency signals. This saturation is acoustic, not electrical, because observation of the waveform indicates that the signal does not reach the maximum amplitude allowed by the CAM (no clipping on the waveform) (see Figure 12). When listening, the recording is indeed saturated and all relevant audio signals (conversations, warnings, callouts) are covered by the low frequency noise.

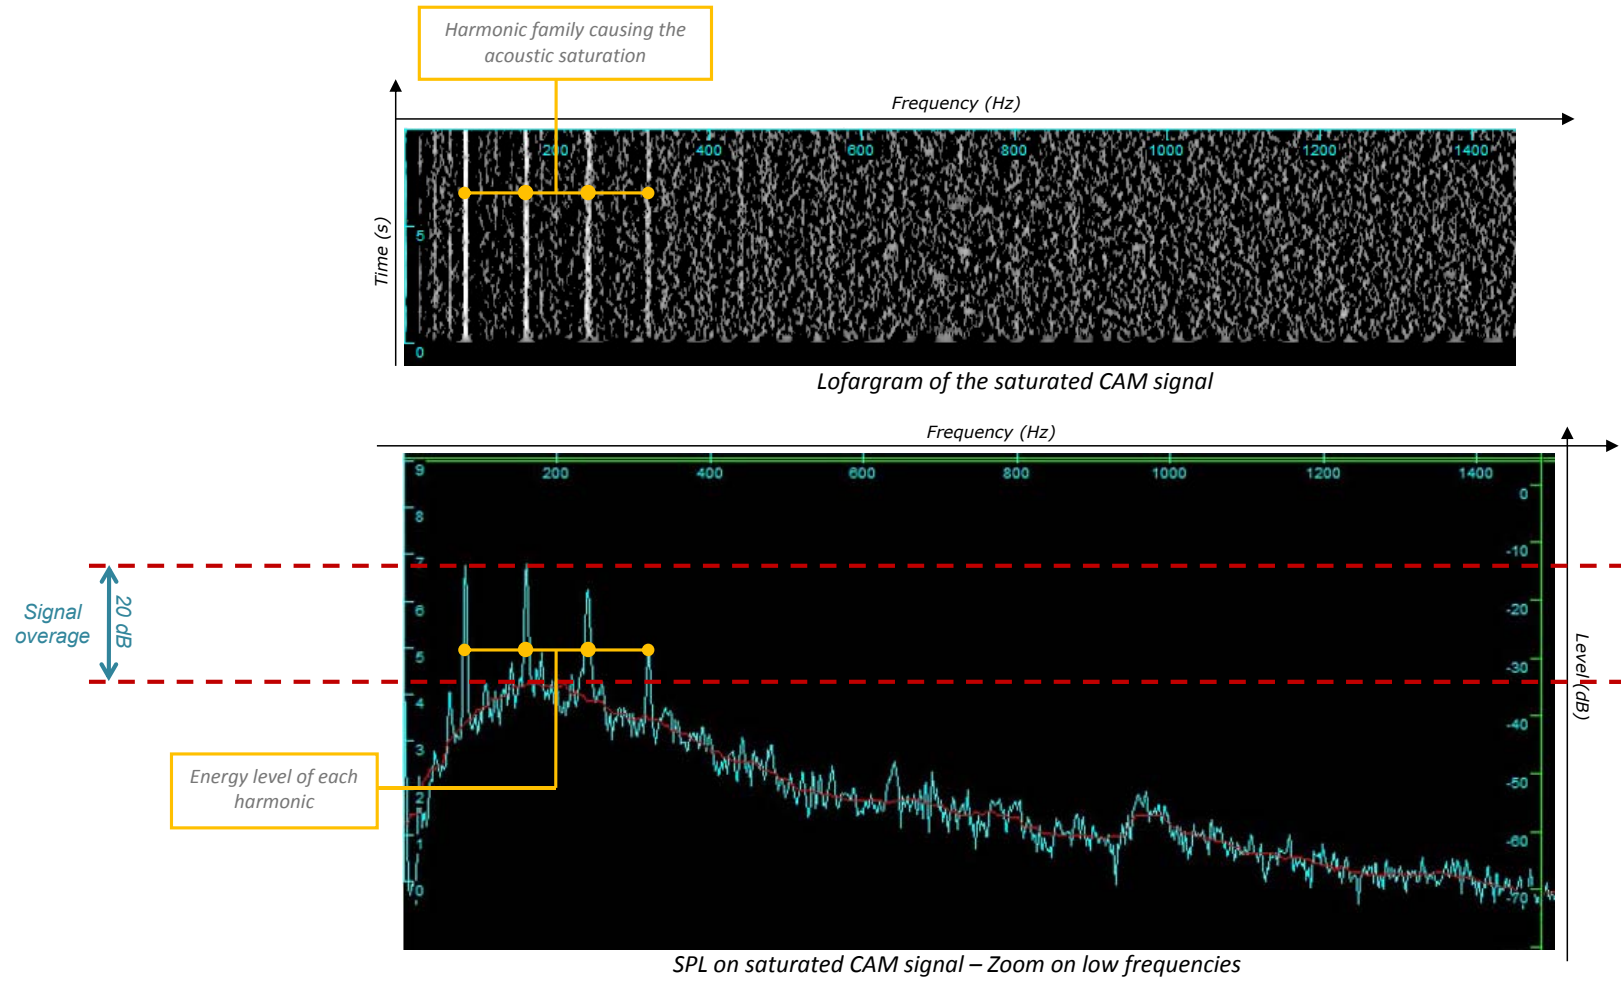
Figure 13 - CAM recording saturation - spectrum views (Lofar and SPL)

A spectrum analysis makes it possible to reveal this anomaly. In the example below (Figure 13), a harmonic family with fundamental frequency of 80 Hz (probably the acoustic signature of the aircraft propeller) is present. An SPL shows that this low-frequency harmonic family has a clearly predominant level compared to the general level of the CAM signal. This high level of energy is the cause of the acoustic saturation.

This interference causes listening discomfort which lowers the performance of the person responsible for carrying out the transcription work. However, it should be emphasized that ED112 does not mention any restrictions or limitations on the level of the recorded signal as long as it does not exceed the recording capability of the whole CVR installation. However, in an evaluation of CVR recordings, it is essential to draw attention to this problem when it occurs.

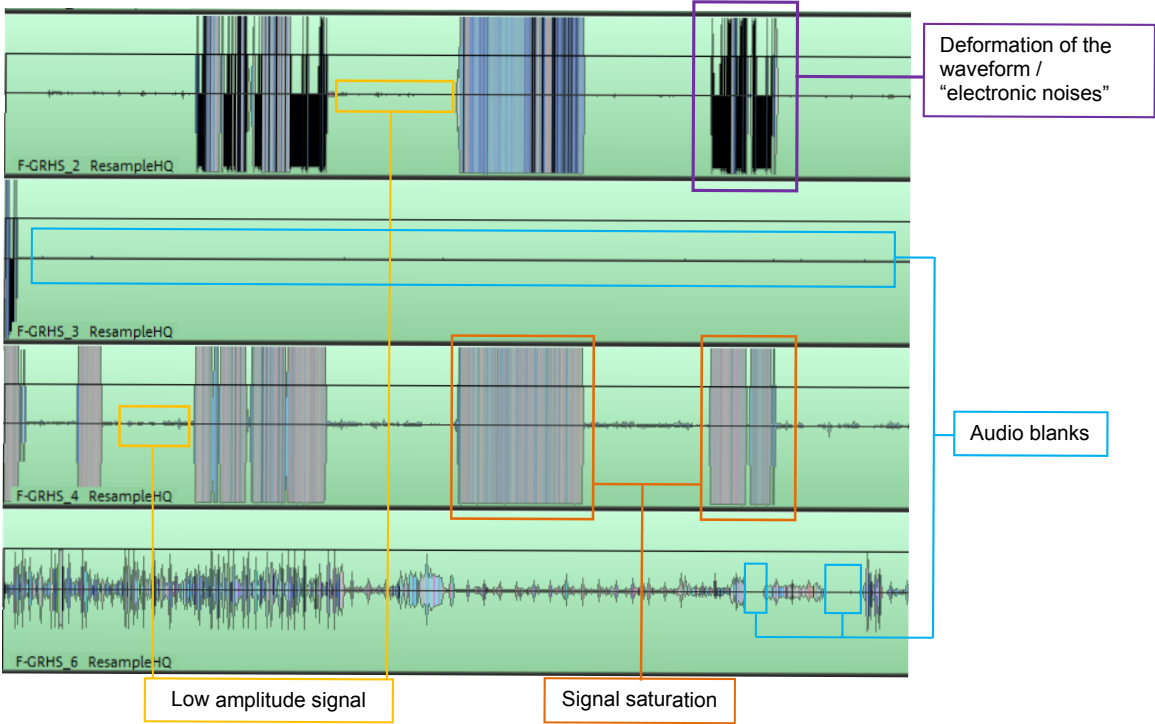
Figure 14 - erroneous memory management - waveform overview

This anomaly is characterized by a deformation of the audio signal. In some parts of the recording, the signal becomes unintelligible and includes “*electronic noises*”. It may happen that some parts of the signal have very low amplitude and sometimes a total lack of audio data (audio blanks).

This problem can be quickly identified by observing the waveform of the CVR recording (see Figure 14), observation confirmed by listening to the audio data. Generally, the waveform presents “*blanks*”, significant differences in amplitude on the same track (alternation of saturated signal and low amplitude signal). This defect often makes CVR recordings unusable, causing partial or total loss of audio data.

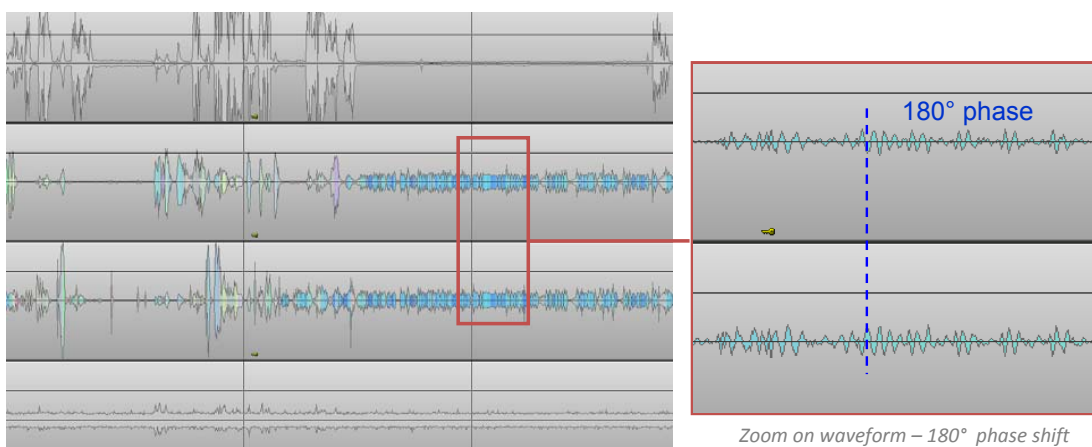
Figure 15 - audio signals in opposite phase - waveform overview

It sometimes happens that some audio signals (crew conversations, warnings, ATC communications, etc.) are not recorded with the same phase on each track of the CVR. This phase shift is particularly troublesome when it is 180° (opposite phase signals).

In practice, the same sound event (ATC message, warnings, etc.) will have weakened or even canceled amplitude if it is recorded on a mixed track on the CVR. The effect of this anomaly also appears when the tracks containing phase shifted signals are synchronized and played back simultaneously.

This anomaly is similar to a loss of audio data and is detrimental to any analytical work on audio recordings, particularly if some of the information useful for the investigation can be found only on the mixed track.

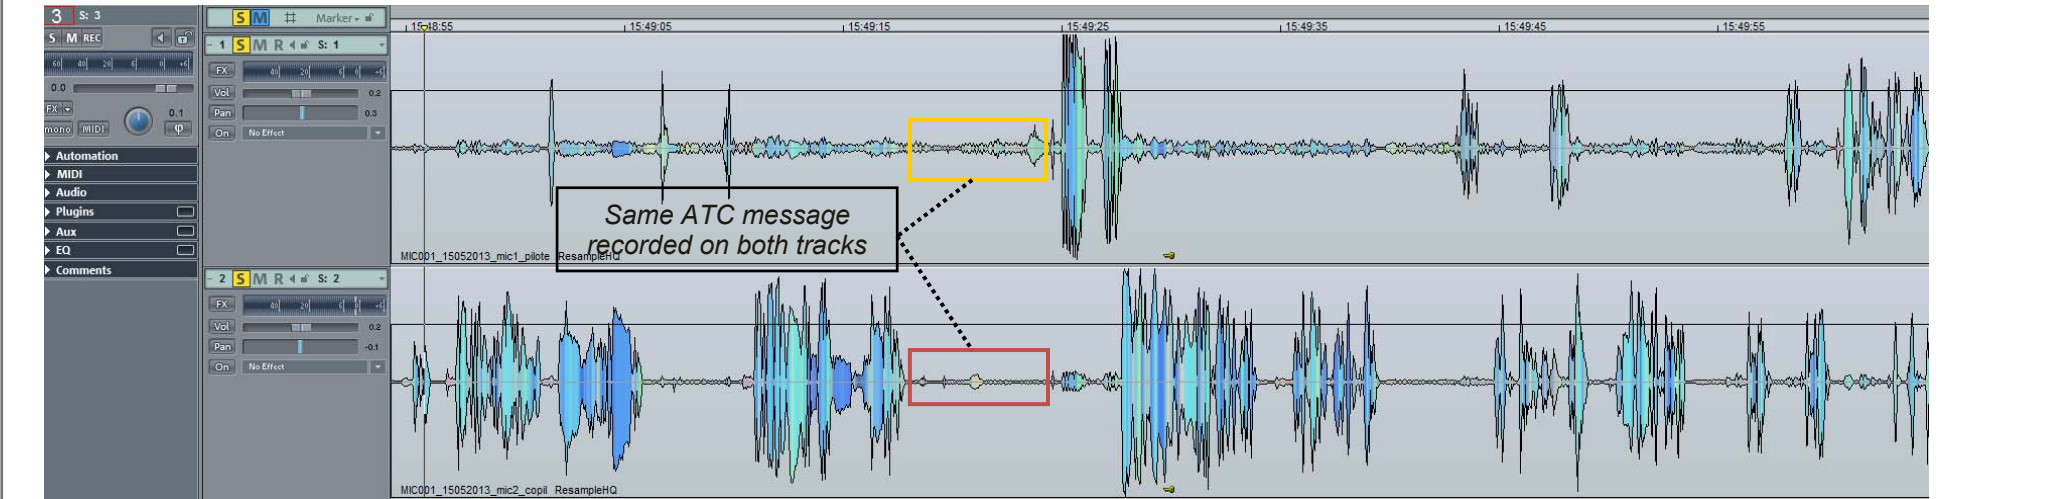
Figure 16 - level imbalance - waveform overview

This anomaly is characterized by a level difference between the input signals, particularly with regard to the level of ATC communications. In the following example (Figure 16), the ATC message is strongly attenuated on the second track (circled in red), and is almost inaudible.

This defect is detected by observing the waveform of the signal on each track. It can be confirmed by listening to each track separately, the difference in level can then be easily detected.

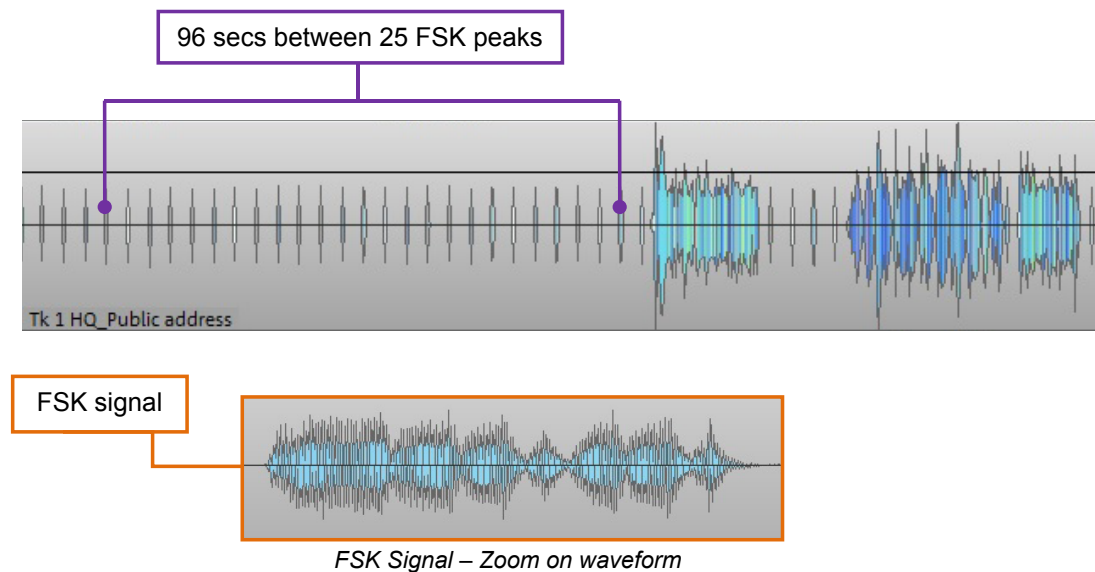
Figure 17 - FSK signal - waveform overview

This anomaly has only been encountered once at the BEA. During normal playback, the audio data downloaded replayed slower than the original data (audio content slowed down). This defect was due to a problem during the signal sampling.

Example (see Figure 17): There is theoretically 96 s (24 four-second gaps) between 25 FSK peaks. If the measured value of 25 peaks is not equal to 96 s, then the fault is present on the CVR.
