# INVESTIGATION REPORT

## Serious incident to the ATR 42-600 registered V2-LIK

on 14 October 2014

## Martinique Aimé Césaire airport

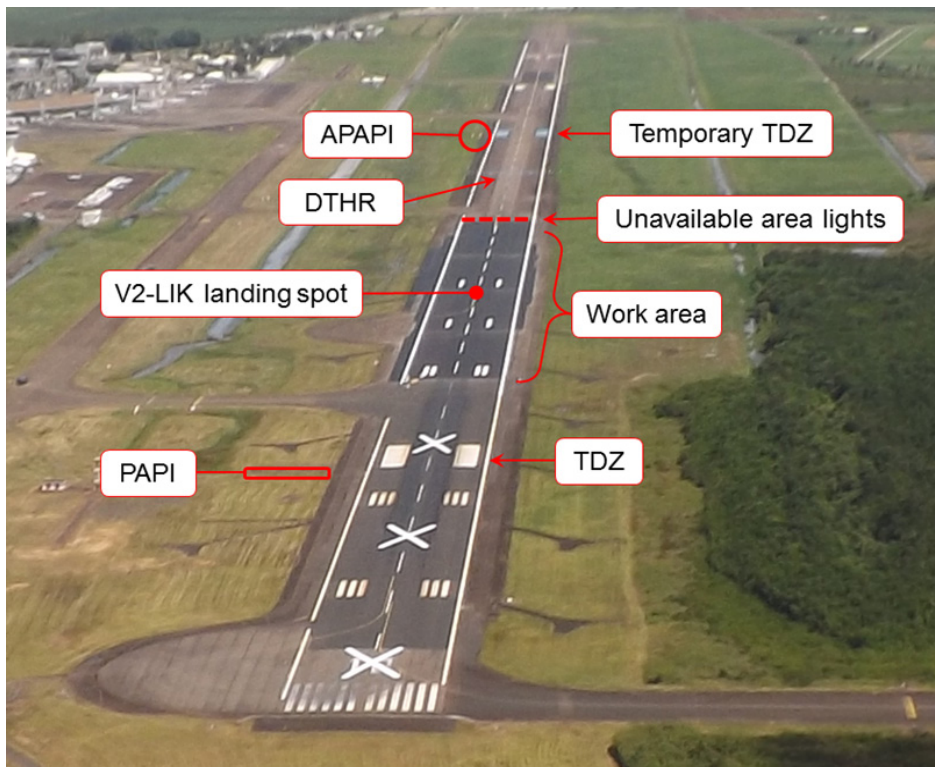
Figure 1: View of airport taken day after event. See Appendix 4.

The aeroplane landed 940 m from the runway 10 threshold, i.e. 560 m from the temporary displaced threshold, in the work zone; during the landing run, it struck a temporary boundary light.

The aeroplane continued the run. The pilots saw the APAPI. The first officer told the captain that he had not correctly identified the line marking out the work. He thought that the APAPI was "too far away" and had thus not been alerted by its red lights. He specified that the day before he had landed at the beginning of the runway.

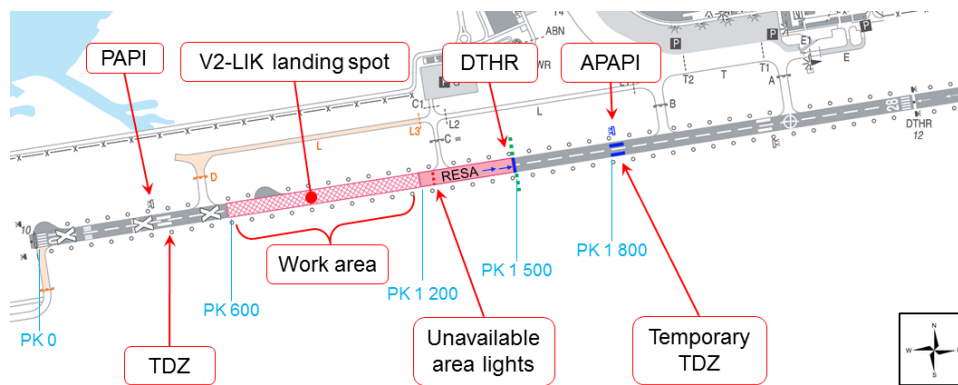
Figure 2: Diagram of runway

The worksite was positioned between PK 600 and PK 1,200 (see Figure 2: work zone). A RESA<sup>(9)</sup> was created before the displaced threshold, between PK 1,200 and PK 1,500 (see Figure 2). The runway use restrictions, indicated in the AIP supplement (SUP AIP, refer to [annexe 2](#)) were the following:

The airport operator chose to mark the unavailable zone of the runway with white crosses as recommended by the CHEA order. However, the white crosses were only affixed before the work zone and not at each end of the prohibited portion.

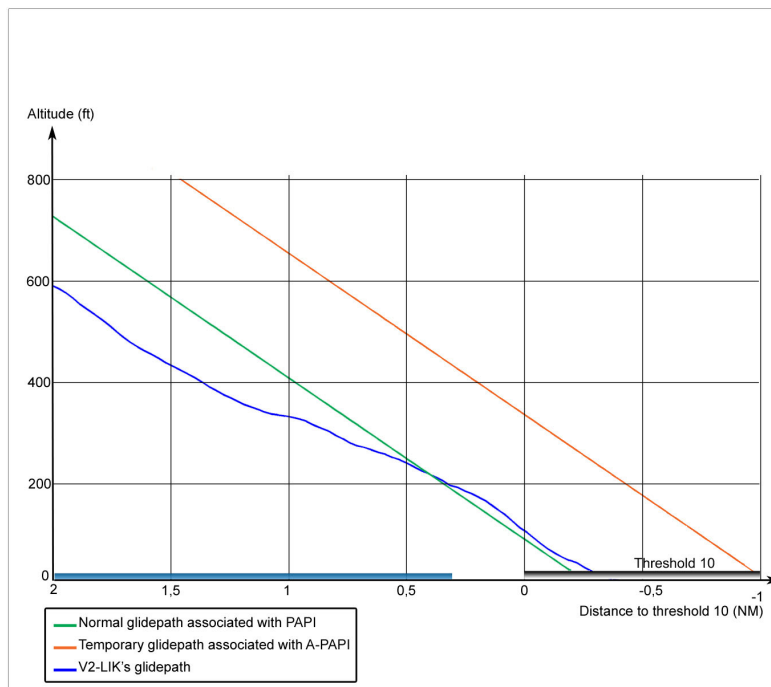
Figure 4: Glidepaths

It can be seen that the aeroplane was below the normal glidepath up to around 0.4 NM from the threshold of runway 10 before passing above this path up until landing. It landed 940 m from the runway threshold. It did not follow the temporary glidepath shown by the APAPI.
