Serious incident

to the Airbus A319-112 registered **LZ-FBB**
and the Airbus A320-232 registered **TC-FBJ**
on 25 November 2014

at Paris-Charles-de-Gaulle airport⁽¹⁾ (Val-d'Oise)

Runway incursion by an aircraft during take-off of another aircraft

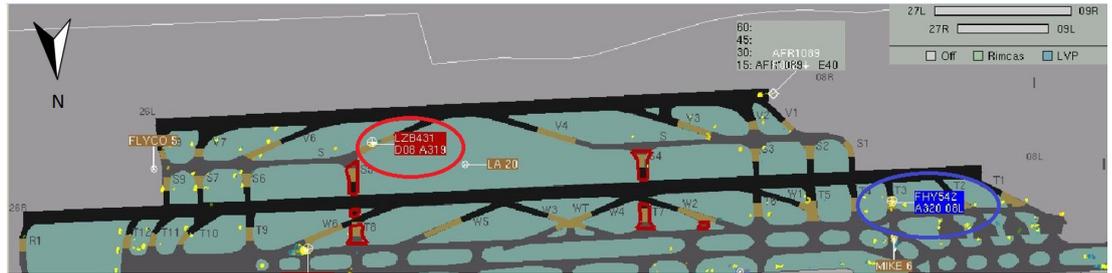
At 08:18:43, the LOC controller⁽⁶⁾ indicated to the crew of flight LZB431, which had just vacated runway 08R via taxiway V5: *“Bulgaria 4 3 1, hold short of 0 8 L, holding point S 6.”* The crew of flight LZB431 correctly read back.

Figure 1: positions at 08:18:43 (ground radar): LZB431 in red and FHY542 in blue

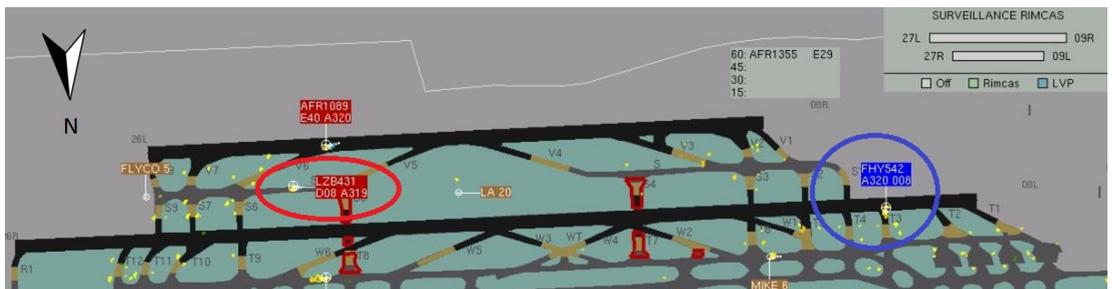
At 08:19:34, the LOC controller indicated to the crew of flight LZB431, *“Bulgaria 4 3 1, number one, keep on taxiing.”* The crew of flight LZB431 read back using the same terms as the LOC controller.

At 08:19:37, the LOC controller told the crew of flight AFR1089 to taxi behind the 319 Bulgaria on left. The crew of flight AFR1089 asked whether they were cleared to cross. The LOC controller replied no. These exchanges were carried out in French.

Figure 2: positions at 08:19:30 (ground radar)

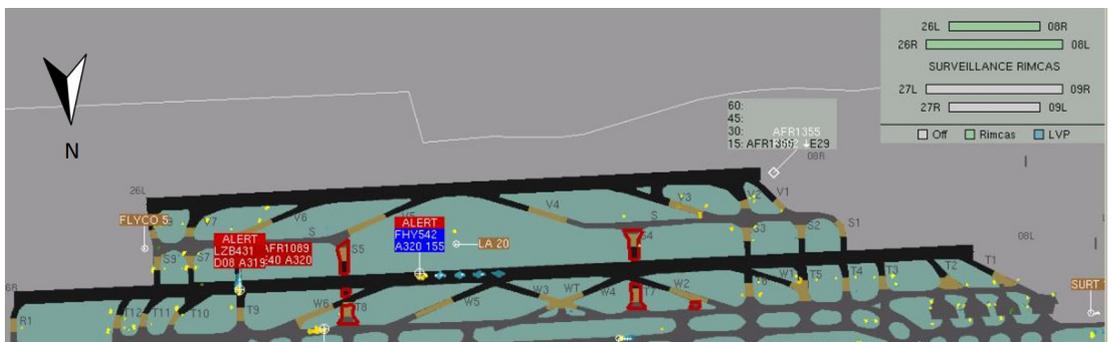
At 08:20:17, LZB431 entered runway 08L via S6. The RIMCAS⁽⁷⁾ warning was triggered one second later. FHY542, performing the take-off run, was at approximately 1,500 m before the intersection with taxiway S6 and at an indicated airspeed of 139 kt.

Figure 3: positions at 08:20:28 (ground radar)

At 08:20:37, FHY542 flew over the intersection with S6 at a height of around 500 ft. LZB431 had vacated the runway and was stopped on taxiway T9.

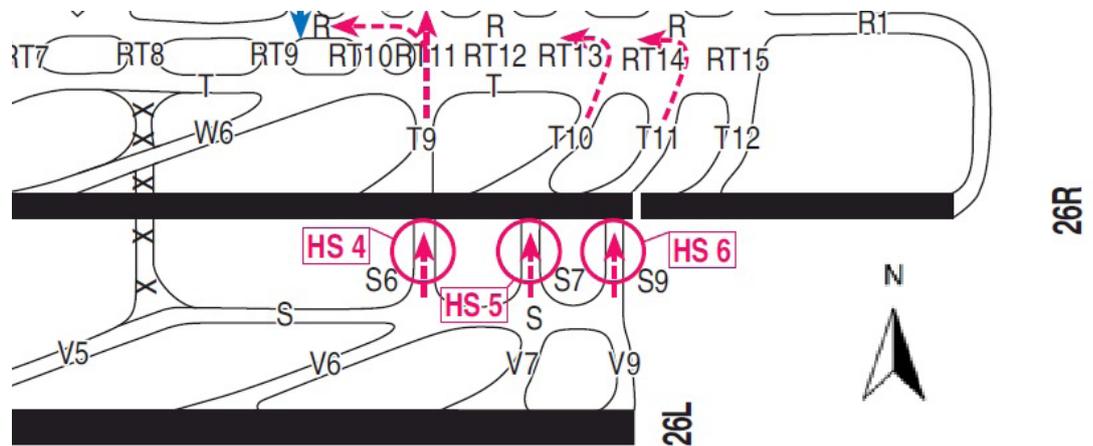
For each runway direction, the taxiways closest to the centre of the runway were closed so that the runway is crossed at a greater distance from the threshold of the runway in service. Thus, in the event of an incursion, there is a greater chance that the aeroplane taking off will have taken off before crossing the aeroplanes crossing the runway. On the south twin runways, taxiway S5 had therefore been withdrawn from use. When vacating via taxiway V5, the first intersection taxiway is therefore S6.

Figure 4: drawing of intersection taxiways

There are differences in altitude between the various points of the Paris-CDG airport. In particular, the first five hundred metres of runway 08L are around eight metres higher than the threshold of runway 26R. It can therefore be difficult for pilots crossing the inner runway via S6 to see aeroplanes taking off from threshold 08L.

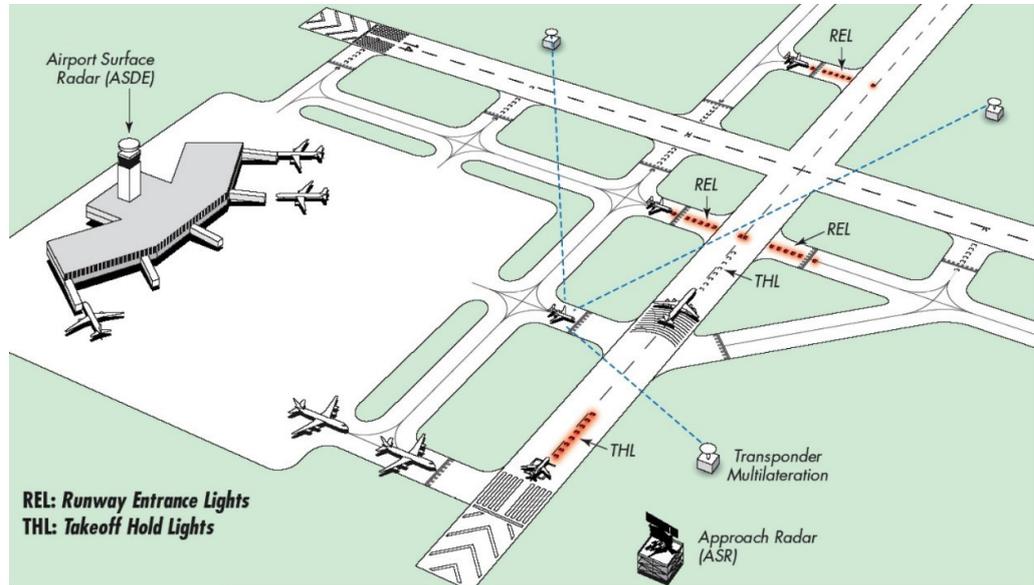
Figure 5: General diagram of RWSL

In addition, the RunWay Status Lights system (RWSL) initially installed and tested at the beginning of 2016 on the north twin runways of the Paris-CDG airport was deployed and commissioned on the two, north and south, twin runways on 23 May 2017⁽¹⁴⁾.

When an aeroplane has started its take-off run, the RELs light up to indicate to the aeroplanes on the runway access taxiways that the runway is occupied and that it is dangerous to enter or cross it. When one or more aeroplanes are crossing the runway, the THLs light up to indicate to the aeroplane lined up that it is dangerous to take off on this runway.
